# Destructive testing and failure analysis of a full-scale composite tidal turbine blade

Fergus Cuthill, Sergio Lopez Dubon, Christopher Vogel, Miguel Valdivia Camacho, Conchúr Ó Brádaigh and Eddie McCarthy

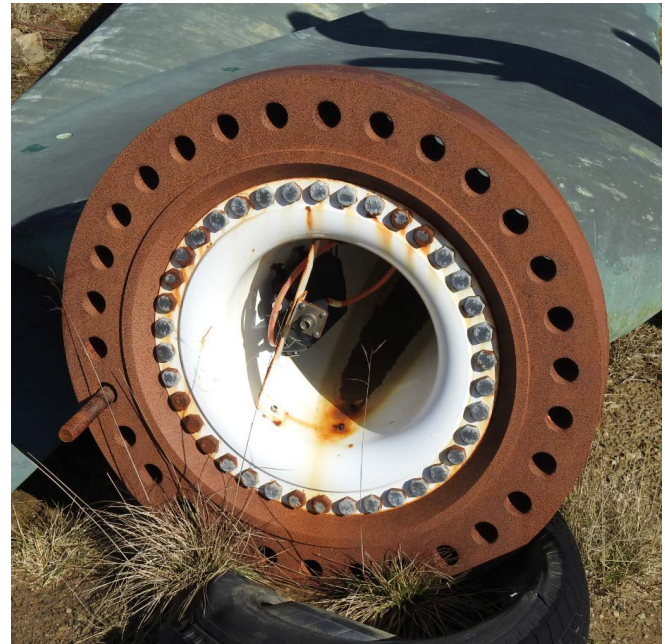
Following the successful deployment at EMEC, the turbine was later upgraded to 1 MW in January 2013 [11], this resulted in the blades from the 500 kW version lying in storage in Orkney as seen in Fig 2. The blades were stored uncovered, outdoors, for 8 years before being delivered to FastBlade in 2021 for testing. In

Fig. 2. 500 kW TGL Turbine blade stored outdoors in Orkney.

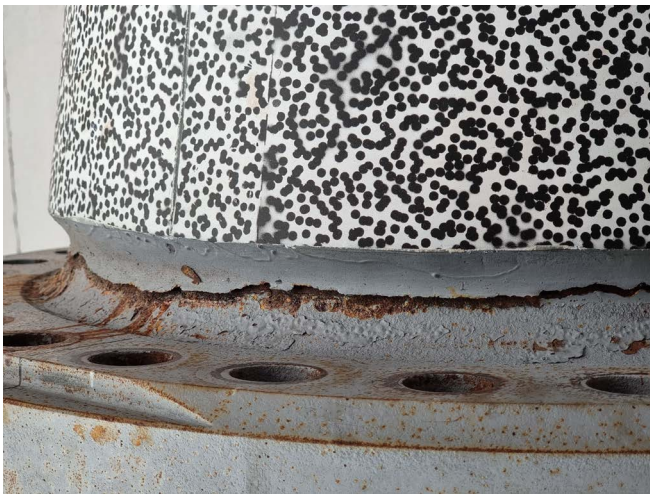
Fig. 6. Image of failed blade root showing crack from delamination extending around the circumference of root connection.

described in the timeline of blade testing above, the first detectable failure occurred at the root of the blade. The failure initially appeared as a debond between the glass fibre skin of the blade and the steel root connection, as shown in Fig 7. The failure occurred during a static test, targeting an actuator load of 220 kN at a loading rate of 1.467 kN/s; during the ramping, failure in the root occurred at 200.3 kN, with an average load drop of 5 kN on each of the 3 actuators. Nevertheless, the test was continued, as the load appeared to recover and stabilise after the initial failure; however, after a further failure at 206.2 kN, it was decided to stop the test for inspections. A graph showing the initial load drop for a single actuator can be seen in Fig 6. After the inspections identified the delamination root failure, the test was repeated, and the load of 220 kN was achieved and held for 150 seconds with no further failures detected. After this test, the decision was made to attempt to initiate a crack failure in the blade, as the first failure mode had been identified, and it was believed that pushing further would have resulted in further failures at the root with little extra information gathered about other areas of the blade.

The delamination that occurred between the steel root plug and the composite skin was the first failure mode that was detectable in the turbine blade, without artificial influence from stress holes/notching. However, this failure may have been influenced by the service and storage conditions of the blade; as can be seen in Fig 2, the root section of the blade was coated with rust after years of storage. This rust may have extended into the bonded area between the skin and the steel, resulting in reduced bond strength and the resulting failure. Rusting can be a major concern while a blade is deployed in the ocean, but regular inspection, with rust prevention techniques and coatings, may have prevented extensive rusting of this blade. After the root debond failure occurred, the blade was still capable of withstanding the design fatigue and ultimate load cases, so it is not expected that this failure would have been catastrophic for a blade in service, and it may have been repairable.

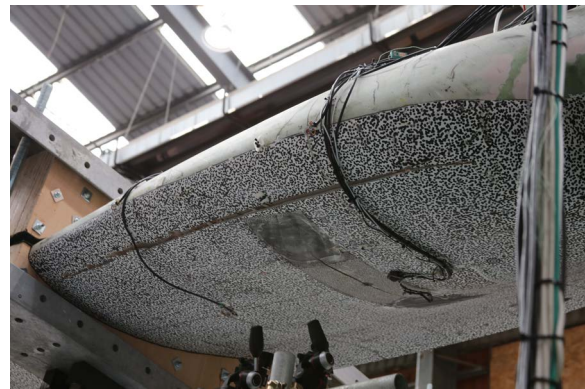
The final failure of the blade occurred during fatigue testing, where the aim was to further progress the cracks that had been detected at the notch tips. The bonded seam between the top and bottom skins of the blade, along the leading edge, suffered catastrophic debonding, with approximately 1 m of seam bursting open in less than 0.1 seconds. This seam then continued to open until the clamping force of the loading saddle restricted its further propagation along the leading edge. The seam burst on the cycle before the test was stopped, meaning the reduction in stiffness of the blade

resulted in the control system increasing the oil flow required to deliver the additional displacement of the actuators. This resulted in an overshoot of the target load as seen in Fig. 9, with the test system reaching a limit state and shutting down. The seam failure near the leading edge of the blade is shown in Fig 10.

Fig. 10. Image showing blade seam failure at the overlap where the top and bottom skins of the material were bonded.

The most significant failure, relevant to the blade in service, is the debonding of the adhesive at the bond line along the leading edge of the blade. In the testing at FastBlade, however, this failure likely occurred due to the machined notch weakening the blade and altering the load path to the root as no significant strain was noted along the leading edge before the notches were cut in the blade. Manufacturing issues or debonding of the adhesive between the spar and skins could easily result in this load path through the skin being a likely failure mode for the blade. If this blade failed in this way during service, it is unlikely that any repair would be possible due to the difficulty in re-establishing a good bond between the skins and the inability to inspect or repair any bonding issues anywhere else in the blade.

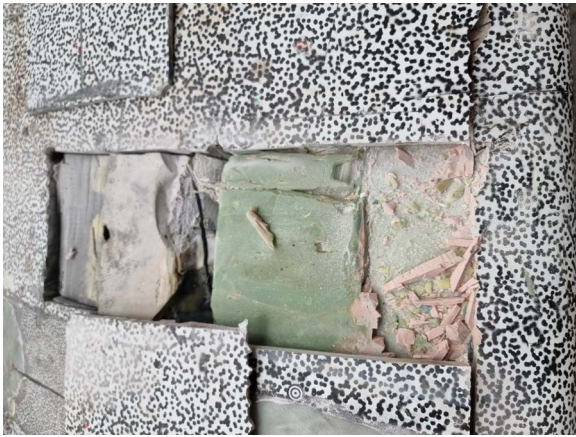
3) *Incorrect bond areas*: 3) Along the skin bond at the leading edge, the manufacturing drawings indicated a full structural bond throughout the entire overlapped area, however, when inspecting the failed edge, it was found that only approximately 50 % of the overlap was bonded, the rest appeared to be a non-structural filler. This was likely required due to issues encountered when attempting to assemble the blade but will have reduced the strength along the leading-edge bond significantly. A cutaway section of the blade from the leading edge bond to the carbon spar can be seen in Fig 14.

Fig. 14. Image showing a section of blade with the outer skin removed. From bottom to top: leading edge of blade, pink coloured filler at overlap seam, green Spabond adhesive, black carbon spar.

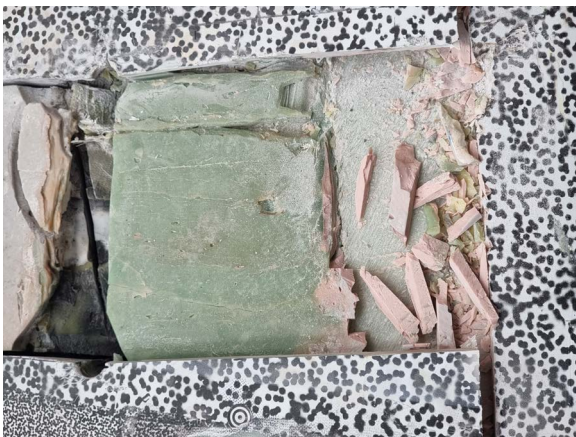
4) *Adhesive voids*: Where the adhesive is used in the blade, there are large voids where the adhesive has not fully spread to cover the area under the skin. Fig 15 shows this, where it appears that the adhesive was applied in lines, expecting the compression of the skin to spread the adhesive correctly. This likely resulted in reduced bond strength and stress concentration along the numerous additional bond edge voids.

Fig. 15. Section through blade skin showing voids in between adhesive bond lines. Adhesive thickness at this location is approximately 15 mm.
