FoDTEC final summary report

Author: Tim Warren
Date: 07/05/2020
Reference: FT-008
Version: A

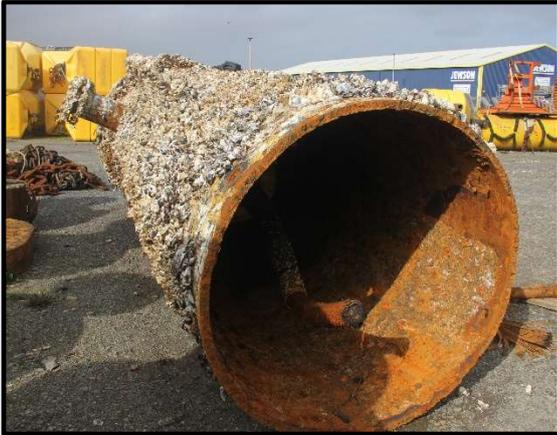
Tower top survey: this structure was almost entirely covered in biofouling organisms creating a complex matrix extending typically 8-10cm but in places to over 12 cm in thickness (Figure 5). The dominant species were *Chirona hameri*, *Mytilus edulis*, and a wide variety of sponges, especially underneath features. Significant fouling was observed of saddle oysters, a turf of hydroids, and the barnacle *Balanus balanus*. Biofouling of structures placed in the marine environment will undergo a series of successional changes, depending upon the season of deployment. Pioneering macrofouling is often associated with colonial hydroids. After prolonged deployment, larger and more slow-growth species may dominate fouling. Studies of the fouling assemblages on the TGL tripod reported here can be considered as indicative of 'end-stage' or 'climax' biofouling communities on steel in these habitats. Once these stages have been reached, the assemblages observed here would not be expected to change much over time, except for localised areas of disturbance. Reports from the oil and gas sector have identified similar fouling assemblages on long-term deployed infrastructure in the North Sea (Forteath *et al.*, 1982). Patches of thicker fouling versus exposed substrate indicate that some level of disturbance can and does occur, perhaps as the consequence of large sediment impact.

Figure 5 - The vertical subunit of the tripod surveyed on 15 September 2019. Note the thick encrustation of barnacles and mussels

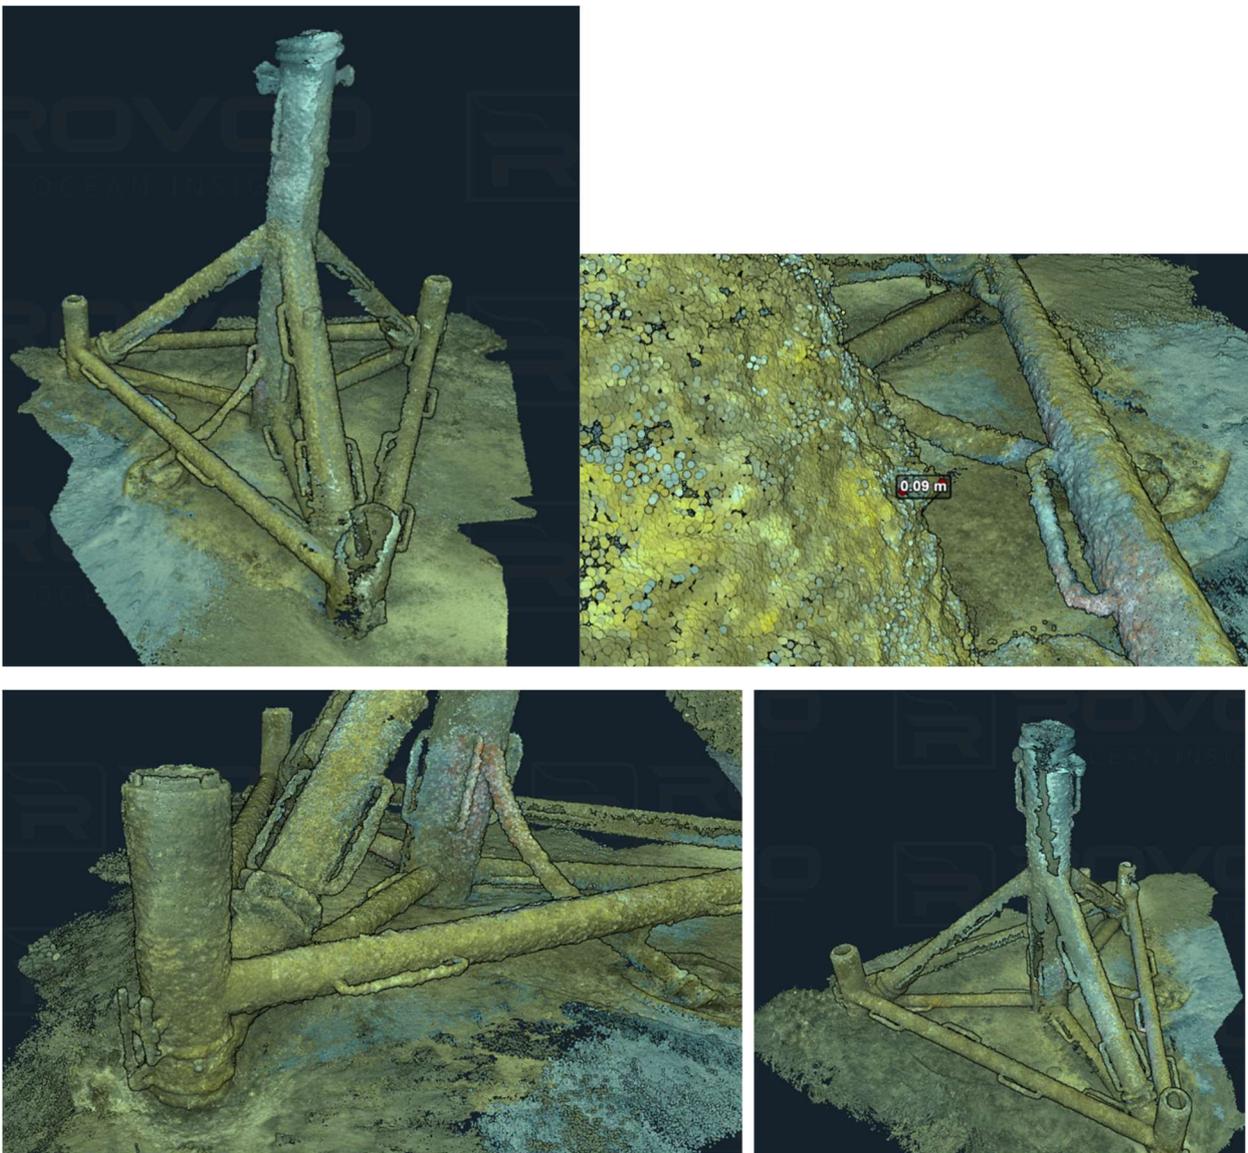
Figure 7 - 3D scanned point cloud data of underwater tripod, showing overview, a measured biofouling thickness and details of key features.

- The 3D point cloud images provide excellent overview of the tripod, and it is clear that this technique can provide invaluable data for subsequent marine operations.
- Some point cloud data is missing, in particular on the underside and “inside” surfaces of the tripod members. This is due to restricted access of the ROV, as it is unable to fly under some members to view the underside.
- Analysis to determine the effects of tidal direction have not highlighted any particular results. This implies that flow speed in tidal sites is not too fast to prevent growth, nor is there any preference of biofouling to grow in higher or lower flow speed regions. This is corroborated by the biofouling survey and visual inspections
- Assessment to determine biofouling thickness has determined a large range of thicknesses. This is not particularly dependent upon flow direction.

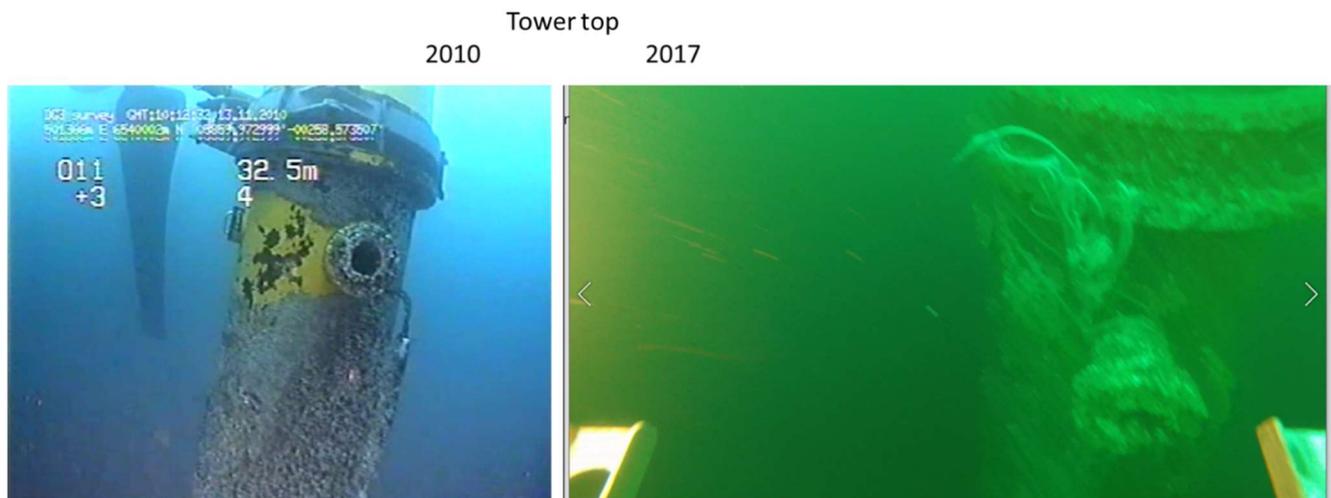
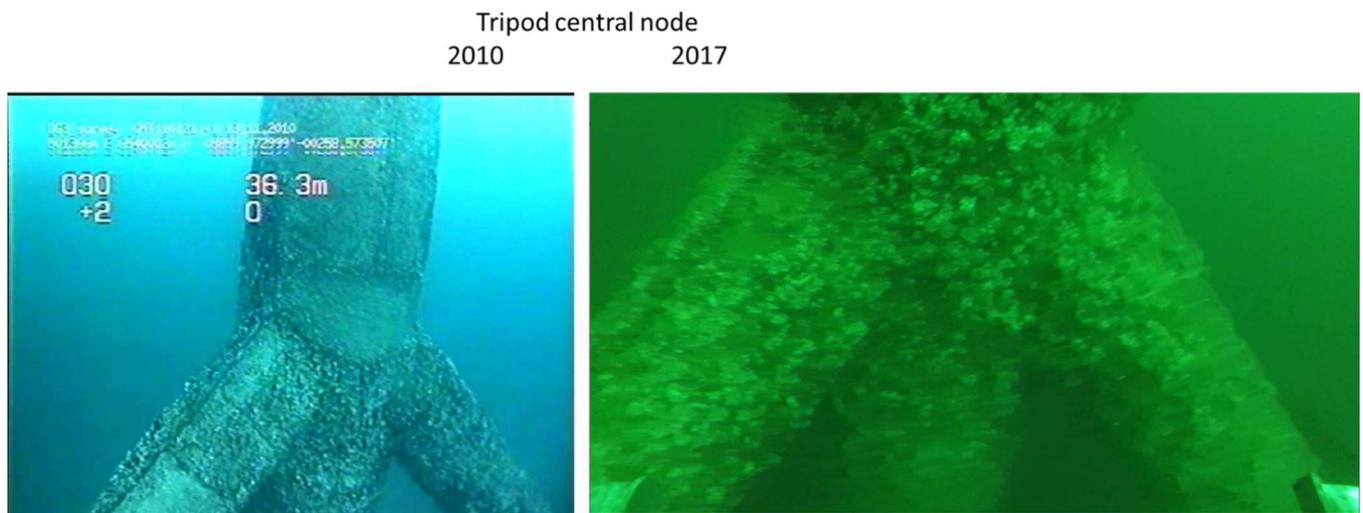
J-tube with cable exit
2010 2017

Specific conclusions from the ROV footage are difficult to draw, but it is clear that the biofouling has increased significantly over the time period. It is not possible to infer conclusions about directionality of the tidal flow and the effect on bio-fouling, but it is clear that biofouling is less dense where:

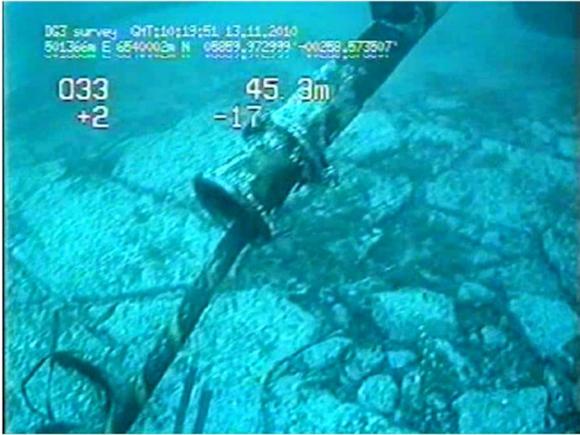
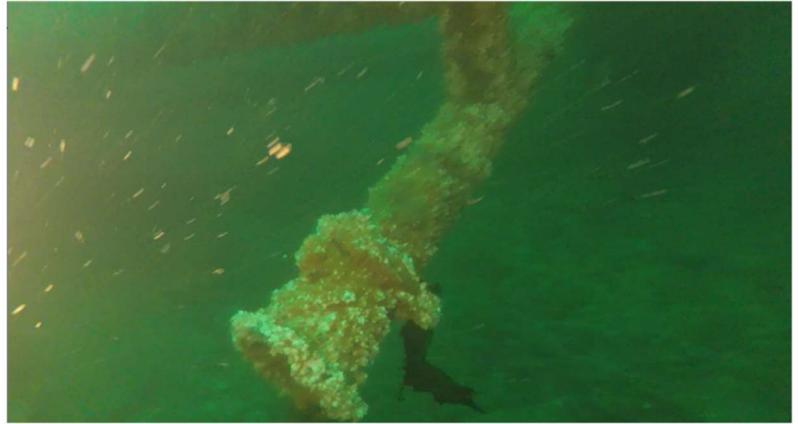
Tripod leg with grout lines
2010 2017

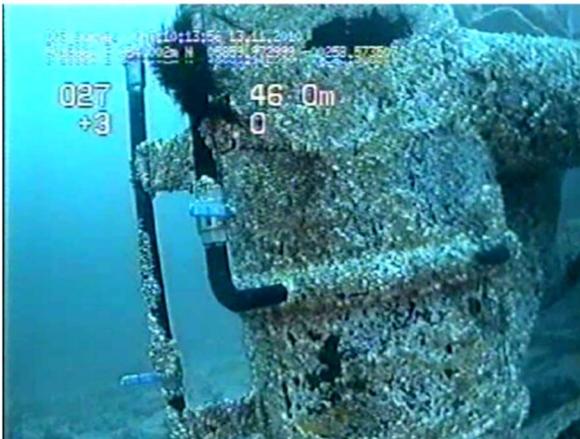
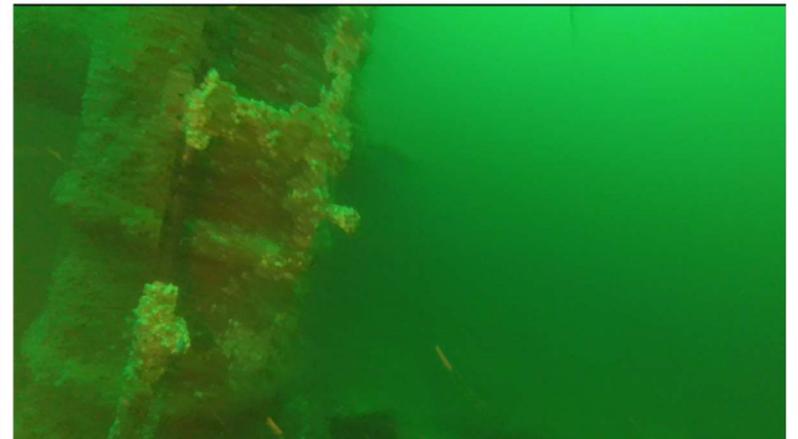
Tripod leg with stinger
2010 2017

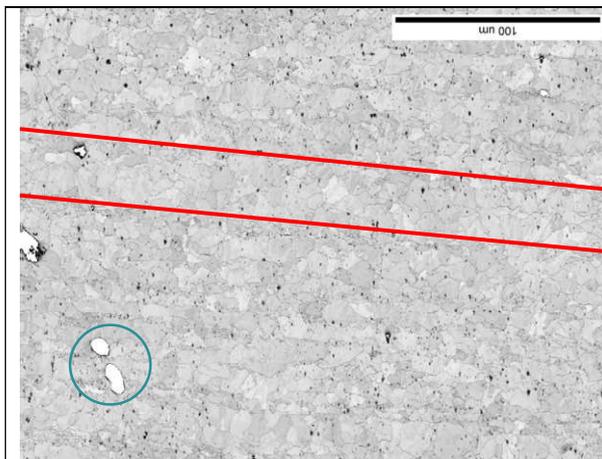
This sample showed a ferritic structure, determined using the indexing of the diffraction patterns obtained by EBSD, with randomly oriented (Figure 14) equiaxed grains of 10-20 μm size. Bands (highlighted in red in Figure 11) derived from the hot rolling are visible in the material without any deformation of the alignment. Furthermore, the random orientation observed (Figure 11 and Figure 14) indicates that heat treatment was performed after rolling to minimise the rolling effect and allow grain relaxation. Strain can be seen as internal misorientation in the grains, but no strain was visible within the grains, any misorientation detected was due to sample preparation. This can be ascertained looking at the variation of orientation (misorientation) within the grains and observing if this variation continues in the adjacent grain or not. If the misorientation can be seen in 2 or more adjacent grains then the variation is due to sample preparation, if it is confined within one grain then it is due to strain. Some porosity is visible in the sample (left hand side of Figure 11, white ellipsoidal points highlighted with blue circle), however they do not show any link with the exposed surface (i.e. they are not linked to pitting) and they do not show any deformation.

Figure 11 Image Quality map showing the banding phenomenon (highlighted in red) and some porosity (white ellipses in the left-hand corner)

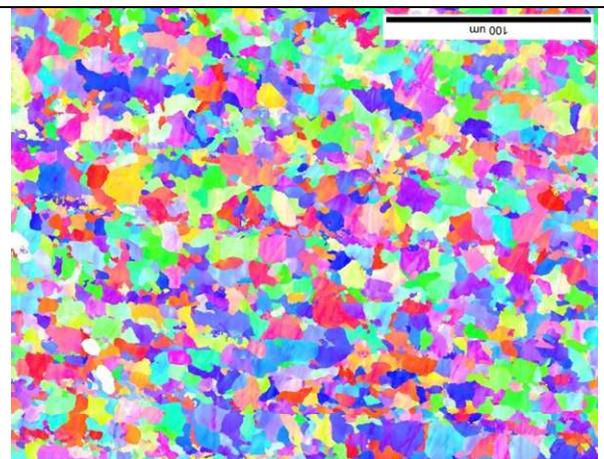
Figure 12 Inverse Pole Figure map showing the random orientation of the grains and the banding of smaller grains (perlites)

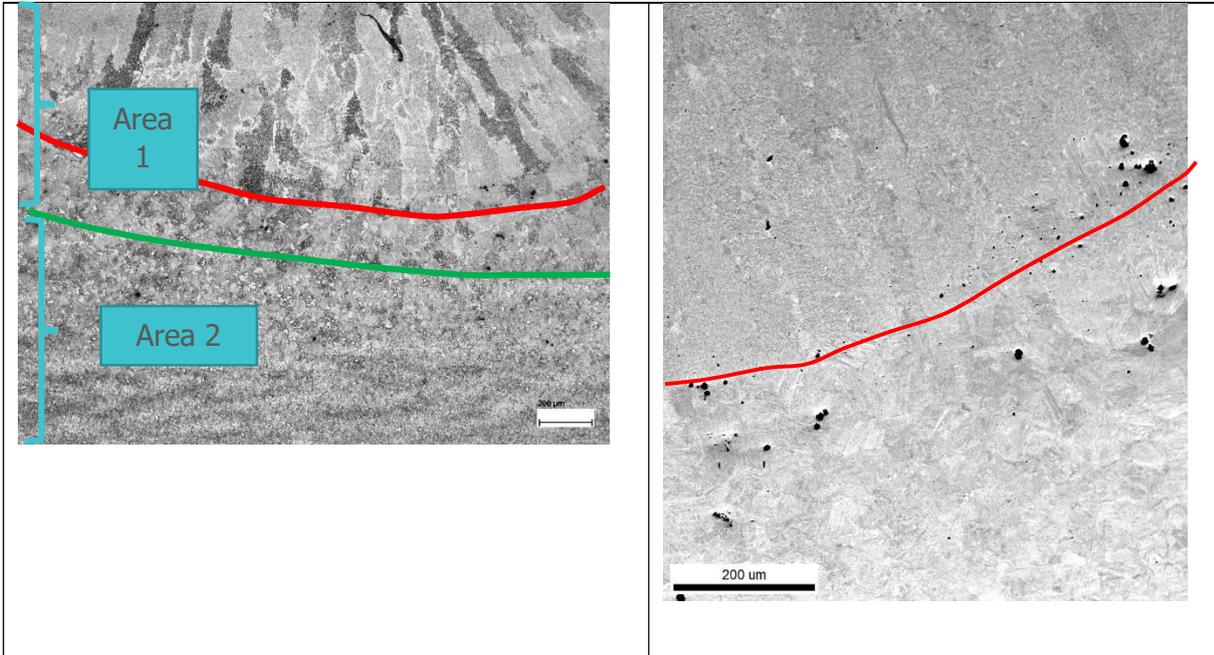
Area 1 (Figure 18) The optical microscopy observation shows a variation in the texture of the sample (elongated grains above the red line in Figure 19, Widmannstatten microstructure between the red and the green line and equiaxed grains below the green line). On the top elongated grains are visible, then a Widmannstatten microstructure can be observed with an area containing equiaxed grains beneath. Closer observation using electron microscopy on the top section (Figure 20, Figure 22 and Figure 24) indicated that the grain start recrystallising as elongated dendrites growing perpendicular to the top surface and are then quenched during the welding, and rapidly cooled provoking a large outer grain while on the inside very small single grains were formed (Figure 21). The specific orientation relationship between the finer grains in this top section is 47 degrees, which corresponds to the orientation relationship in the bottom section of this sample (below the red line) typical of body centre cubic ferritic iron under rapid conditions transforming the ferritic structure into a Widmannstatten one, generally present in welds and seams. This microstructure consists of intertwined lamellar grains, with a relationship similar to the one showed for twinings, deriving from the fast cooling of austenitic grains produced in the ferritic steel by heating above the stability temperature of ferrite (which happens during welding) . Porosity is also visible in this area indicating (1) a decrease in volume of the material, which corresponds with the description of the twinning formation creating the Widmannstatten microstructure, as described by Cox (1954), (2) gas formation during the welding process. An evaluation of the strains in these areas was performed (Figure 23, Figure 24). The Kernel maps are shown in red the areas with higher strains. Analysing the results it can be noted that areas of major strains are the "shells" of the elongated grains in the welding areas (Figure 24), containing the finer grains deriving from the quenching process after welding. In detail (Figure 23) further strain is visible in the Widmannstatten area just below the elongated dendrites (below the red line in Figure 19, Figure 20, Figure 22) , while the strain decreases in the Widmannstatten area further below. This location of the strain and the associated location of the

porosity seem to point towards a phenomenon linked to the welding process more than with the use which could be expected to occupy a larger portion of the sample and not been limited to the heat affected zone of the welding itself.

Figure 19 Optical microscope image of sample A3-1 showing the upper region of elongated grains towards the surface of the V shape area (Figure 17, Figure 18), above the red line. Between the red and the green line is the Widmannstatten area and below the green line the equiaxed ferritic/pearlitic zone.

The sample A3-1 shows a microstructure with evidence of overheating, as expected in a welding area, with a fine grained quenched top layer and a Widmannstatten area just below. The presence of porosity and the fact that the Widmannstatten microstructure is harder and more brittle, could have caused failure in the material and high strain concentration. However, fact that the porosity is not deformed seem to indicate that the microstructure is convincingly the result of the welding process more than the response of the stresses during use, and no fractures or fatigue corrosions were initiated in this areas.

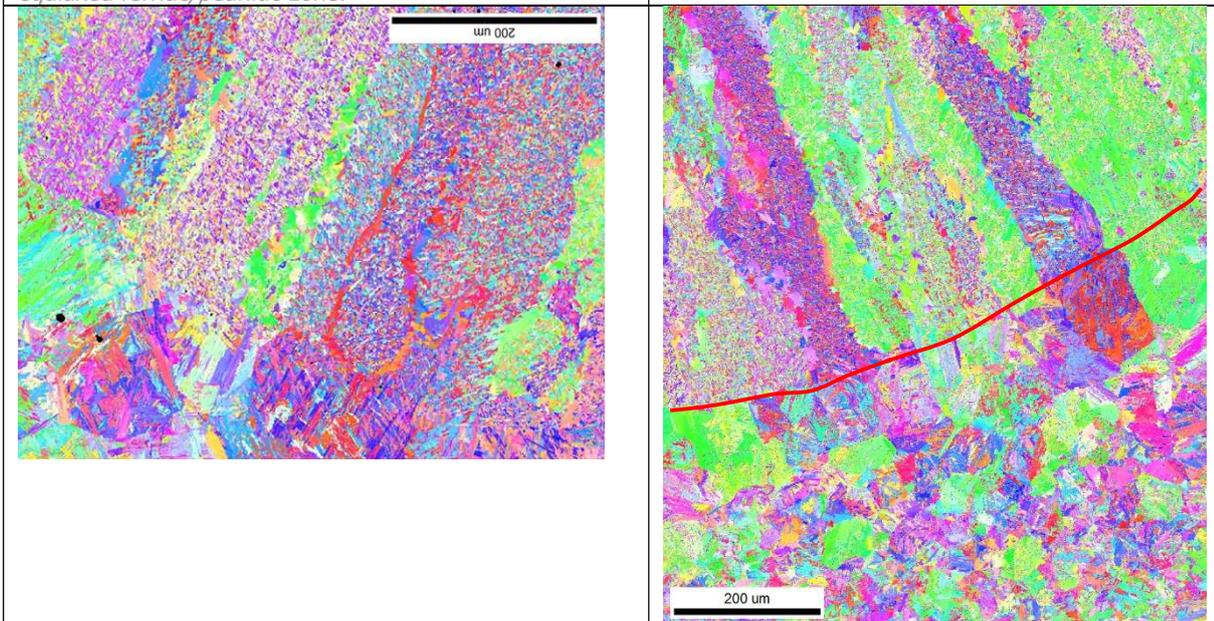
Figure 21 detailed view of the boundary between elongated grains and Widmannstatten area. It is visible here that the elongated grains are formed by minuscule

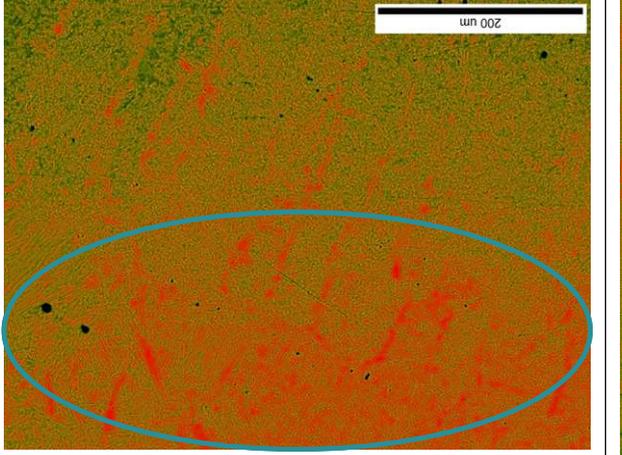
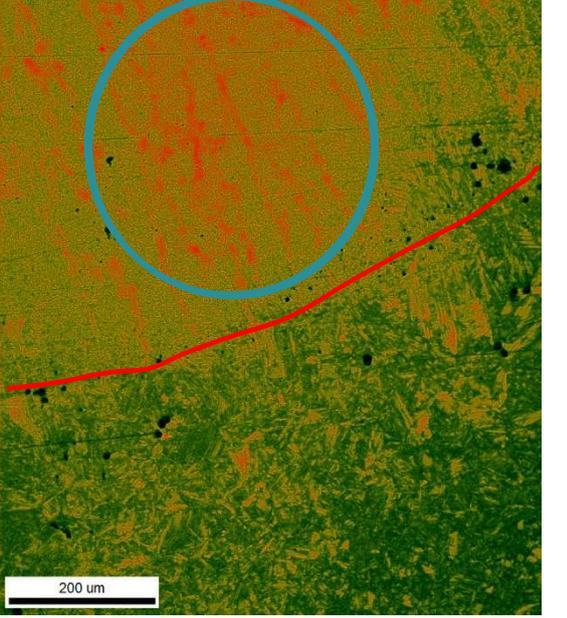
<p><i>Figure 23 Kernel average map of Figure 22 showing the maximum strain along the edges of the elongated grains at the boundary Widmannstatten zone and on the upper layer of the twinned zone (circled in blue)</i></p>	<p><i>Figure 24 Kernel average map of Figure 20 Figure 22a and b showing the maximum strains at the boundary of the elongated grains (circled in blue). Visible porosity along the line limiting elongated and the Widmannstatten area . (analysis courtesy of Rene de Kloe – EDAX/Amete</i></p>

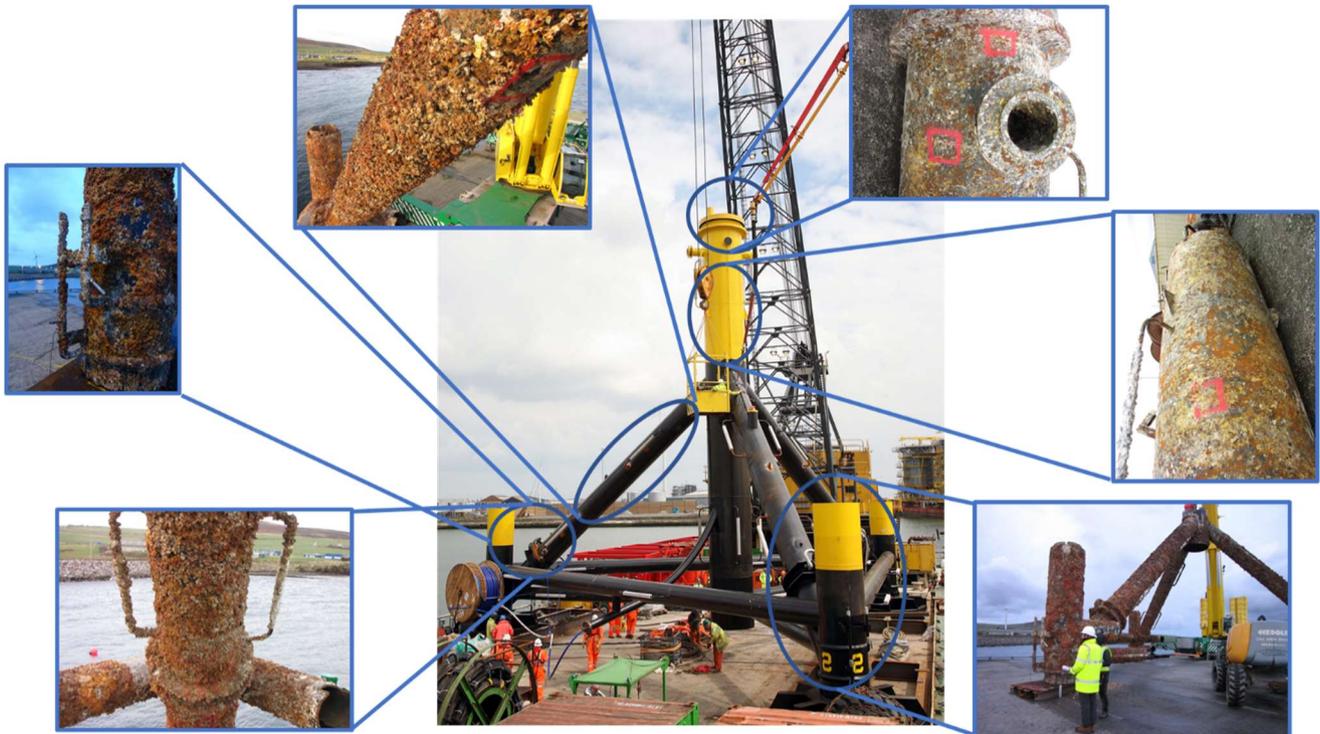
- Biofouling is extremely heavy in nearly all areas. Very few parts of original steelwork are visible. ICIT noted that biofouling is typical of end-stage' or 'climax' biofouling communities. Thicknesses up to 12cm are present.
- Overall, there does not appear to be a significant directionality effect due to the tidal flow. Growth is relatively even across all areas of the tripod. It has been noted that in sheltered areas there are some different species, most notably sponges

- The painted carbon steel surfaces seem to have survived reasonably well. Where biofouling has been scraped away, there is still significant evidence of the black paint. In general, the top section seems to have suffered worse, with random patches of rust covering approx. 25% of the surface area and this may well be due to the increased flow velocity higher from the seabed. Significant biofouling of the main tripod members makes a similar assessment difficult, but where biofouling has been removed the paint seems to be in-tact.

- There is very little evidence of any yellow topcoat paint left.
- The stainless 316L components, including M4-M10 fasteners, have survived well and little corrosion is visible. Some discolouration is present but overall. Fasteners have been unscrewed from their holes rather than needing to be cut off.

Figure 26 - Overview of tripod condition after 11 years

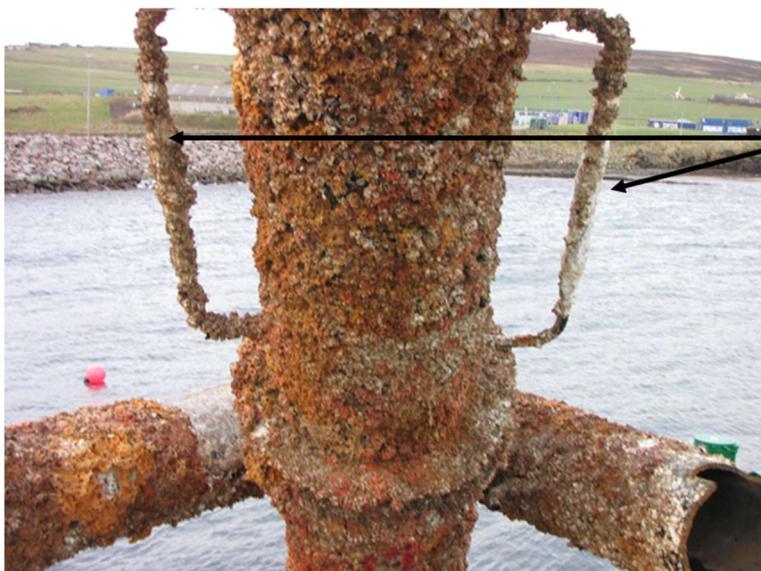
Photographs clearly show that the sponge species seem to be attracted to the anodes, as can be seen in Figure 28 below. It cannot be confirmed if this has a detrimental effect on the cathodic protection performance of the anodes, but may be something to investigate further.

Anodes with particular prevalence of sponges

Figure 28 - condition of anodes after 11 years

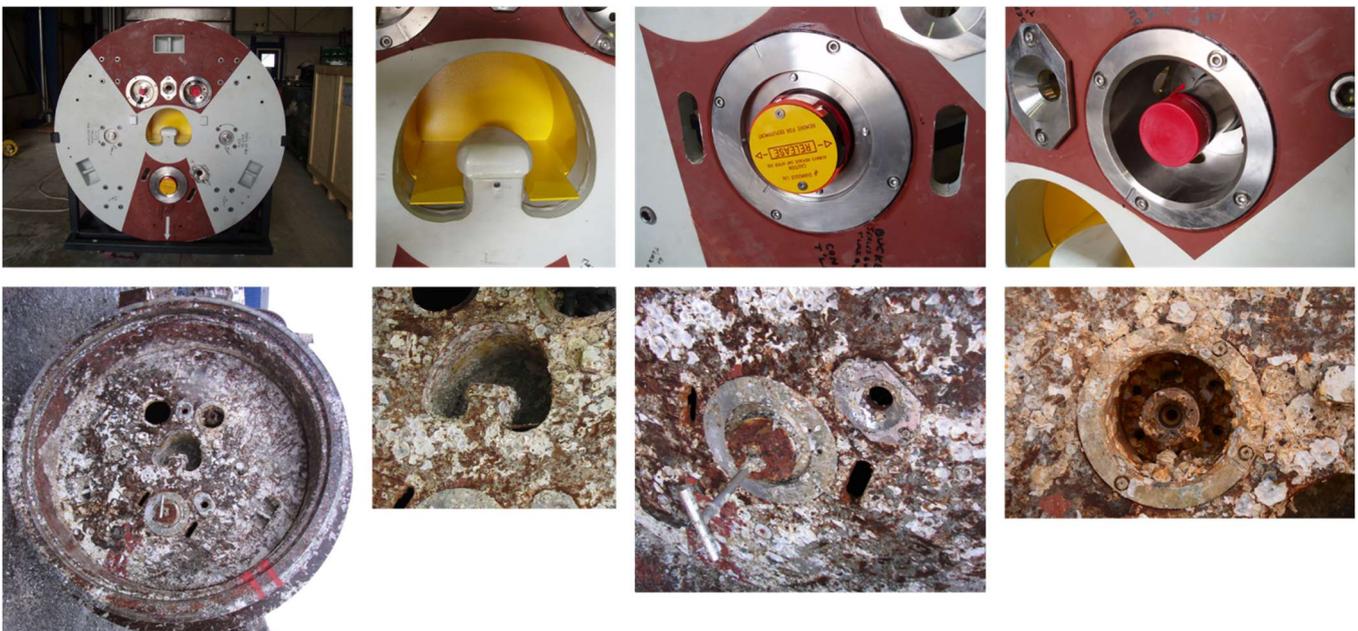
Comparison of new and recovered cartridge plate

A photographic comparison of the cartridge plate is seen in Figure 29. Clearly there is a marked visual difference due to biofouling, but a more detailed study shows that overall the components have survived well, in particular the stainless steel 316L parts including fasteners. Most fasteners were removed easily with hand tools and did not require to be cut or drilled.

Figure 29 - Comparison of cartridge plate and connectors

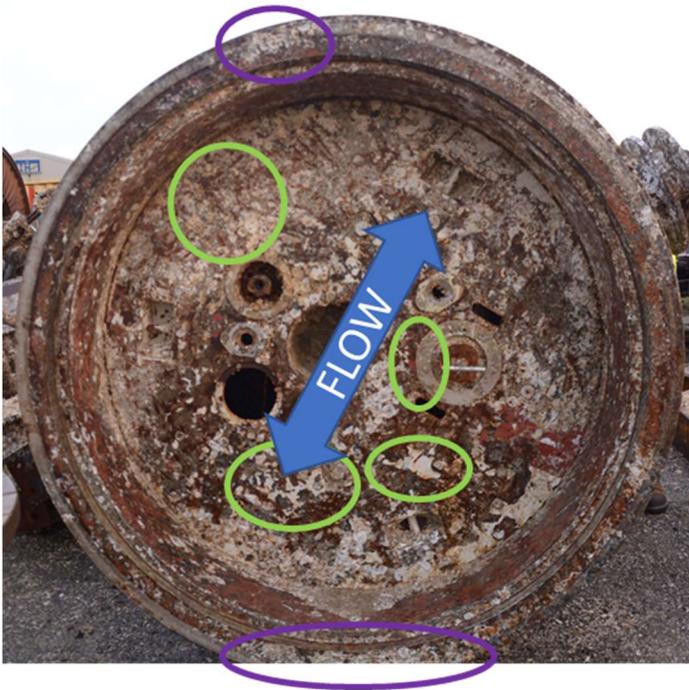
Figure 30 - Tower top with cartridge plate. Green circles indicate remaining paint, purple circles indicate thicker biofouling regions on flange

- It is notable in comparison to the tripod that the paint on the cartridge plate has almost entirely disappeared. Some of the paint may well have been removed during the scraping of the biofouling from the cartridge plate as there are indications of mechanical biofouling removal but there is significant indications of corrosion on much of the plate, indicating the paint had fallen off whilst it was still submerged. Unfortunately, it is not possible to provide a conclusion of the root cause of paint removal.

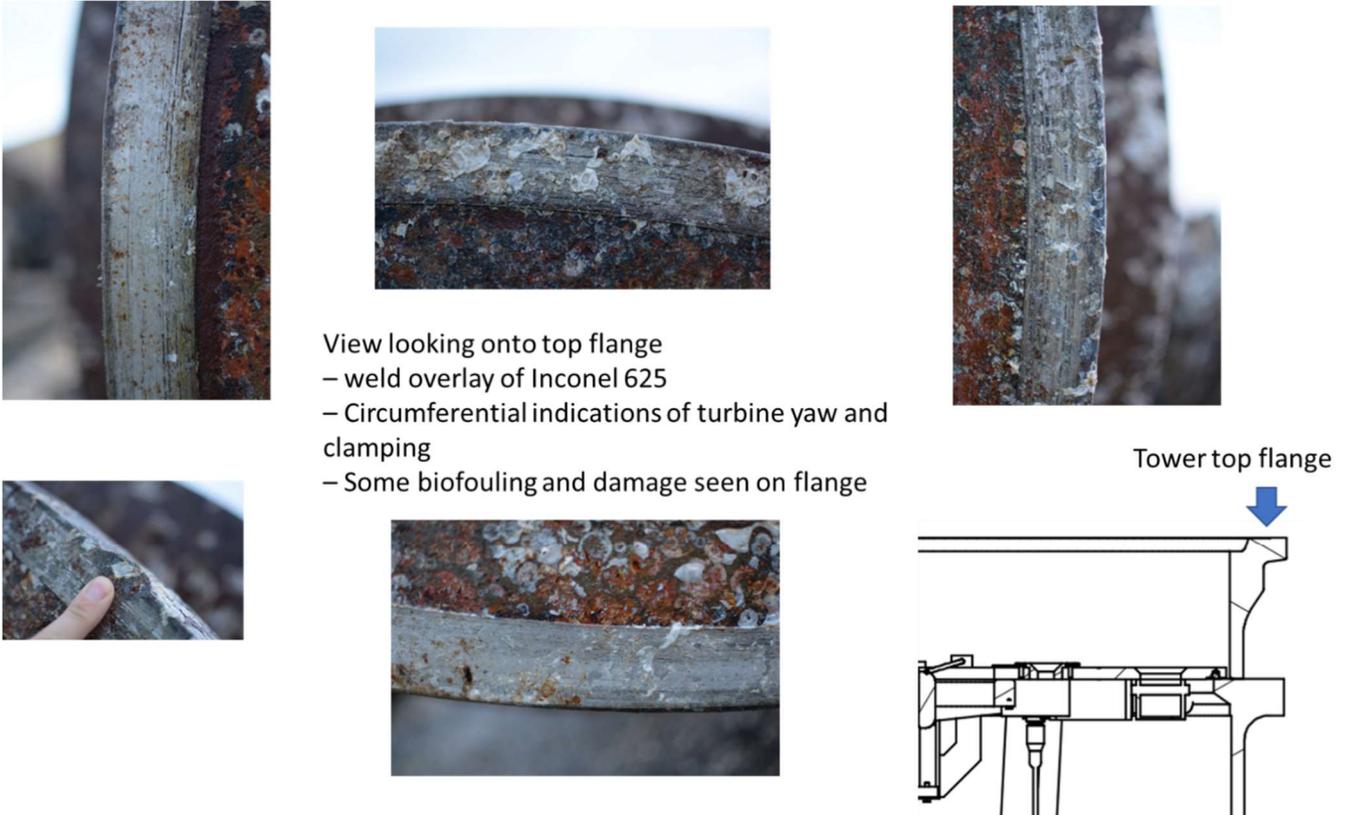
Figure 31 - View of tower top flange

- Circumferential marks are present from both machining marks and also where the turbine used this as a yawing bearing surface.
- There is no particular location that show greater wear than others
- There is indication that biofouling is more prevalent in one direction, which correlates to approx. 60 degrees from the flow direction (purple circles in Figure 30). No particular conclusion can be drawn from this relating to the flow direction and prevalence of biofouling, given the lack of evidence from the tripod structure.

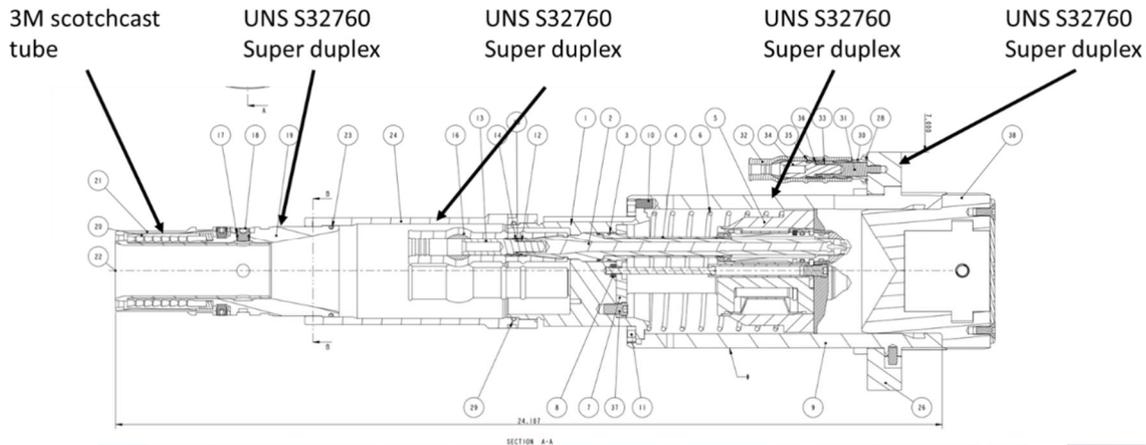
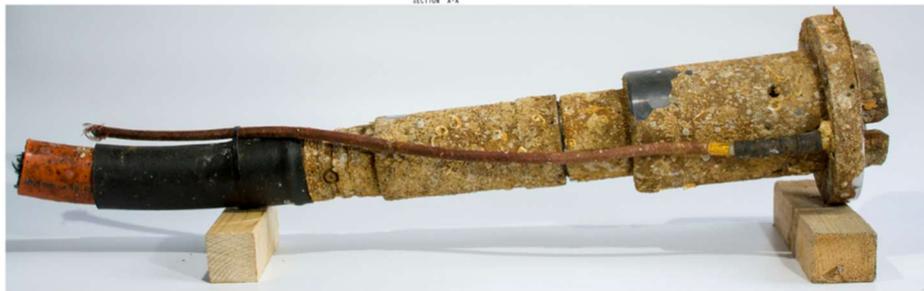
Figure 32 - Assessment of Diamould power connector

- Super duplex stainless steel has resisted corrosion well, but is not immune to biofouling.
- The synthetic compounds (3M Scotchcast and HDPE) are very resistant to biofouling
- The pins of the connector show signs of corrosion, but this connector was exposed to seawater for prolonged periods of time throughout its lifetime. The ROV cap was not properly in place, and it was clear when this was removed that there was significant biofouling inside the top of the connector. Proper and timely connector capping would have likely reduced this considerably.

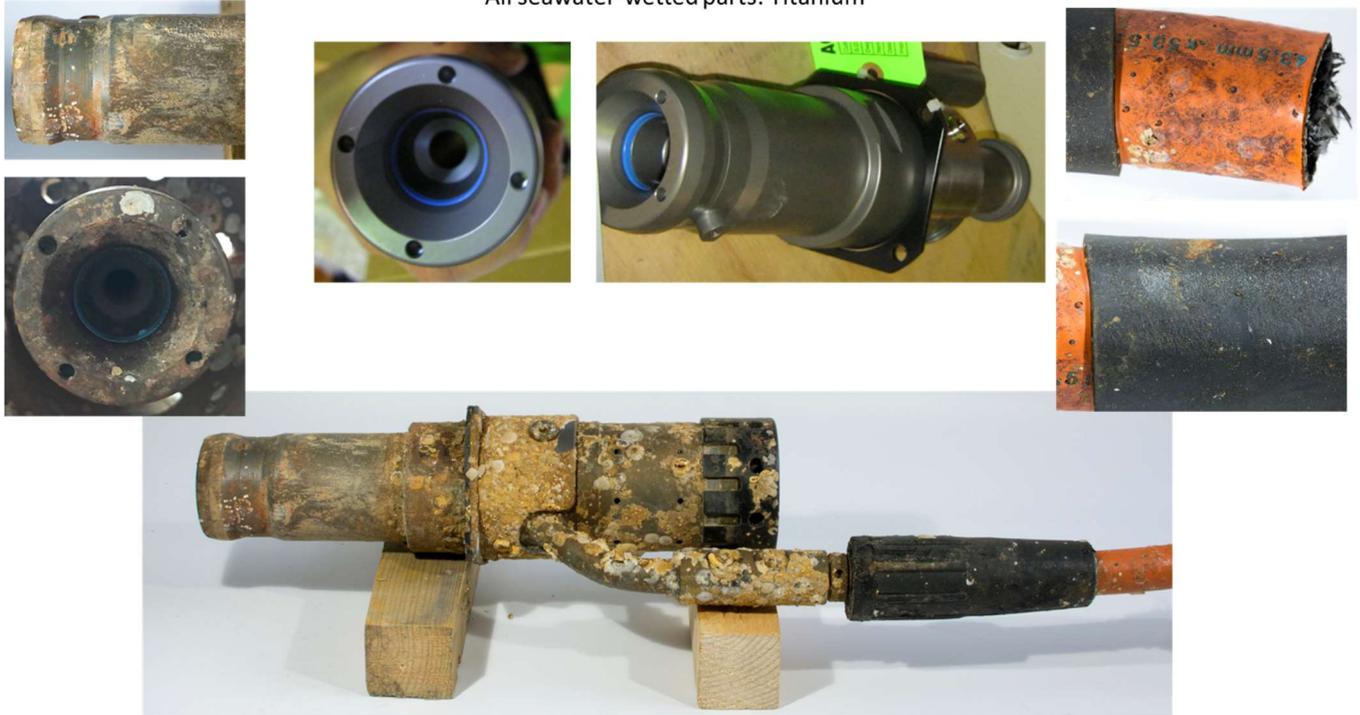
Figure 33 - assessment of Seacon fibre optic connector

- The titanium surfaces are not immune to biofouling, but once scraped off it is apparent that the titanium surface is undamaged
- There is no apparent corrosion on the titanium surfaces
- Rubber and HDPE materials are biofouling resistant.
- One of the major concerns during build was the use of M4 bolts to clamp the connector to the flange. This was impossible to change at the time. However, it is apparent that even these small bolts have survived well and there is little evidence of corrosion, thread damage or even discolouration.
- The tip of the connector appears to have biofouling on it – this is likely due to the fact that the ROV cap was not installed correctly.
- It was very difficult to remove the stainless mounting bucket through the cartridge plate as the biofouling prevented it coming through the near size for size hole.

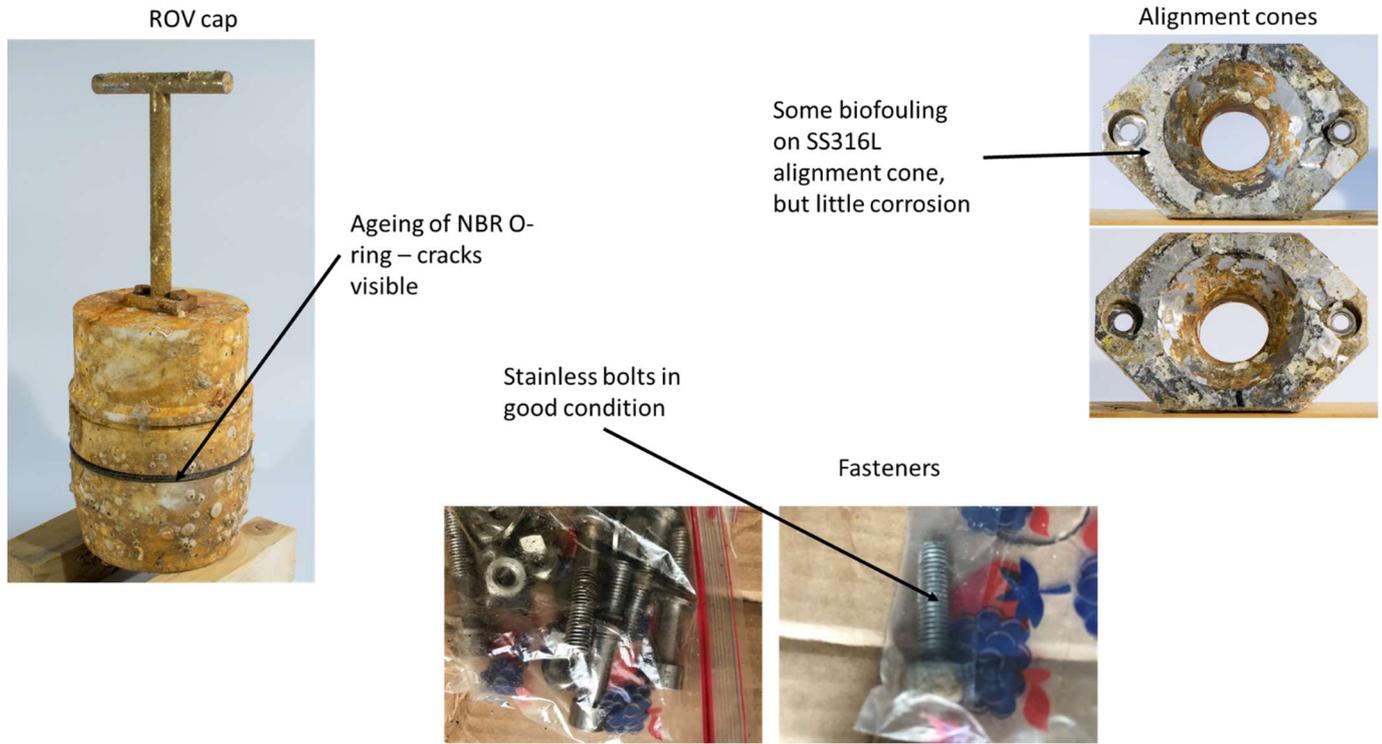
Figure 34 - Assessment of other small components on the cartridge plate

- Stainless fasteners have survived very well, even those exposed to the tidal stream on the top of the cartridge plate.
- The NBR O-ring material has shown signs of ageing and cracking. It is not clear what conditions have caused this as the history of the part is not known. UV, temperature, and long term exposure to seawater can all cause ageing effects.
- The yellow plastic connector cap has more biofouling compared to the connector hoses. Examples of mature barnacles are present.
- SS316L alignment cones have survived well, with little corrosion. Some biofouling is present, particularly on the upper surface exposed to the tidal flow.

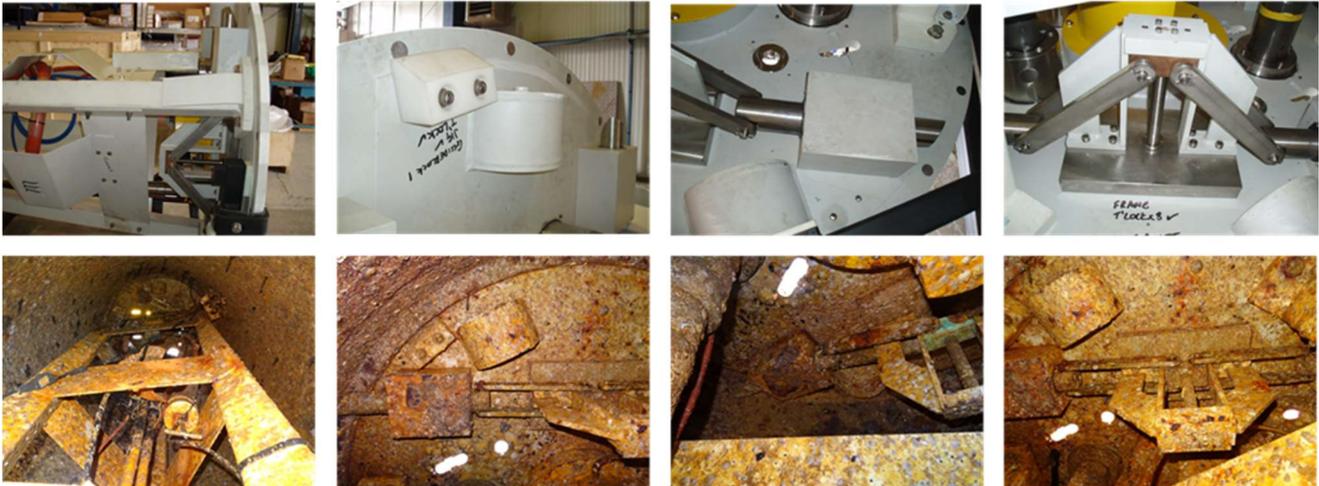
Internal volume of top section

- Much lighter biofouling
- Paint in good condition under biofouling
- Minimal fouling on cables

Figure 35 - Cartridge plate internal features

- Condition of these components is generally quite good. Paint has survived well under the biofouling
- Levels of biofouling are significantly lower than seen on external surfaces.
- Cables, cable sheaths and cable ties are in excellent condition.
- It is worth noting that the ROV connector cap was found loose in this volume. This is photographed in Figure 34 where O-ring cracking can be seen. It is possible that this was lost up to 10 years ago and the O-rings have been left exposed to seawater for the entire deployment time, hence the ageing and cracking.
