Analysis of mooring line failure in real sea conditions

[#] *Biscay Marine Energy Platform (BiMEP)*
C/ Atalaia n°2, bajo, E-48620 Armintza, Spain

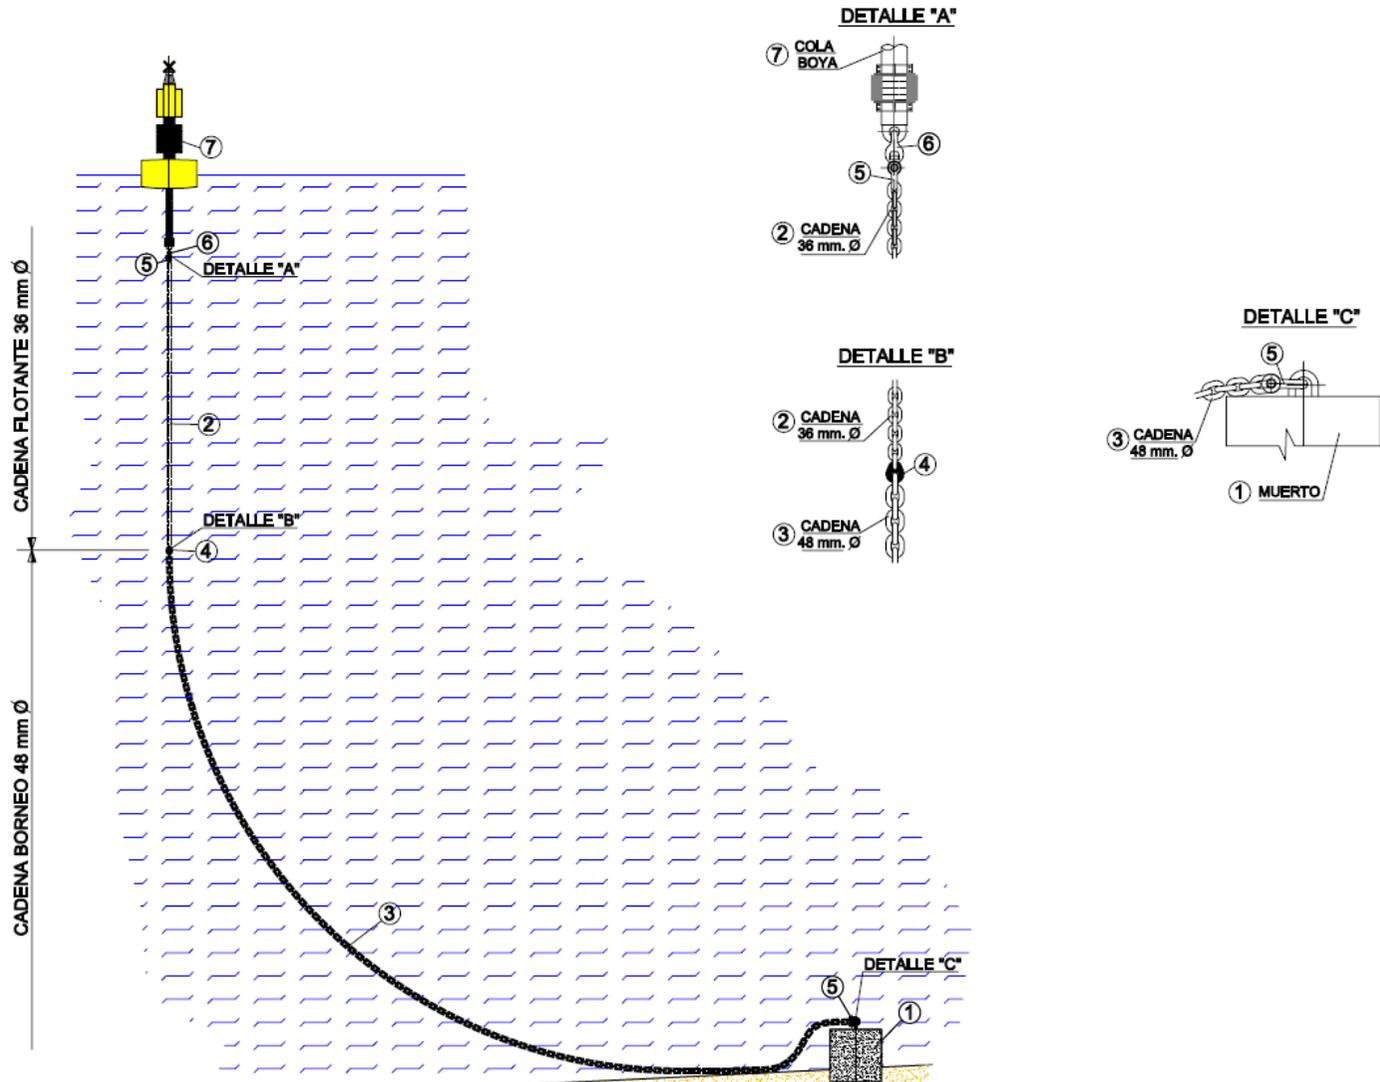
Fig. 4 Perimeter marker buoy mooring system

However, in the case of the perimeter marker buoys there were no signs of corrosion. The analysis that was carried out to identify the reason why the mooring lines had broken shows that in all cases one of the Kenter shackles had opened up or broken. This led to the investigation of Kenter shackles in mooring lines finding that while these are normally used for linking sections of chain, their use is discouraged for permanent mooring lines where long term corrosion and wear issues could occur [8]. In addition, even though the riding chains were dimensioned according to the water depth at the location, it was found that the damaged Kenter shackles were located at points where they continually struck the seabed due to the action of waves, wind currents and tidal range. In other words, the design geometry of the mooring lines took into account average water depth at different locations but failed to take into account the variations caused by waves, wind currents and tidal range. In addition, it was also found that some mooring lines were not working correctly for two different reasons. Firstly, although the mooring line installation operation had apparently been carried out successfully, inspection dives found that the ground chain had wrapped itself around the sinker during descent, effectively shortening its length. This went undetected until the loss of the buoy was investigated. Secondly, bad winter weather conditions had prevented buoy cleaning operations from being carried out. As a result, chain weight combined with

biofouling overloaded the system making it unable to work as it should have done.

With respect to the perimeter marker buoys, the design geometry of each of the mooring lines was modified: the length of the ground chain was increased in order to make part of it work as riding chain, i.e. not in contact with the seabed, assuring that the link between chains is always floating and not being struck against it. In addition to that, the ground rope which had originally been made up of three 27.5m sections linked with shackles, was replaced by a bespoke 82.5m chain without any intermediate connecting shackles, so as to reduce the probability of failure.

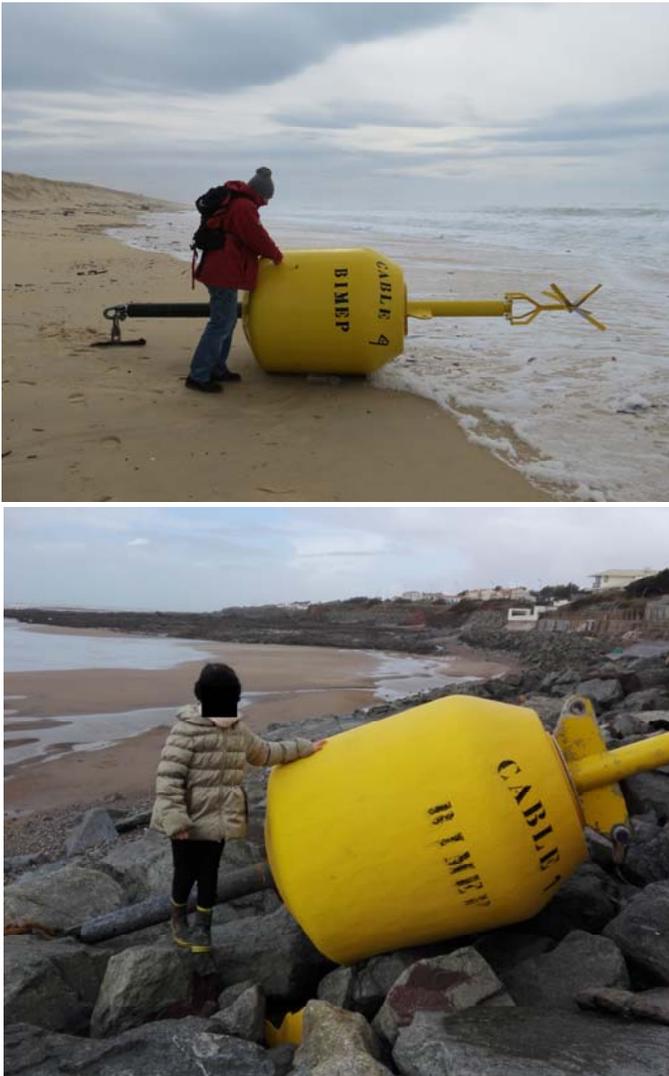
The laying of the four subsea cables and their corresponding connectors took place in September 2013. During the first winter three of the four subsea connector marker buoys broke their moorings. These were all recovered and reinstalled in spring 2015. However, in the following months the four connector marker buoys broke their moorings and by spring 2016 no buoy was in place. This complicated and seriously extended the lifting works of subsea connector number 4, and consequently the connection operation of the MARMOK-A5 device that took place at that time.

Fig. 5 Connector marker buoys that had broken their moorings found along the French coast

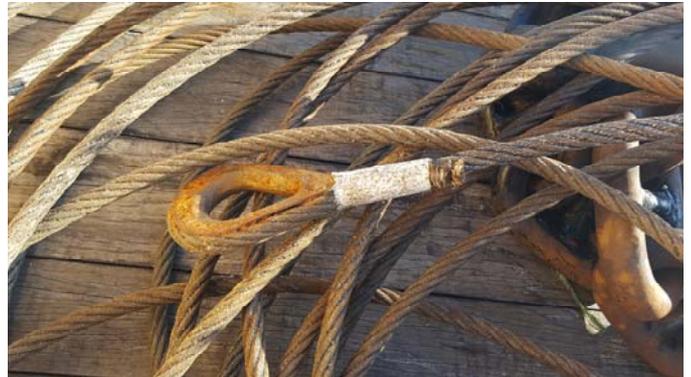
After recovering the subsea connector marker buoys, visual inspection revealed that all the wire ropes appeared to be suffering the same problem of corrosion. To verify this, Tecnalia’s technical services division was engaged to carry out an analysis of the end loop locking sleeve. Their subsequent report revealed that the end loop locking sleeve was made of aluminium, and that it had suffered galvanic corrosion in service, i.e. an inappropriate material had been used [7].

Fig. 6 Aluminium locking sleeve showing corrosion evidence

In view of the results from the analysis of the material used in the subsea connector marker buoy mooring lines and considering that both wire rope sections of each mooring system (all 8 wire rope sections) would suffer the same deterioration, it was decided to replace them all. The solution chosen mixed innovation and tradition, consisting of 18mm Dyform ropes married with plaited end loops. Dyform is an exclusive material specifically designed for use in marine environments with twice the sectional strength of conventional cable. Even though plaited end loops are little used today, they have a clear advantage in that the possibility of corrosion due to contact with other material is eliminated.

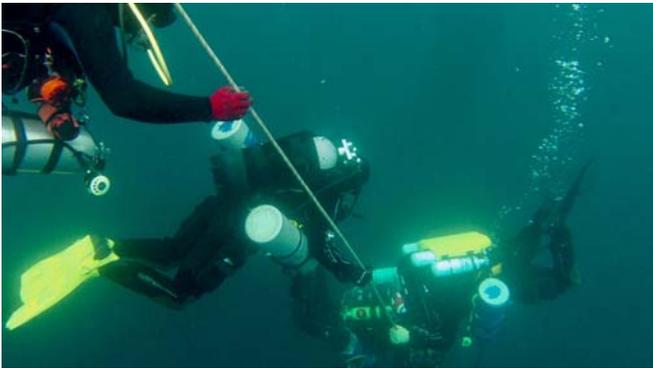
Fig. 7 Ground wire rope replacement operation
