# **Post Access Report**

MRE Dynamic Seals Performance Investigation

Awardee: Verdant

Facility: NREL

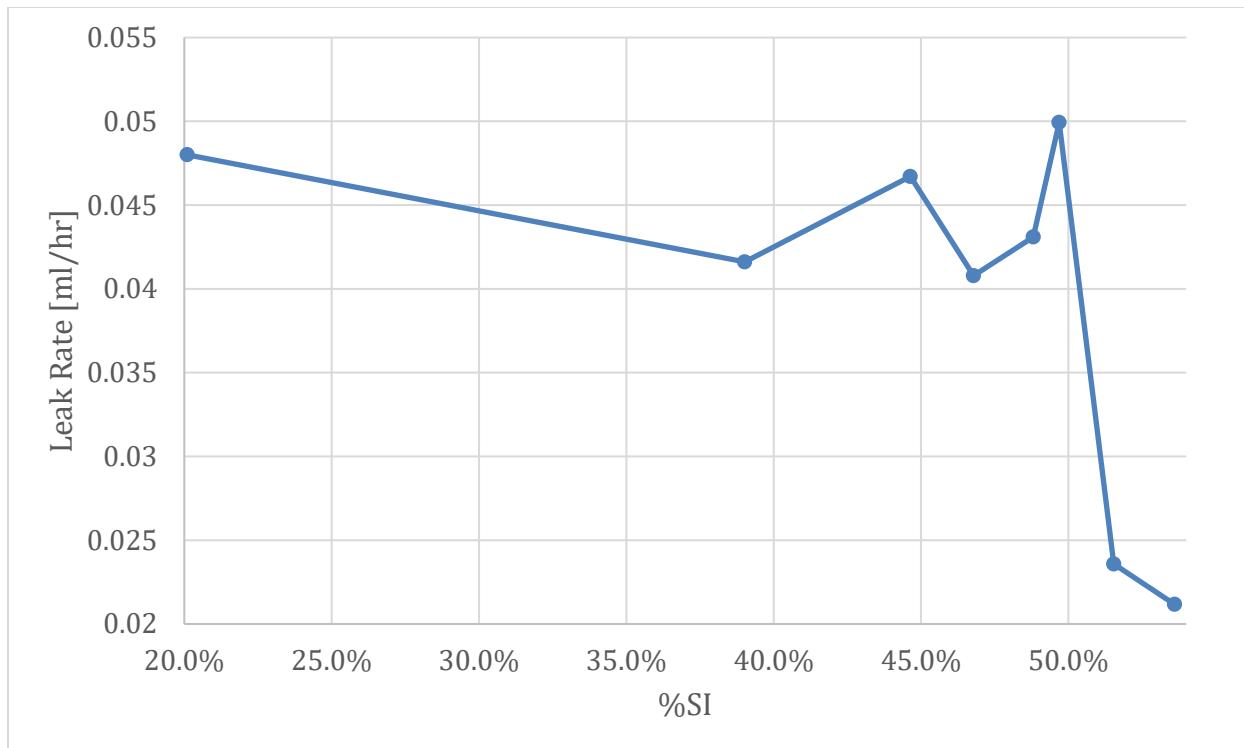
**Figure 2: Water leakage rate vs percent of total service interval.**

Water leakage was relatively consistent throughout testing and with previous testing conducted by Garlock and Verdant Power. It did not appear to have a deleterious effect on internal seal components. Increased leakage through the back of the seal was observed toward the end of testing, however the rate of this increase is uncertain at this time. Over a 5-year service interval water leakage will need to be addressed; possibly by filtering and discharging overboard. Given the similarities between this data and previous work these results were seen to satisfy task 1 and 2 objectives.

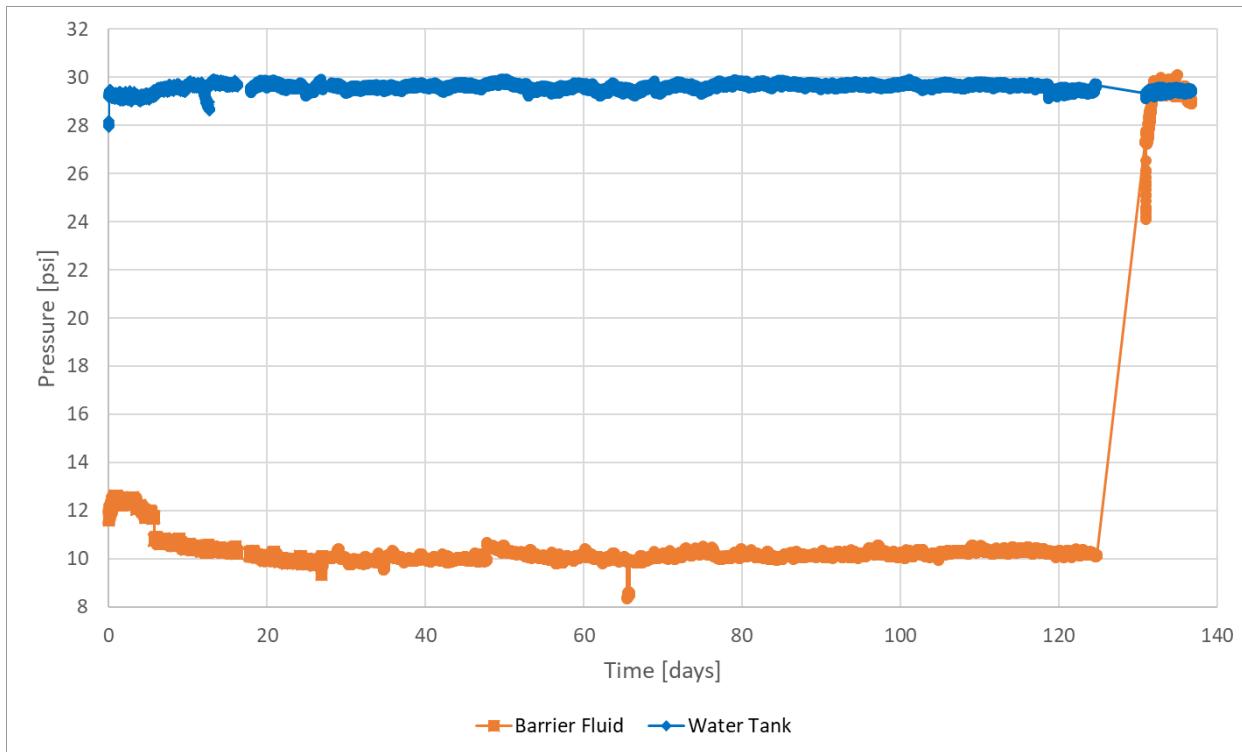
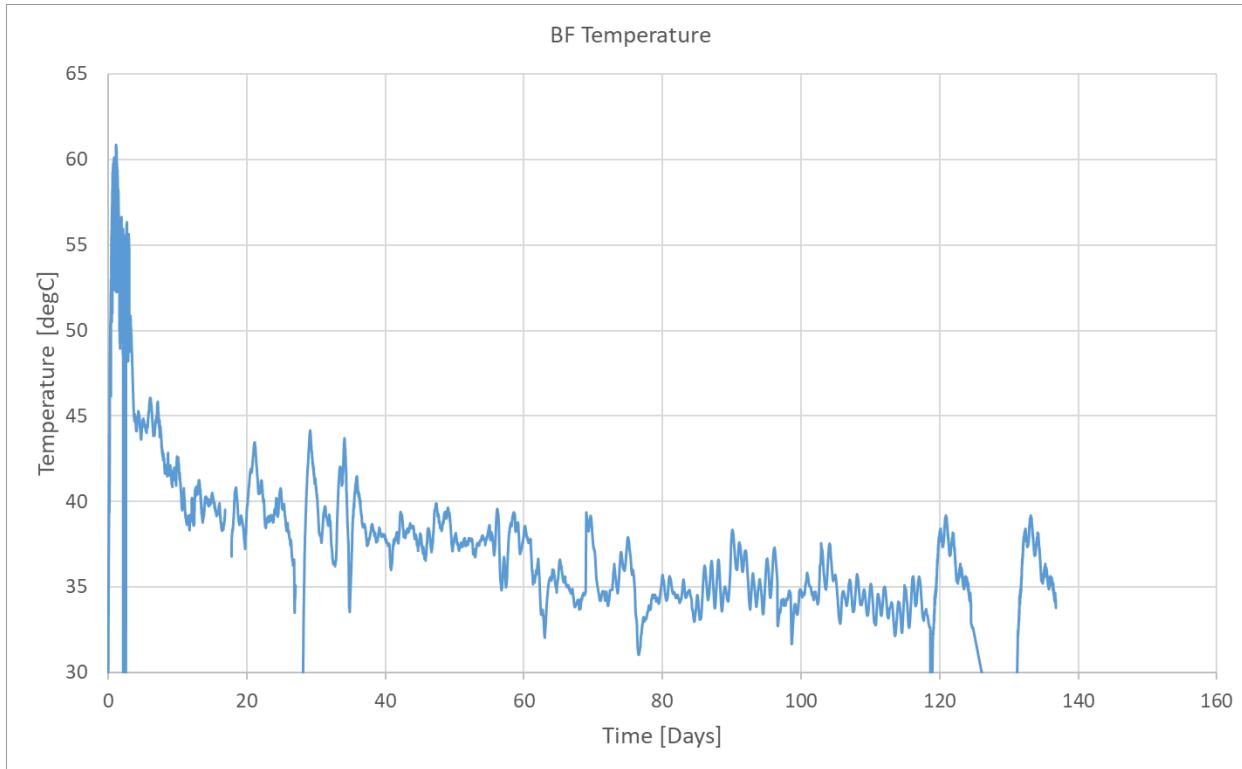
**Figure 5: (Top) Water tank and BF pressure during operation. (Bottom) Temperature of the BF during operation. The BF temperature sensor is placed inside the housing to best measure the operating temperature of the seal.**

Figure 5 (top) shows the BF pressure increases marginally during the first few days of testing. During this time the BF temperature varied from a peak of 61°C to a low of 30°C. While the average temperature range for most of the testing was 35°C to 40°C. The highest temperatures were recorded during the first 10 days. This period also corresponds to the largest motor current draw, shown in Figure 6 and when the most water leakage was recorded in the initial oil sample, 26 ml. It is likely this initial period corresponds to a brief wear in time where asperities between the anti-friction rings and seal facing rings are eroded away and smooth sealing surfaces form. After this period temperature stabilized and was significantly influenced by diurnal rhythms within the testing facility. Additionally motor current draw reduced and stabilized.

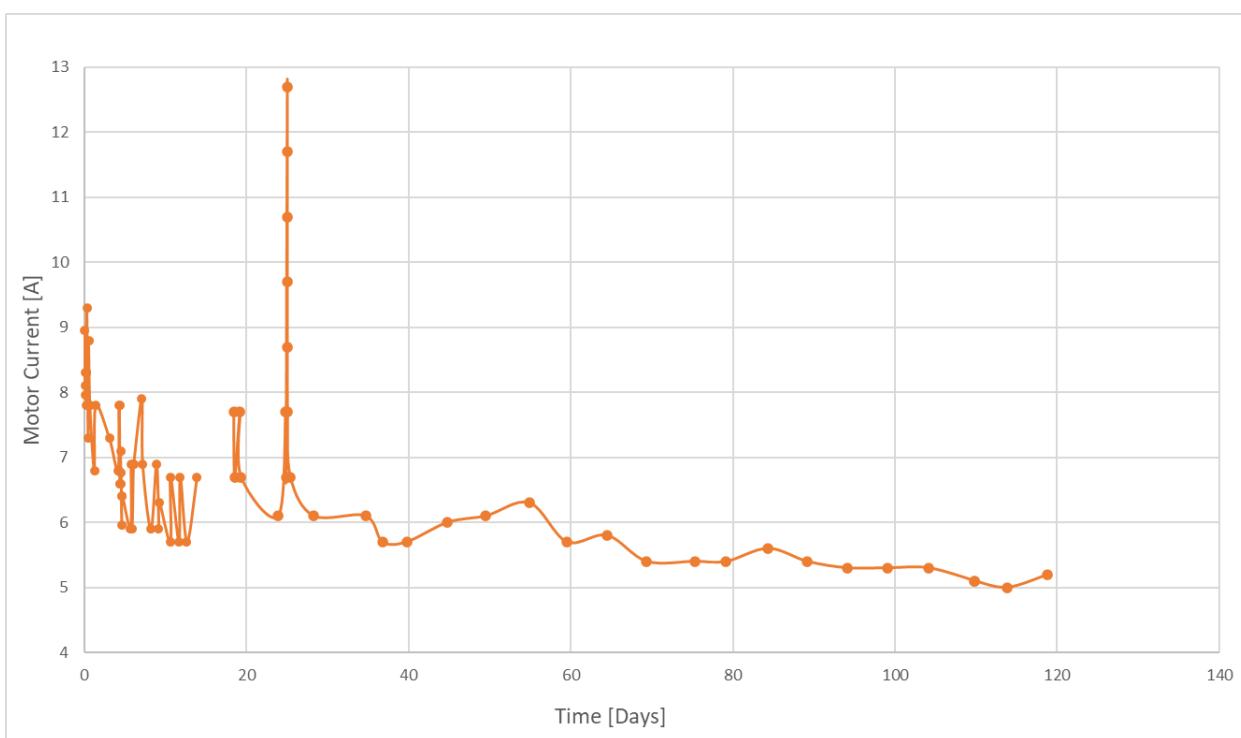
**Figure 6: Motor current draw of test stand during operation. This measured the current required to maintain a constant 160 rpm.**

The gap in the data at 18 days and the spike in at 25 days were due to a circuit breaker failure and reactivation. The motor current draw was relatively large and chaotic initially during the theorized wear in period before settling into a more stable, slowly decreasing trend for most of the testing. This is consistent with a brief wear in period while the asperities are worn away between the mating surfaces. It also suggests the combination of BF and carbon particulate form an effective lubricating medium that produces a more favorable interface conditions during operation.

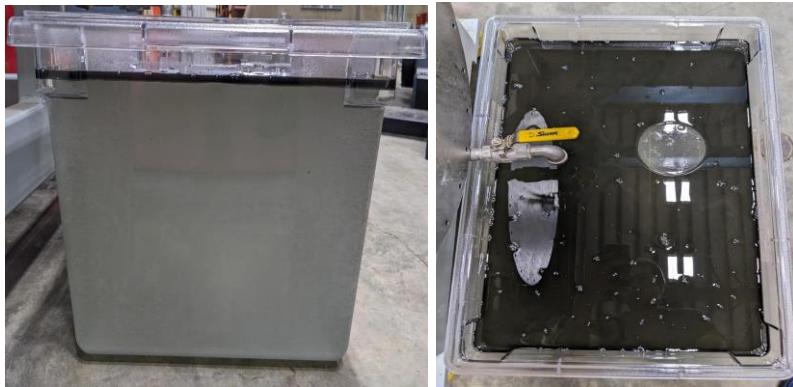
At the end of testing, 125 days, an unexplainable step change in BF pressure was recorded. Because of this it was decided that any future results would not be meaningful, so testing was stopped for the final data collection. When draining the water and BF tanks approximately 1.1 liters water was found in the BF and an equal amount of BF in the water tank. Only minimal fluid leakage was recorded through the back of the seal into the atmosphere. The collected fluids can be seen in Figure 5. Considering the seal maintains a pressure gradient between the water tank and the atmosphere, it was believed a small pressure gradient would always exist across the seal. This was clearly not the case after the test ending malfunction given the observed fluid exchange.

**Figure 7: Images showing the fluid removed from the water tank. The BF floats on top of the water and is stained black from suspended graphite particles worn away from the anti-friction rings.**

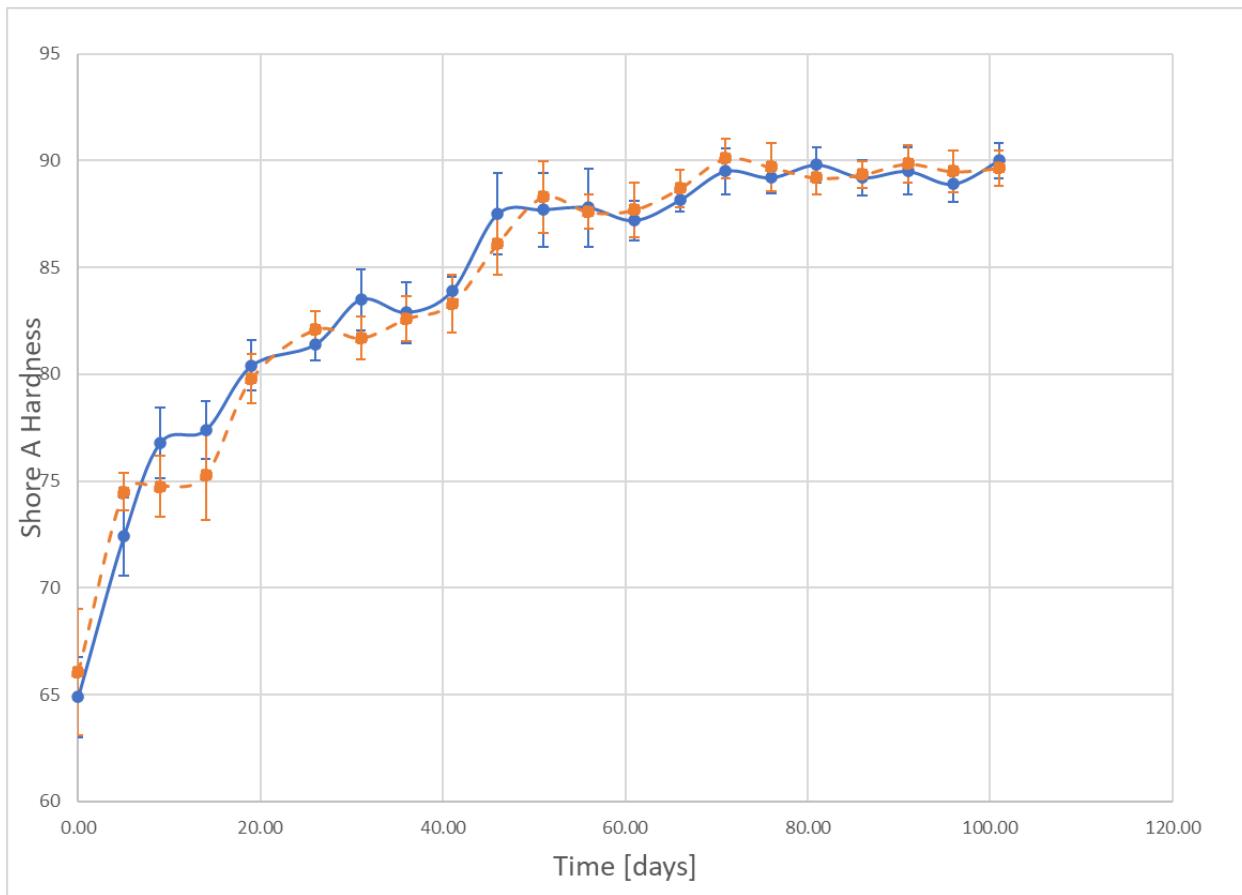
After wear testing completed the drive ring hardness for the in-situ rings was measured as 76.8 and 77.4 for the front and rear rings respectively. The wear testing was conducted for approximately 130 days at between 35°C and 40°C depending on ambient temperature and heat generated from friction. This suggests the seal hardness is highly dependent on ambient temperature. Considering the wear testing simulated 40% of the expected SI, the drive rings are unlikely to reach full hardness before the SI completes.

**Figure 8: Shore A hardness of the NBR drive rings during accelerated aging testing. The rings were allowed to cool to room temperature before measurements were taken.**
