# An Experimental Investigation of Textured Response Between Micropile Forming Grout and Synthetic Rock

Kelly Flanagan<sup>a</sup>, Dr. Mohammed Gabr<sup>a</sup>, Dr. Roy Borden<sup>a</sup>,  
Richard Argall<sup>b</sup>, Don Lasser<sup>b</sup>

**NC STATE UNIVERSITY**

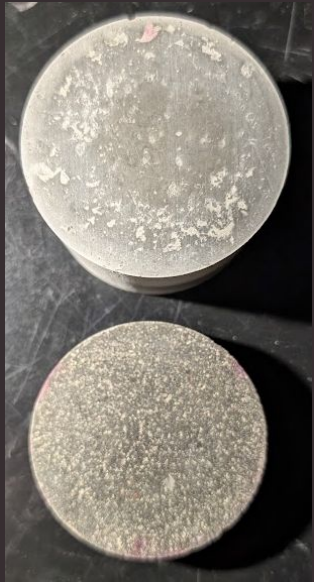
Smooth  
JRC 0-2

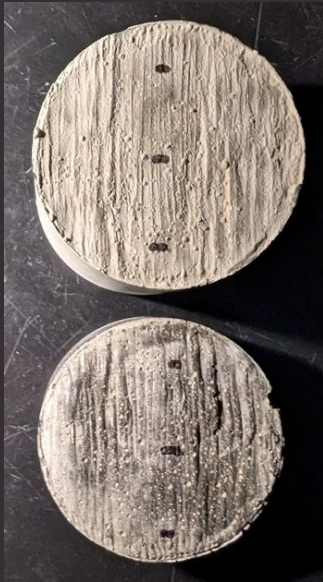
Low  
JRC 8-10

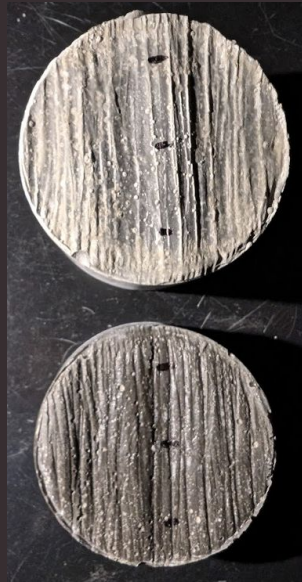
Medium  
JRC 10-12

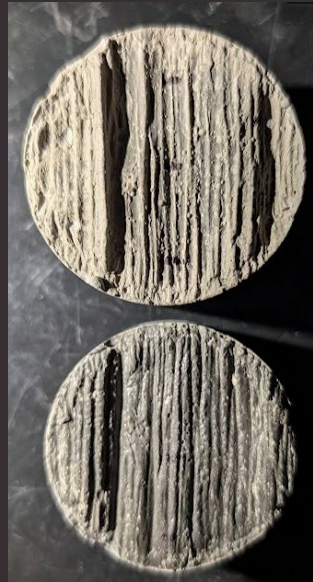
High JRC  
18-20

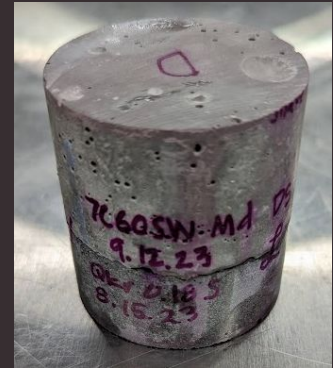
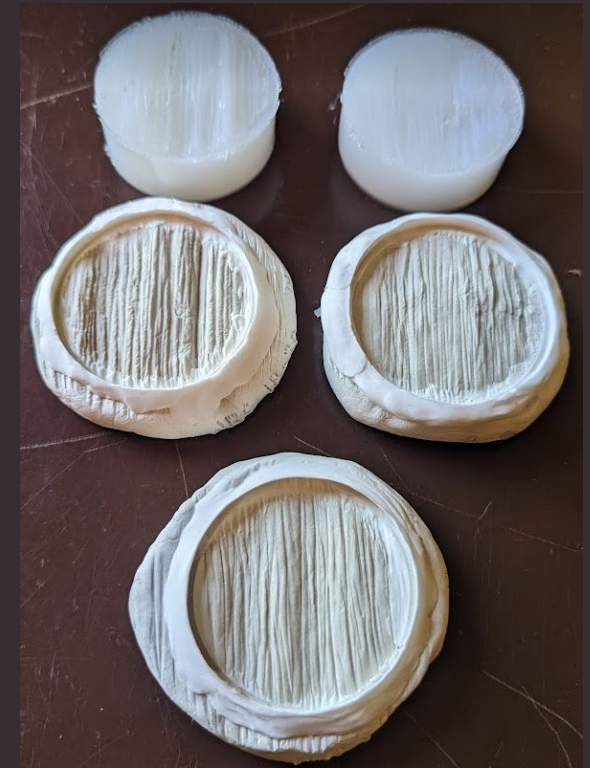
Grout

Synthetic  
Rock

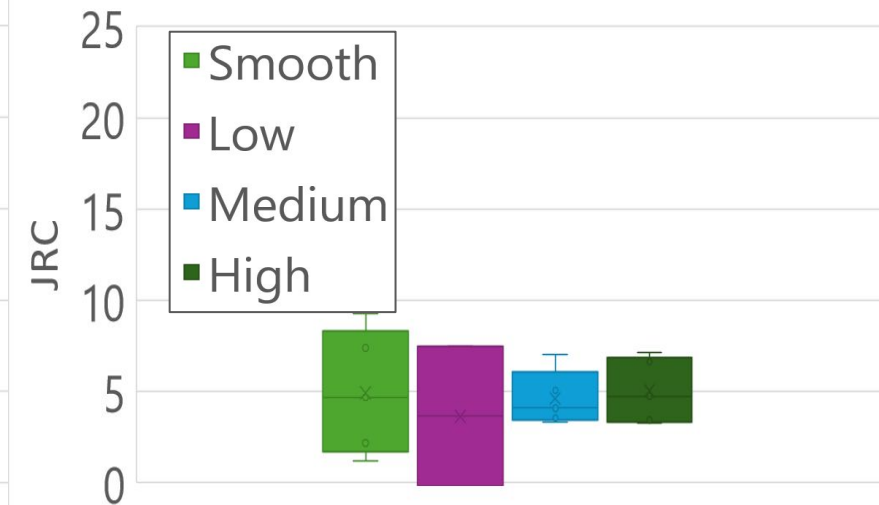
### 10mm Displacement
