Post Access Report

Biofouling and Corrosion Study for a Novel Linear Guided Wave
Energy Converter

Awardee: E-Wave Technologies LLC

Date: May 13, 2025

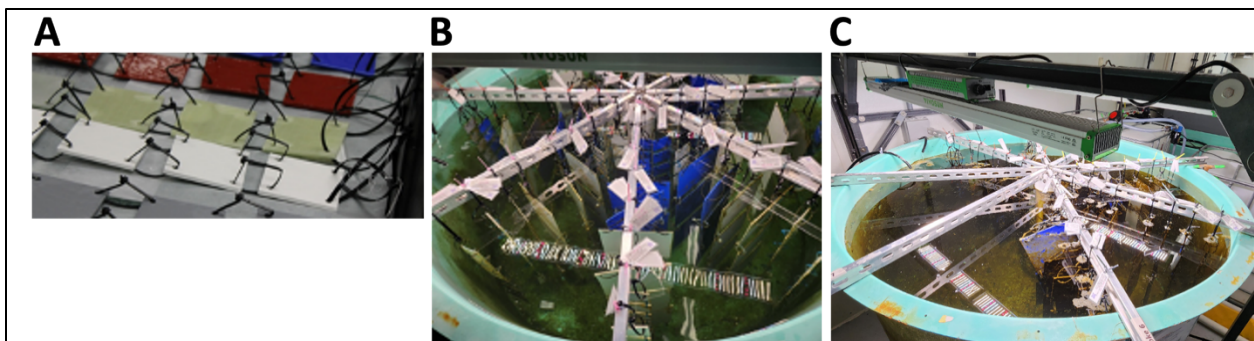
Figure 9 | Coupons prepared and suspended in biofouling tanks. **A.** Depiction of the daisy chain hanging style where 3 in² coupons are shown zip-tied to each other. **B.** E-Wave biofouling tank 1 month after all coupon samples were submerged. **C.** E-Wave biofouling tank photo taken after 6 months (note that 3- and 6-month time point coupons had been pulled for processing).

room temperature for 1 week before 3 in² coupons were weighed again. Coupons were strung together in groups of 6 for 3 in² coupons, and groups of 3 for 8 in² coupons. Zip ties were used to attach coupons to one another, and they were then packed carefully for transport to the PNNL Sequim Marine and Coastal Research Laboratory.

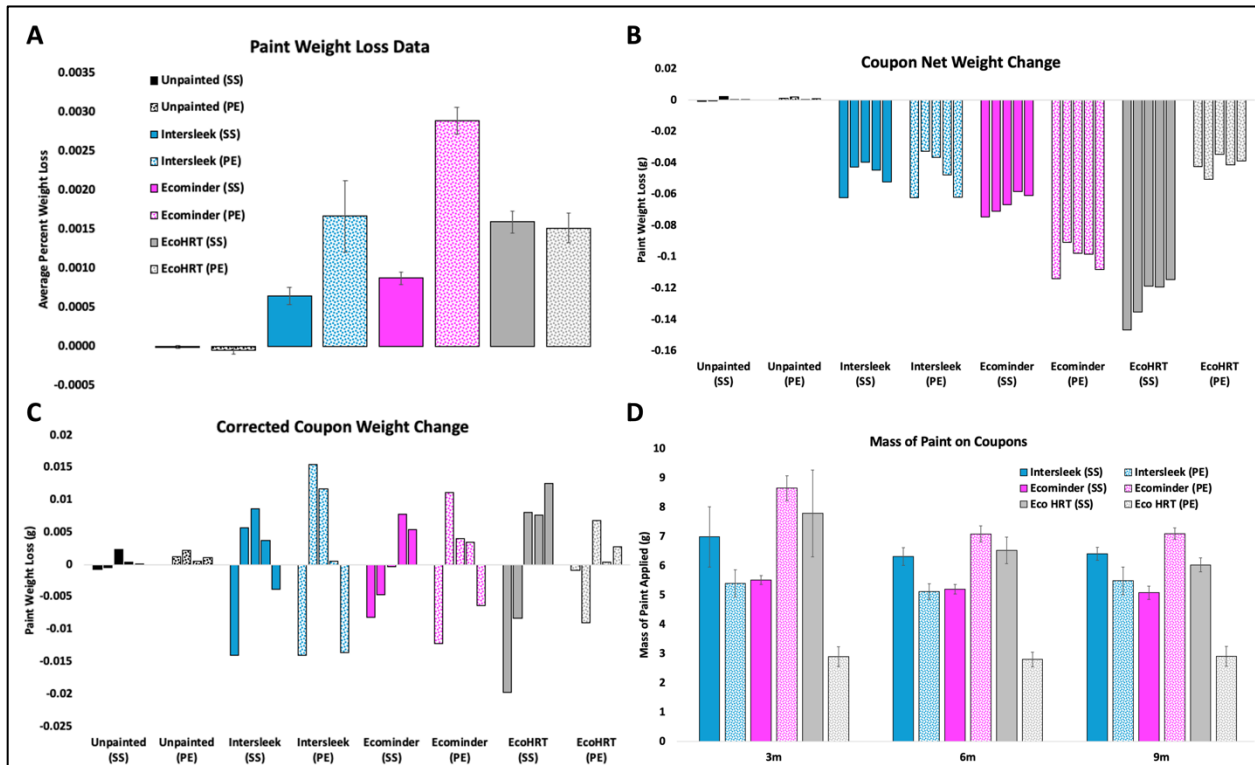
Figure 12 | Determination of paint mass loss and impact on coupon weights. A. Bar plot indicating how much mass is lost when painted coupons of SS and PE are baked at 50 °C overnight and then weighed again. Each bar represents n = 5, with error bars depicting the standard deviation of the mean. B. Shows the coupon net weight change for each individual replicate in a group. C. Correction factor of paint mass loss was applied to determine the effect on coupon weight change to gain a corrected weight change. D. Average mass of paint applied to submerged coupons for each time point and combination of paint and material type. Error bars indicate the standard deviation of the mean of three replicates.

Note: Ecominder on PE loses the most mass during baking, which was likely because this paint and material combination has the most paint applied (**Figure 12D**), followed closely by ECO HRT SS and Intersleek SS. Each paint and material combination has specific manufacturer recommendations that were closely followed during painting, which includes more or fewer coats of paint for each system and substrate combination. Ecominder requires multiple additional coats of paint for PE substrates, so it has the most volatile organic solvents that likely are released during the drying process.

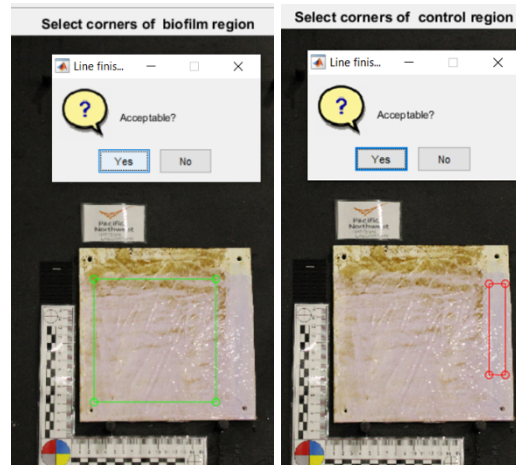
Figure 14 | Example of the selection of the biofilm and control areas of an 8 in² coupon within the BGI user interface. Left: The stained region of the coupon was selected as the biofilm region being quantified. Care was taken to avoid the edges and the holes in the coupon. Right: The wiped, then stained, portion of the image was selected as the control region.

The BGI algorithm requires that one area of the image be selected as the region of interest for the biofilm quantification and another area (the area that was wiped clean prior to staining) be selected as a control

region (**Figure 14**). The regions for biofilm and control were selected manually on each coupon, and these regions were kept consistent from coupon to coupon. The edges and corner mounting holes of the coupons were avoided.

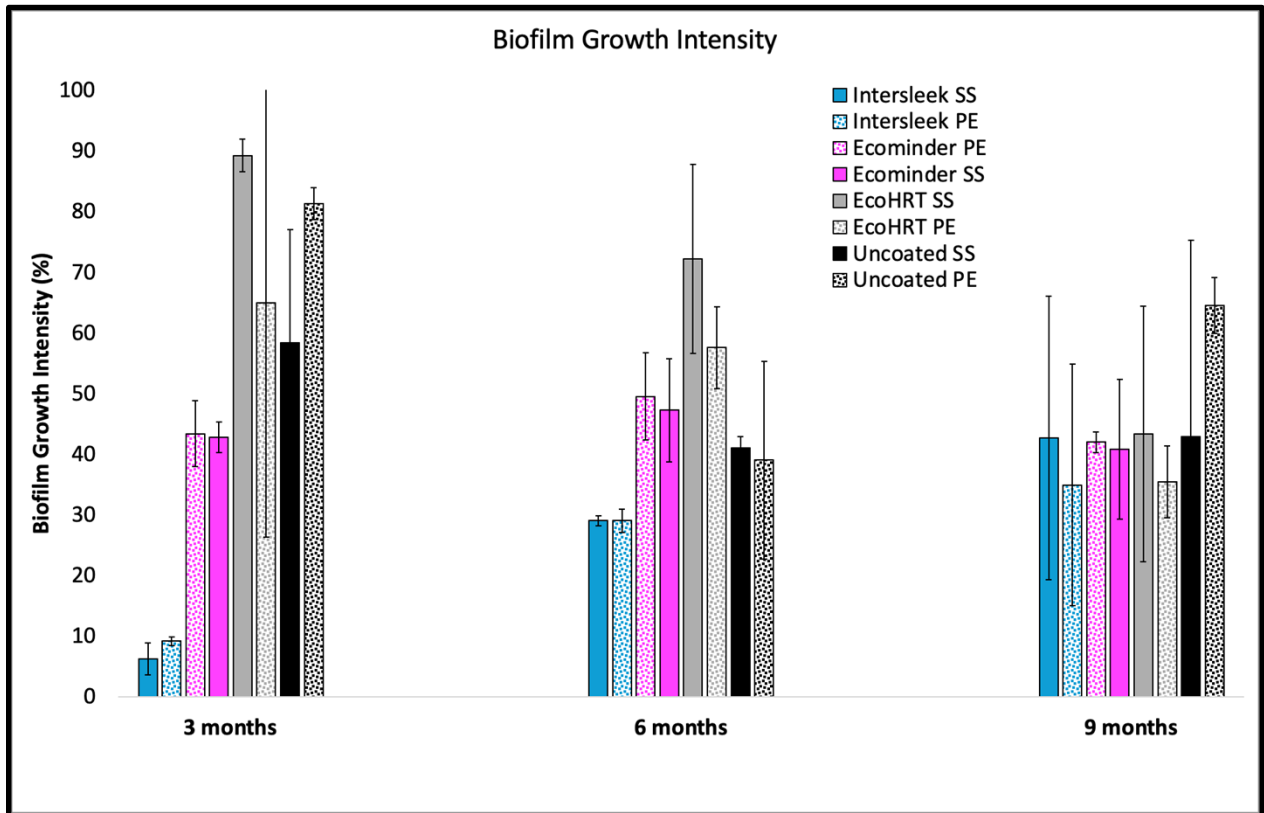
Figure 15 | Graph of biofilm growth intensity. Each bar plot represents n = 3 replicates of the BGI calculated for all time points and coatings. Error bars are the standard deviation of the mean for three replicates.

The BGI results (**Figure 15**) are in partial agreement with the qualitative visual analysis, with Intersleek and Ecominder clearly outperforming ECO HRT and unpainted coupons at the 3 m time point. However, at the 6 m time point, Ecominder was slightly outperformed by Unpainted coupons. At the 9 m time point, the BGI process indicated that the materials performed approximately equally. The 9 m time point BGI results are in stark contrast to qualitative visual analysis, which indicates that Intersleek and Ecominder strongly outperformed ECO HRT and Unpainted coupons at that time point.

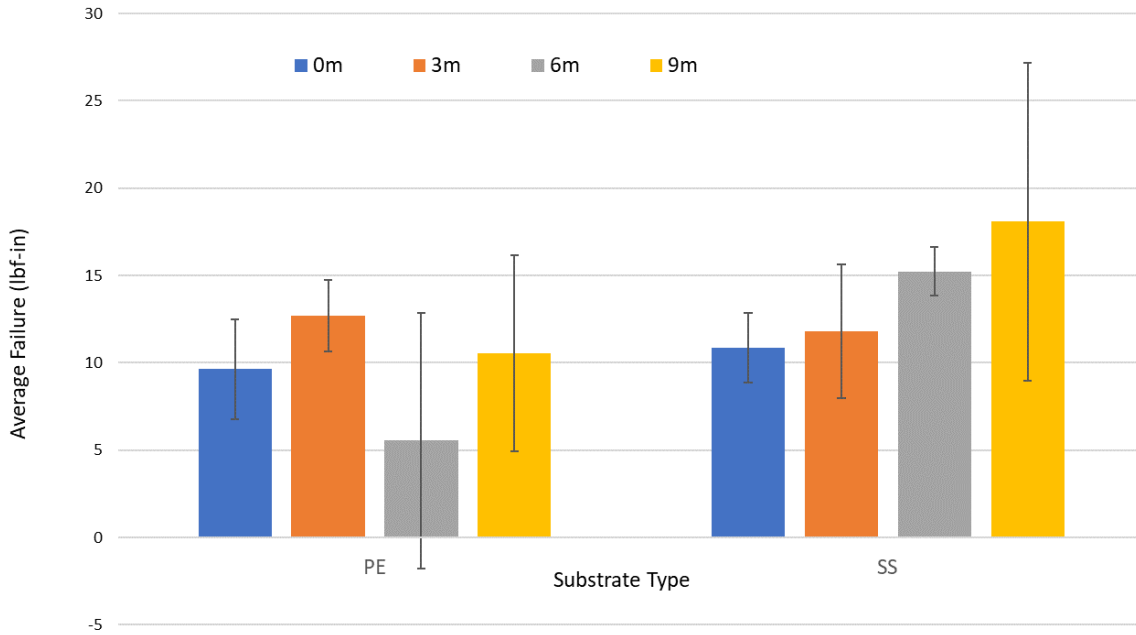
Figure 19| Results of (top) Torque test results for Intersleek coating and (bottom) Intersleek post-test photos.

The Intersleek paint torque values in **Figure 19** are quite low (between 5 and 20 lbf-in) but in almost every case, the epoxy debonded from the paint. These test results can be interpreted as minimum torque adhesion values for Intersleek but there is no way of knowing how much higher the actual values are. The Intersleek paint appears to be designed with a low surface energy to deter the adhesion of biofilms and microorganisms. This low surface energy also prevents the adhesion of the napkin ring test epoxy. It is worth noting that the Intersleek paint broke off in large chunks on three of the 6-month polyethylene coupons during handling and/or testing (**Figure 21**).
