Fatigue and Aerodynamic Loss in Wells Turbines: Mutriku Wave Power Plant Case

Abstract- Wave Energy Converters (WECs) need to operate in a harsh environment, where fatigue in materials and salt accumulation regularly lead to premature failures of components. In the course of seven years of continuous operation of the Mutriku Wave Power Plant, several events of this kind have occurred and are described in detail in this article. Preventive maintenance is conducted regularly in the plant. However, the novel machine learning approach could help to optimize maintenance works, as failure can be predicted without unnecessary replacement of components.

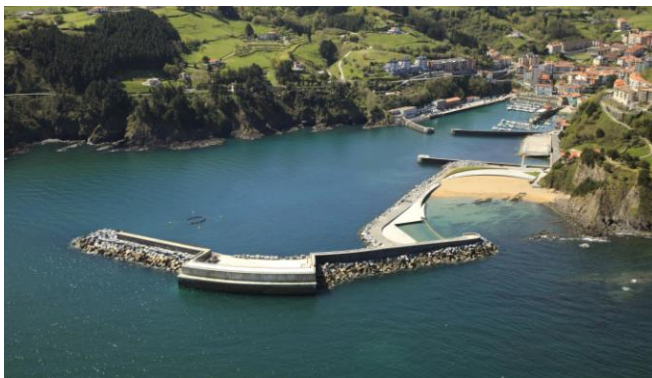
Figure 1: Mutriku Wave Power Plant located at the breakwater of Mutriku’s harbour.

In July 2018, the Mutriku Wave Power Plant will complete its first 7 years of operation. During this period, the power plant has supplied over than 1.6GWh of energy to the power grid, a figure representing significant progress within the wave energy sector. The Basque Energy Agency (EEE/EVE) commissioned the wave power plant in 2011 with the support of the 6th Framework Programme of the European Commission (through the Nereida MOWC project) and the Basque Government. Figure 1 shows an aerial view of the wave power plant.

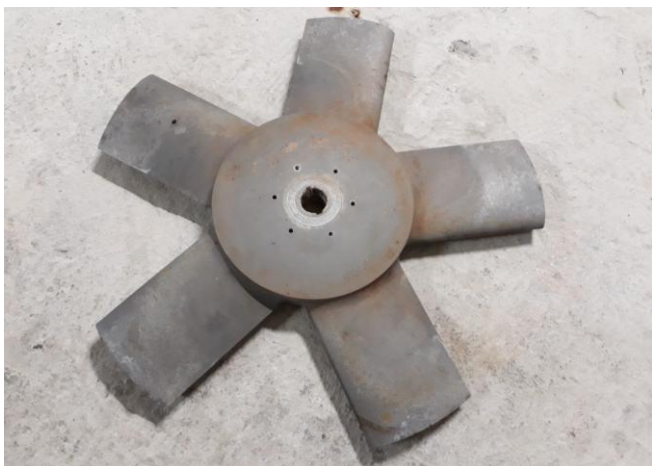
Figure 3: A Wells turbine after five years of operation.

to, may produce fatigue and the subsequent breakage of a component. Figure 3 shows the corrosion in one of the Wells turbines at the Mutriku Wave Power Plant. Furthermore, high levels of salt concentration may provoke aerodynamic losses in Wells turbines. Both events are addressed below.

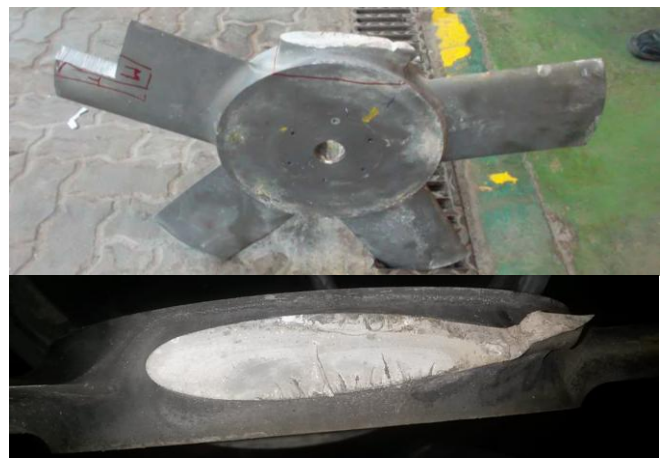
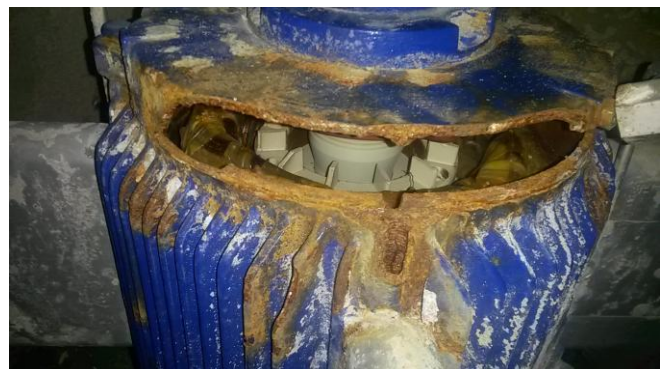
As has been mentioned above, OWC devices usually work with two-way air flows. The force applied by non-constant air flow can be decomposed into two axes. The force of the horizontal axis causes the turbine to rotate always in the same directions. However, the force of the vertical axis has a different direction depending on the air flow and is absorbed by the turbine itself as there is no vertical displacement. This produces stress on the material resulting in possible premature breakage of the component. Figure 4 shows the breakage of one of the blades of a Wells turbine installed in the Mutriku Wave Power Plant as a result of the winter storms in February 2016. The broken blade also hit the generator housing violently, producing the crack seen in Figure 4(b).

Figure 4: Breakage of a blade. (a) Wells turbine with a broken blade and the breakage detail; (b) Damages in the generator.

turbines. To conduct the tests, the damaged areas were first defined. Figure 4(a) shows the failure analysis area and the metallographic specimen and the tensile specimen extraction areas.

From the morphology of the breakage, where well-defined fatigue slip-bands can be observed, it is possible to determine the origin of the initial crack that gave rise to the breakage. It can therefore be deduced that the blade breakage was produced by fatigue. In addition, numerous holes and spots of oxidized aluminium in the central area of the beginning of the rupture suggest that the breakage could have been initiated by pitting corrosion from the surface. Pitting corrosion was also observed inside the specimen extracted from the blade adjacent to the breakage.

After five years of continuous operation of the power plant, generator bearings and turbine rotors were renewed as per the recommendations of the equipment manufacturer. Due to the breakage of the blade in one of the turbines caused by fatigue, the decision was taken to replace the rest of the turbine rotors during the second quarter of 2017. The replaced Wells turbines can be seen in Figure 11.

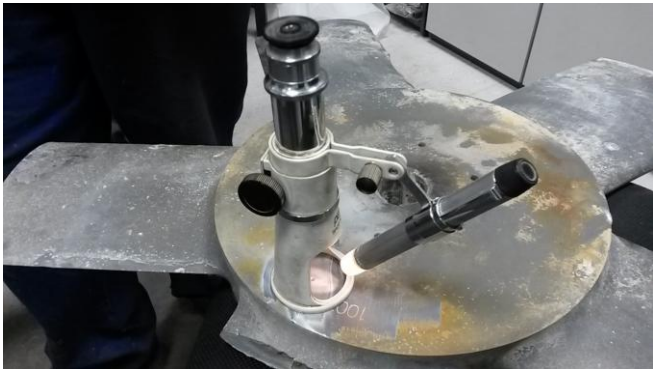
The failure analysis study was carried out by inspecting the fracture area in micrographic detail using optical microscopy and scanning electron microscopy, as shown in Figure 5. Initial inspection revealed a large amount of salt residue embedded on the surface. Therefore, the sample needed to be cleaned in an aqueous solution with 5% nitric acid in order to observe the metallic material.

Figure 5: Failure analysis study of the broken turbine.

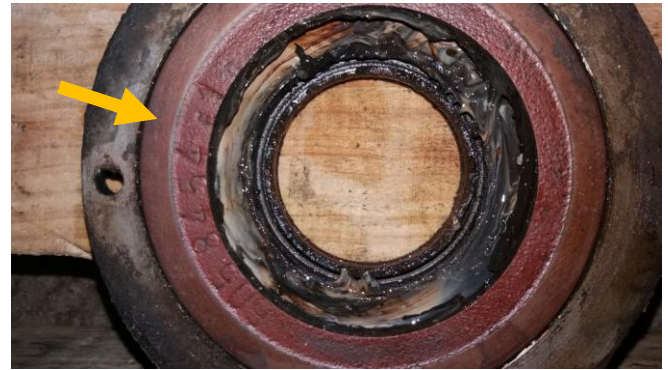
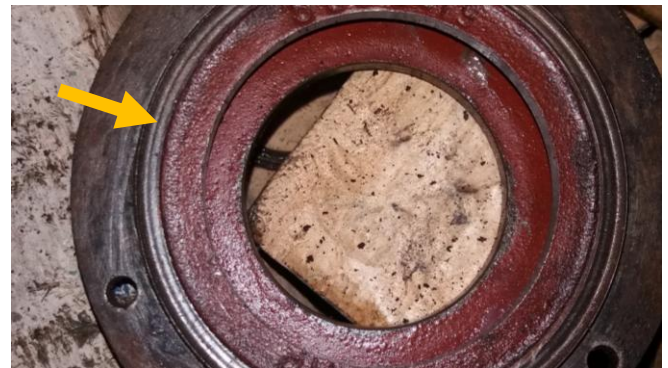
Signs of wear produced by vertical-axis forces have also been observed in the generator. The most frequent failure caused by oscillating forces in the turbo-generator shaft is usually breakage of the washer between the bearing and the housing of the generator. Due to the force exerted by the shaft, the washer is subject to high pressure that causes it to fail. The bearings consequently rub against the inside of the generator cover and wear occurs. This wear can be clearly appreciated in Figure 6. Figure 6(a) shows a generator cover prior to its installation in Mutriku, whereas Figure 6(b) displays a worn-down generator cover. The inner steel band (indicated with an arrow) can be seen to have worn away considerably. This may produce undesirable high vibrations attributable to the friction of the bearings against the generator cover. For safety reasons, turbine high vibrations

Figure 6: Bearing cover of the generator. (a) Before being installed; (b) Worn-down.

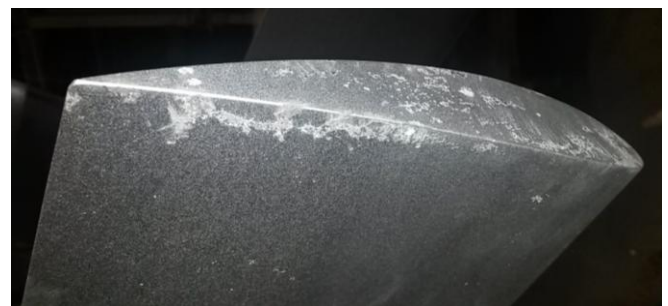
Another factor to take into account is salt accumulation. The air flow through the turbine contains a large amount of saltpetre that remains embedded on the turbine blades, as shown in Figure 7. This may lead to a sudden performance drop, as it not only causes vibration but also significant aerodynamic losses.

Figure 7: Salt accumulation on the surface of the Wells turbine blade.

To avoid this, the turbine blades are regularly washed with fresh water. The interval between each wash depends on the rotational speed of the turbine and the amount of vibrations, but is usually around 90 minutes.

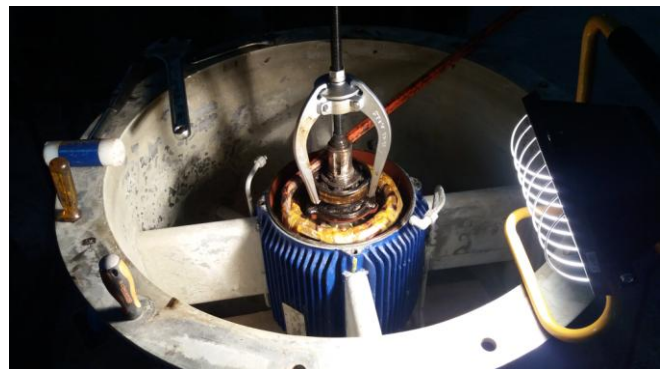
Figure 10: Greasing of roller bearings during scheduled maintenance work.

generator bearings. Figure 10 shows the annual mechanical maintenance carried out in the Mutriku Wave Power Plant. This kind of maintenance work is generally performed during the summer months due to better weather conditions. It must be taken into account that working with RMS chamber pressures above 8000Pa is a safety hazard for maintenance personal: precautionary measures are recommended to be taken when the RMS pressure exceeds 4000Pa. Apart from greasing the bearings, an electrical inspection is conducted annually, covering control system cabinets in the turbine room, the power converters cabinet to detect any sign of overheating and the cables, as well as the SCADA alarm and trip indicators.

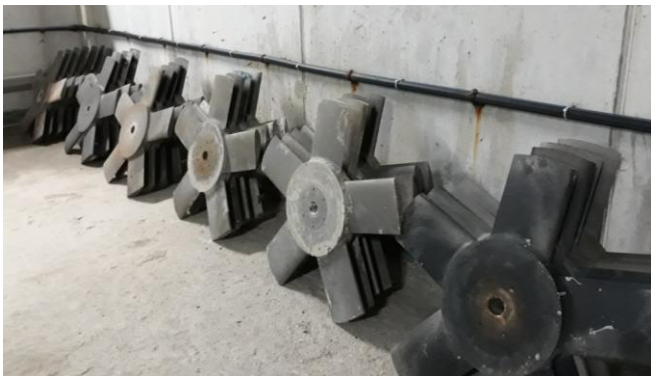
Figure 11: Replaced Wells turbines in Mutriku Wave Power Plant.

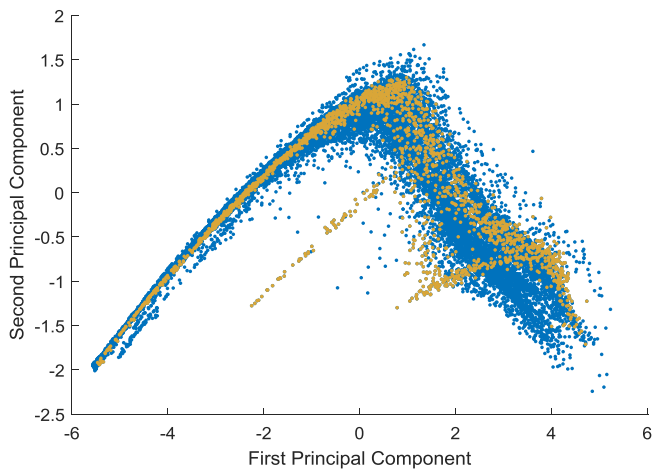
Once a point cloud is obtained from collected data, the challenge is to find the dimension or axis in which the cluster shows more variations. In this sense, the first step of PCA is to analyse which straight line explains the maximum variance, i.e. the maximum dispersion of the data. The first principal component, i.e. the one that contains the highest percentage of information and best explains the behaviour of collected data, is thereby obtained. The second principal component explaining the remaining variance can then be found. This brings a new set of axes where the data can be drawn and measured, as shown in Figure 12. PCA enables most of the information to be captured and summarised in a small set of dimensions.

Figure 12: The point cloud of PCA obtained from a case study.

In Figure 12 data from only eight of the turbines have been analyzed to reduce the computational workload. The parameters analysed include output voltage and currents, generated average power, rotational speed, output frequency, chamber RMS pressure, vibration and damper position. Due to the oscillating nature of the data and to simplify the study, the average hourly value of each parameter has been calculated. The results of the PCA approach demonstrate that some turbines need maintenance, as some components are outside the desirable operating range as indicated by the yellow dots.

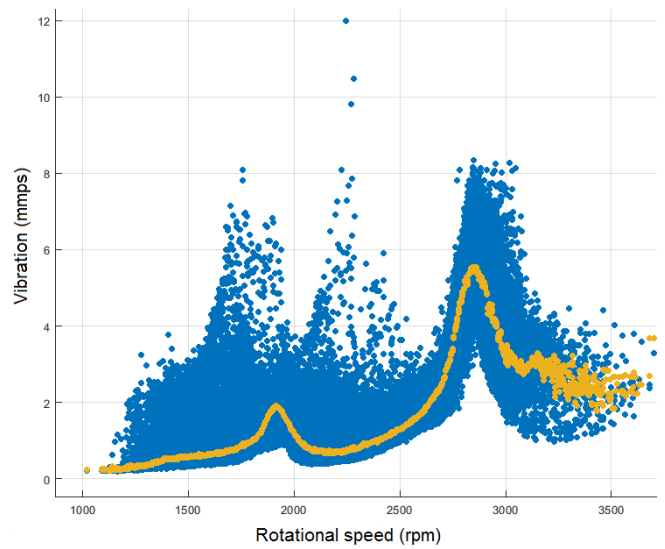
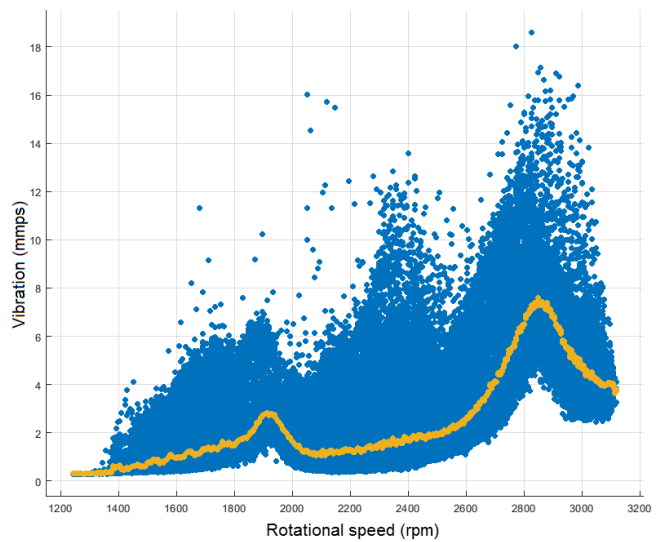
Having detected that a turbine is in need of maintenance, or that a particular component is reaching the end of its useful life, regression models can be trained so as to predict the normal response of the entire system or a single component. In Figure 13 one of these turbines has been analyzed to study the deviation that some parameters show when they are near the failure or breakage point. In this sense, the figure compares rotational speed (horizontal axis) and vibration (vertical axis). Vibration is the parameter that usually shows the highest degree of deviation when some components begin to suffer wear and tear. Figure 13(a) shows vibration levels during normal turbine operation. The turbo-generators in Mutriku Wave Power Plant are balanced around 2500rpm and both ends of the valley reveal undesirable vibration levels.

The machine learning approach can be used to predict the response, where the yellow dots indicate the predicted model. Hence, any turbine should show vibration levels around the predicted values during normal operation. However, through the data in Figure 13(b) are obtained from very similar wave conditions and the same turbine as in

Figure 13: Turbine rotational speed vs. vibration level. (a) non-degraded turbine; (b) degraded turbine.

Figure 13(a), according to PCA analysis the turbine should be in need of maintenance. The trained model demonstrates that, in effect, the values stand outside the regular operation range, as the turbo-generator system produces higher vibration levels at the same rotational speeds. Thus, the decision can be made about whether maintenance is to be performed or not.
