Applications for a Swivel-based Mooring System that Improves System Reliability for Marine Energy Devices

A slip ring-swivel system that addresses axial loading on and rotation of electric/power cables and fluid hoses and has broad applications to marine energy devices.

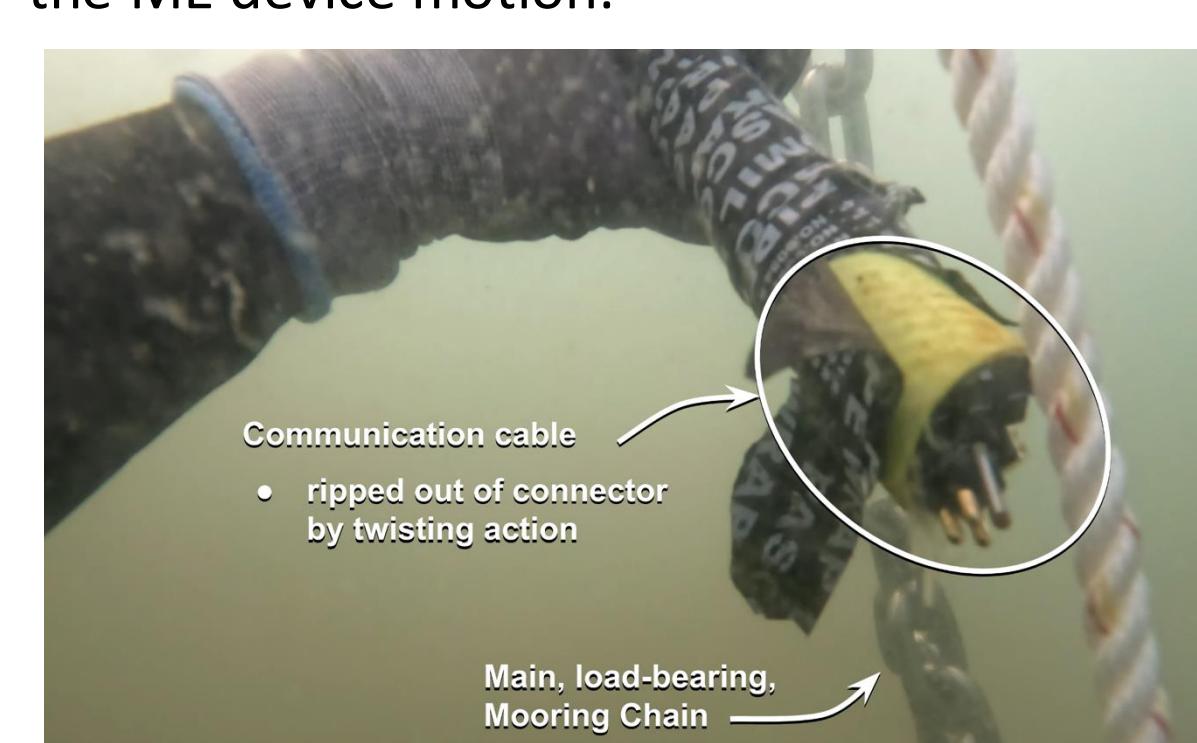
Fig. 1: Damaged wave energy converter (WEC) cable from twisting of the mooring line.

- Ocean testing trials have demonstrated challenges with damage to ME cables (Fig. 1) which can cause the ME device to fail.
- Two major modes of failure are high axial loads from varying sea states and line twisting due to the ME device motion.
