**Asia Pacific Research Initiative for Sustainable Energy  
Systems 2021 (APRISES21)**

**Ocean Thermal Energy Conversion (OTEC)  
Heat Exchanger Development  
(November 2024 to July 2025)**

**Task 5**

**MAKAI OCEAN ENGINEERING**  
**ANNUAL REPORT**

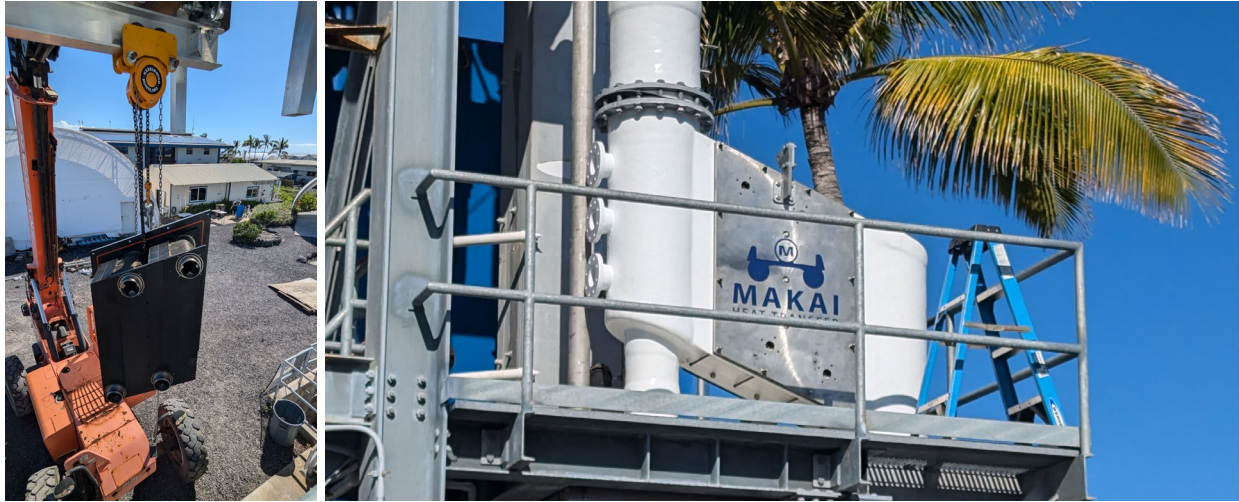
Makai previously reported on the design, construction (under separate funding), and installation of the cassette-style design for large-scale heat exchangers (Figure 1). In this period, Makai commissioned the heat exchangers and the newly upgraded HX Test Facility.

*Figure 1. Cassette design*

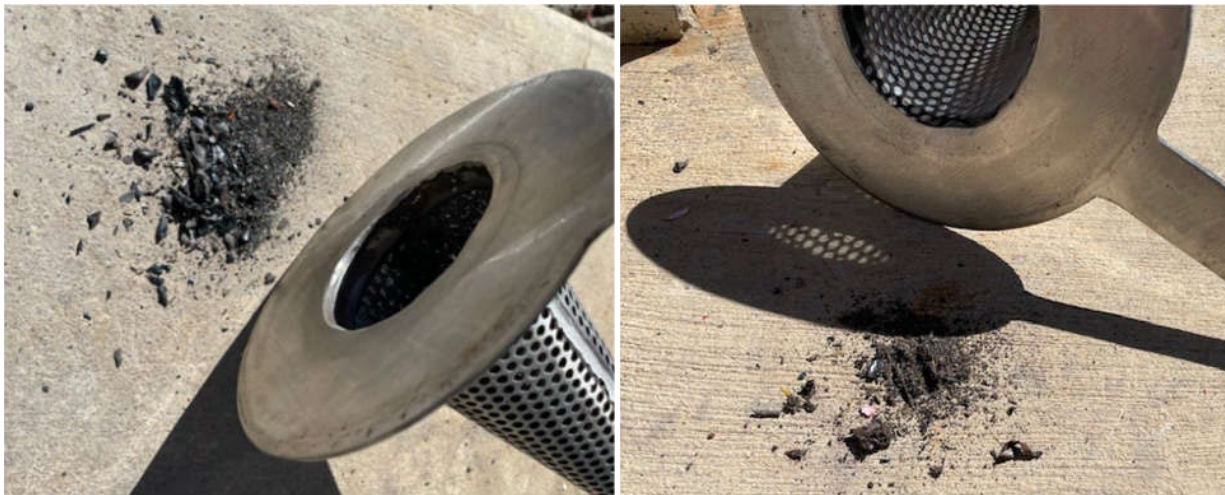
Both pumps seized during startup checks. Upon inspection, the amount of fine particles that passed through the filters at the pump inlets (Figure 6) combined with tight clearances of the pump design, led to damage on the interfacing surfaces of both pumps (gears, bearings, casing) (Figure 7 and Figure 8). The particles were removed and gouges were polished to the best of our ability and the pumps were re-assembled for operation. In addition, a finer mesh filter was added inside the existing filter.

*Figure 6. Debris in ammonia piping caught in strainer.*

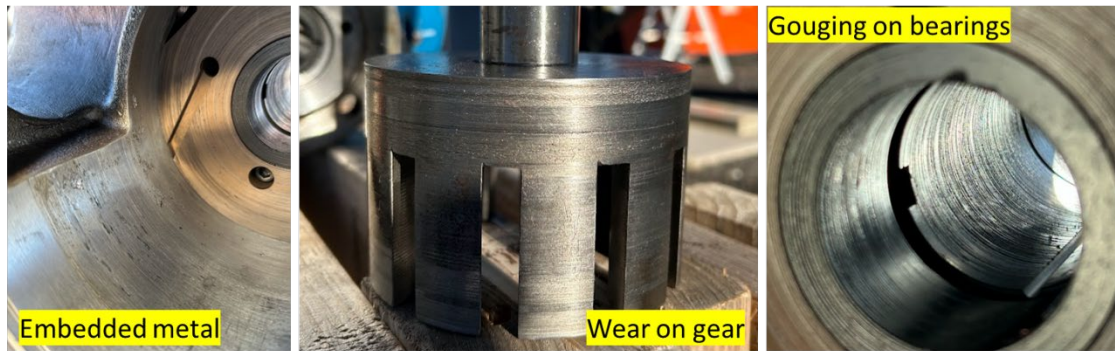
*Figure 7. Recirc pump damage.*

The initial repairs enabled an initial set of performance data collection with constant attention and servicing to the pumps. However, after 2 weeks, the pumps seized again and required an overhaul.

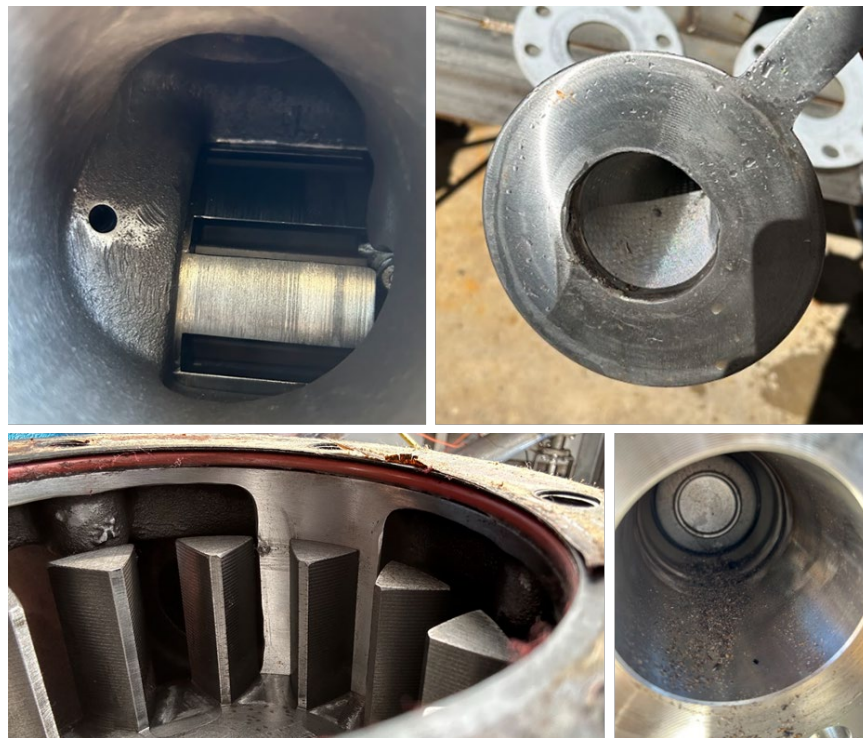
*Figure 8. Feed pump damage.*

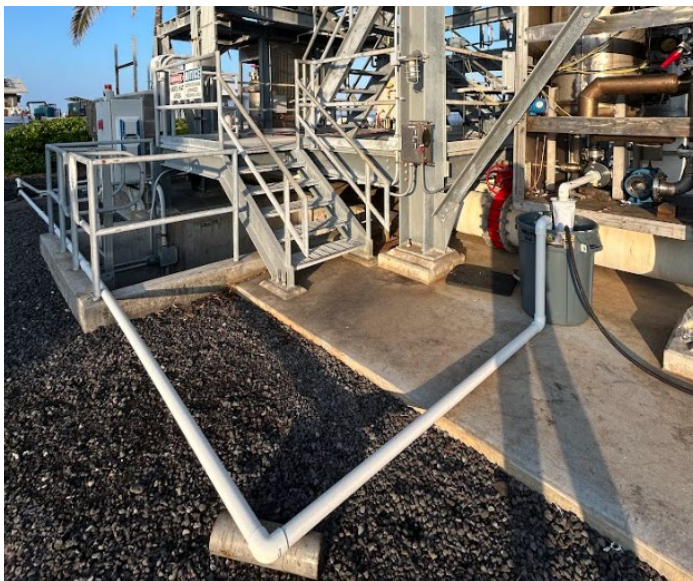
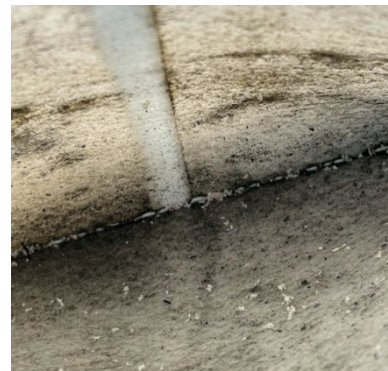
During the overhaul period, Makai installed a backflush line to use water to clean the piping from the feed pump outlet to the recirc pump inlet. Very little debris was flushed out (Figure 10); either most of the debris was already removed in the strainer at this point or the debris was generated by wear and/or cavitation within the pump.

*Figure 10. Flushing the ammonia line between the feed pump outlet and recirc pump inlet did not remove significant amounts of shavings/debris.*

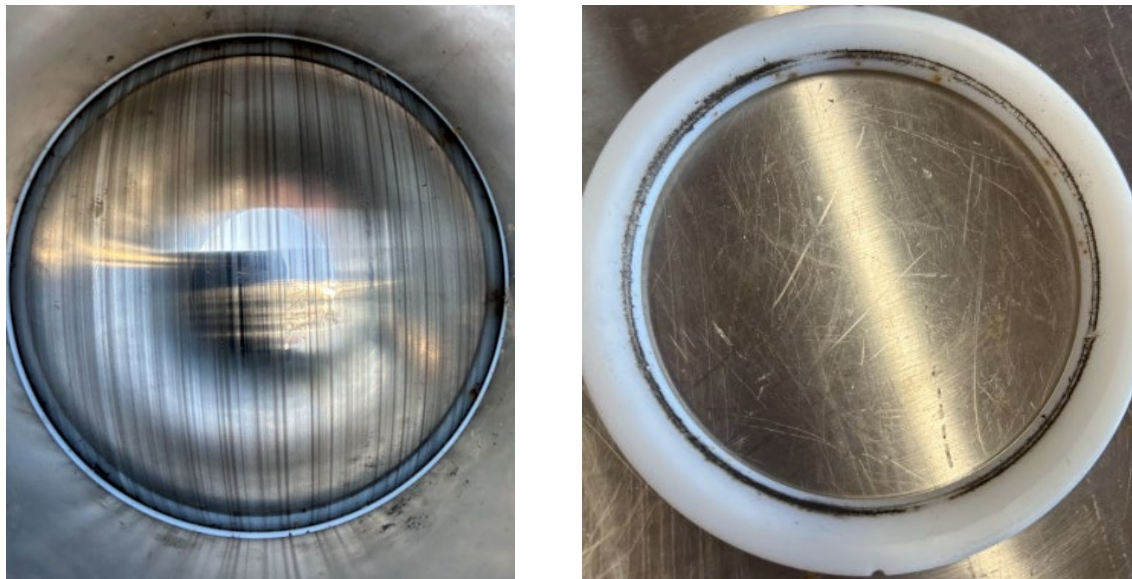
quick close valves to isolate the condenser but the quick close valve at the condenser exit (between the buffer tank inlet and condenser outlet) was found to leak. Makai found weld slag on sealing surfaces that interfered with the seal (Figure 11). Once repaired, the valve was verified to seal prior to returning to ammonia service.

*Figure 11. Weld slag in valve seating surfaces prevent quick-close valve from sealing.*

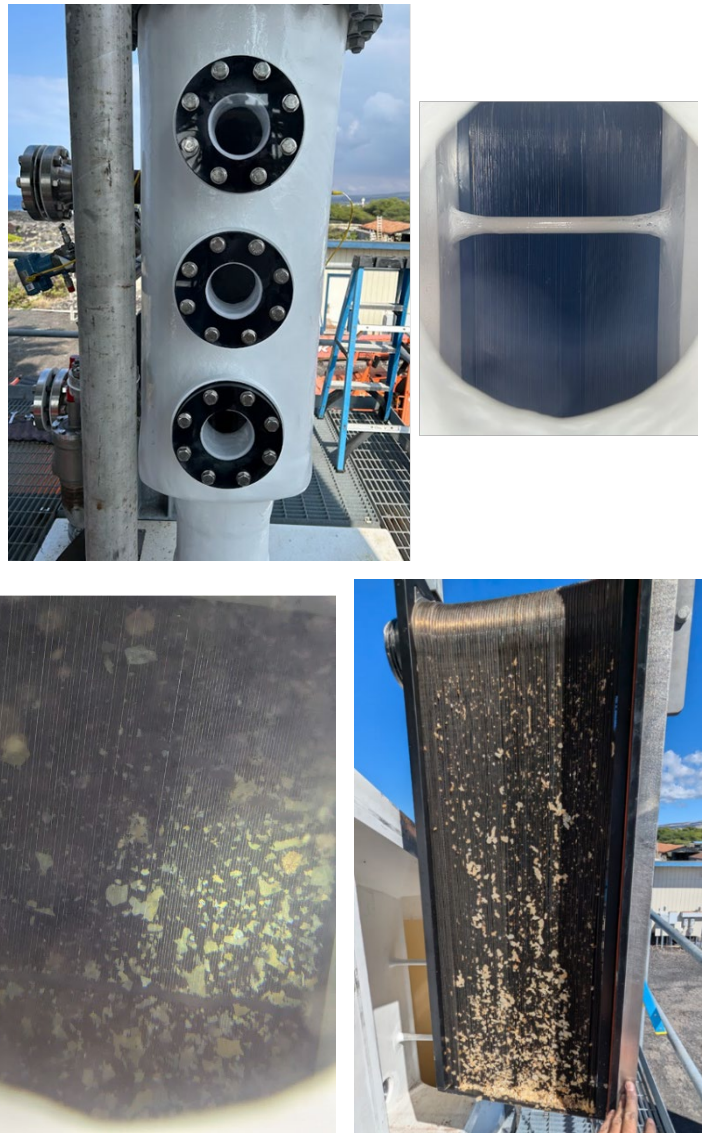
Instead of relying on pressure drop, Makai installed three viewports to observe the evaporator inlet face during operations and a backflush to remove some of the debris without having to remove the evaporator. The viewports also allowed access to manually brush the leading edges. Neither backflushing or brushing were 100% effective but was enough to complete initial performance data collection.

*Figure 12. (top) View ports installed to monitor evaporator leading edge. (bottom) Debris from seawater piping system collected at the evaporator leading edge as seen through the viewport and when evaporator was removed for cleaning.*

Future operations will use a sump pump when the intake strainer needs to be emptied. This effort prevents debris falling into the bottom of the piping during strainer removal. Makai also lined the strainer with a finer mesh screen so less debris can pass through the strainer.

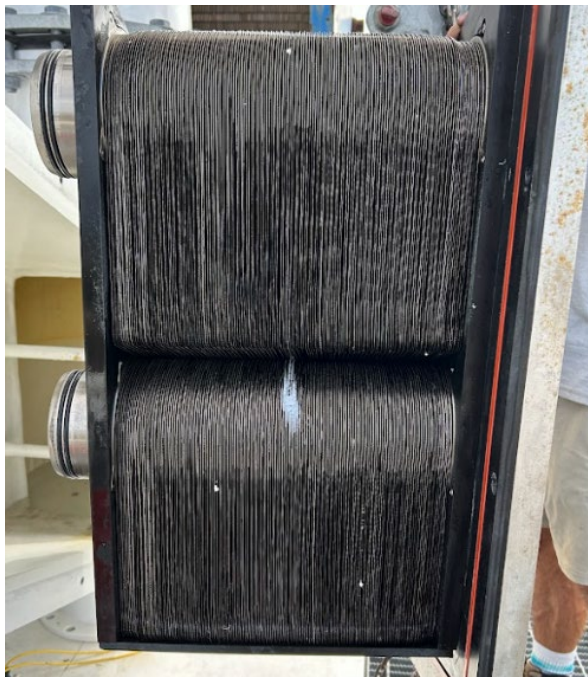
Makai previously established that the TFHXs must be flooded with seawater prior to being placed into ammonia service. This is for safety and because the cassette, housing, and hardware was designed to have seawater pressure counteracting some of the internal ammonia pressure. When seawater priming was lost following emergency system testing, the condenser began to slowly drain. Once priming was lost, cold seawater was no longer flowing to cool the condenser or the buffer tank. Ammonia temperature (and pressure) increased to ambient conditions (30°C, 1166 kPa) and the condenser stack began to leak. Makai attributes the leak to several compounding factors: the condenser experienced plate shift but was still sealed so the condenser was not removed to fix the plate shift; the manifold bolts were bent due to the plate shift event; there was no longer seawater pressure acting on the plates; the ammonia pressure was high, although not to the point of lifting a relief valve. The shifted stack was clearly misaligned in the center and this likely reduced the safety factor for maintaining compression and the TFHX experienced a leak at the center of the stack (Figure 13).

*Figure 13. White residue at the center of the stack is indicative of an ammonia leak.*

In addition to implementing automatic priming to maintain seawater priming, the control program will send alerts if seawater priming is lost or if based on flow and pressure measurements, the seawater side is draining/drained.

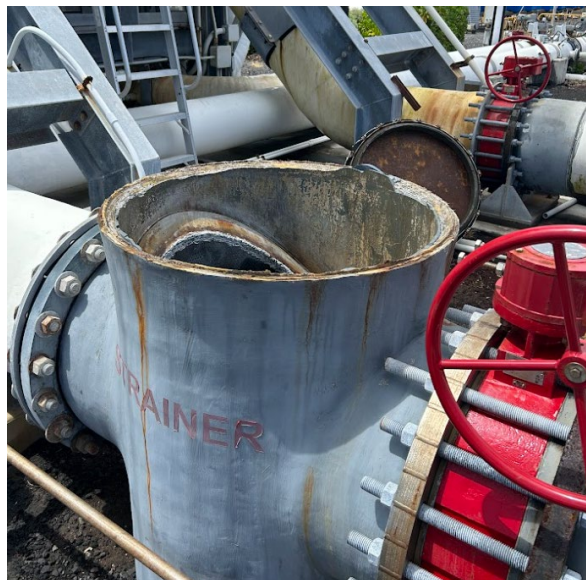
A separate incident occurred as the result of an upstream user at NELHA. After running high flow rates (~6,000 gpm) of warm seawater, flow was instantly stopped by shutting a valve. Makai's HX Test Facility is typically open/connected to the NELHA system (i.e., warm and cold seawater inlet valves are open). Because the NELHA pumps cannot respond instantaneously, the sudden stop by the upstream user produced a pressure transient that sheared off the top part of the FRP inlet strainer housing to Makai's HX Test Facility.

*Figure 14. Top part of the strainer sheared off.*

Makai replaced the damaged plates, re-stacked and re-installed the evaporator. The strainer body required extensive fiberglass work but has been repaired. This event has emphasized the importance of serviceability of the cassette concept and the TFHX.

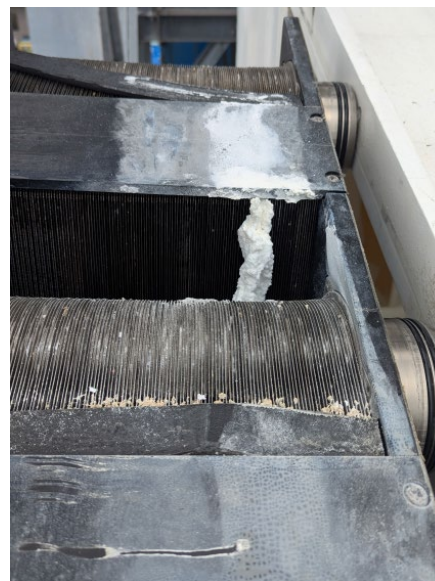
Makai personnel were on site and able to manually close an upstream valve to stop seawater from flooding the area. In addition to severing the strainer housing, the TFHX evaporator was also damaged. After removing the evaporator, pinhole leaks in the transition zone were found on several plates. Makai observed dents in the foil at the leak locations that are likely from debris that was wedged in between the plates. Makai suspects the evaporator had experienced multiple pressurization pulses since placed in service and debris was worked in between the plates during each cycle. Ultimately, one major event led to leaks in several plates.

*Figure 15. TFHX evaporator showing residue from ammonia leak and debris around the manifolds.*

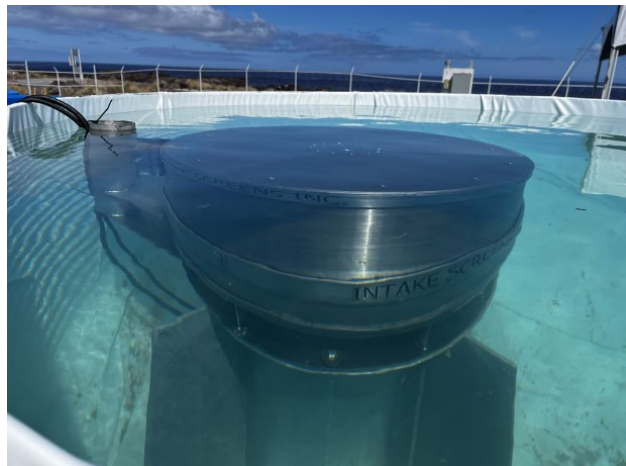
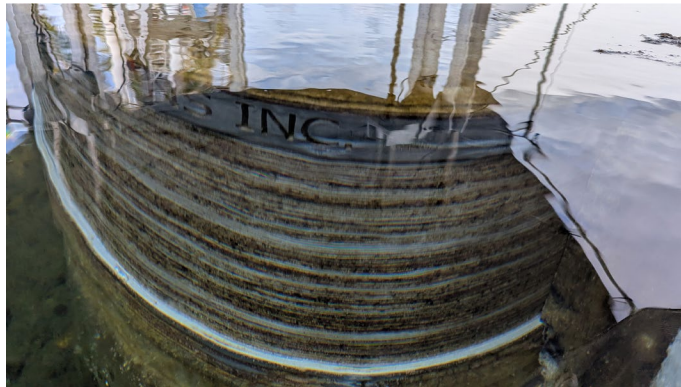
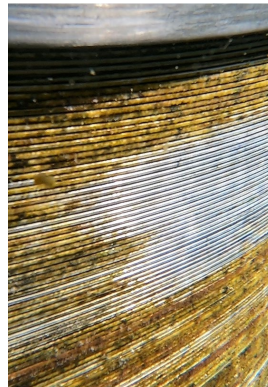
As observed during evaporator testing, the compact channels of the TFHX are susceptible to clogging from debris. Makai has been testing a self-cleaning intake screen by ISI, Inc (Figure 28) for one year. The test is to determine the efficacy of the cleaning mechanism, understand the required maintenance cycles, and evaluate the durability of the components in order to understand where improvements are needed for long-term deployment.

The discoloration on the screen is fouling that is easily removed with a brush. Makai has observed that the screen is not perfectly round and the screen bristles do not evenly make contact across the entire surface of the screen. There has been no corrosion observed on the screen. The anode surface was cleaned twice, at about 3 and 6 months after installation and replaced at 10 months (Figure 29).

*Figure 28. (top) Intake screen upon installation. (bottom) Intake screen after one year.*
