# **Asia Pacific Research Initiative for Sustainable Energy Systems 2011 (APRISES11)**

## **OTEC Heat Exchanger Development and Testing Task 4.1**

# **OTEC HX TESTING PROGRAM**

## **2014 ANNUAL REPORT**

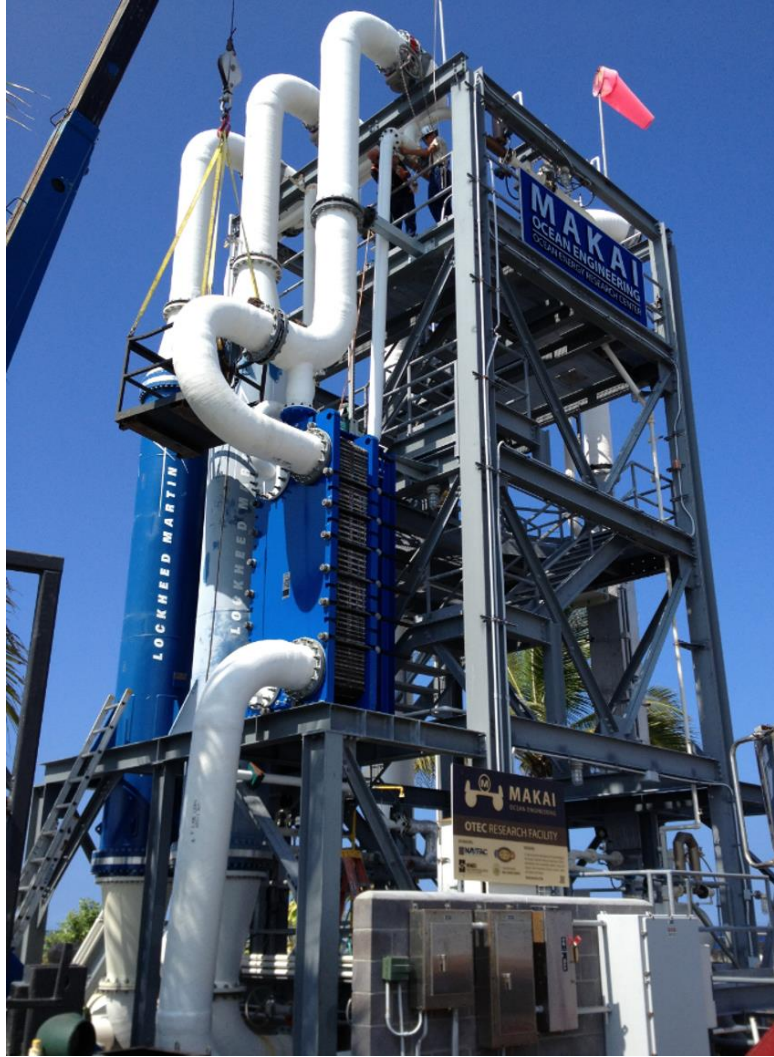
*Figure 3-1. APV Titanium plate-frame heat exchanger installed on the OERC HX Performance Testing Facility.*

The APV condenser arrived in the OERC on October 14, 2013 and was installed over a ten-day span. Performance testing was conducted on October 28, 2013. A total of 19 operating points were tested (Table 3-2). Each operating point was held at steady state for at least ten minutes. Steady state was defined as being within +/- 3% for duty, +/- 2% for seawater flow rate, +/- 0.1°C for seawater inlet temperature, +/-0.2°C for seawater temperature difference, +/- 2% for LMTD, +/- 2% for ammonia flow rate, +/- 2% for quality, and +/- 1 kPa for condenser pressure.

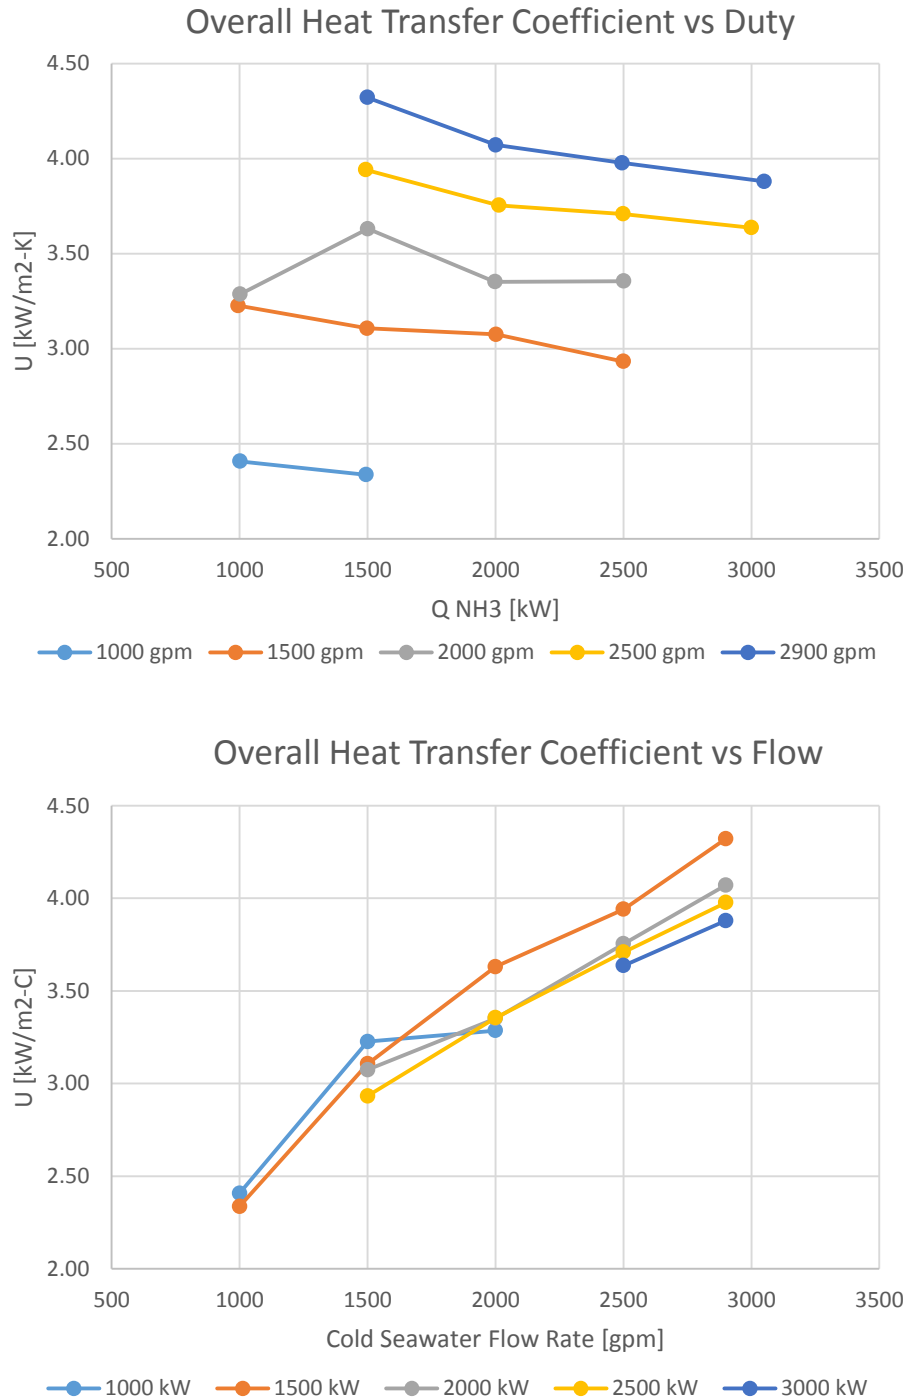
U is plotted below in two ways – with lines of constant seawater flow and with lines of constant duty. U is mostly dependent on water velocity and less dependent on duty, indicating the heat exchanger is limited by the water-side heat transfer rate.

**Figure 3-2. Condenser overall heat transfer coefficient**

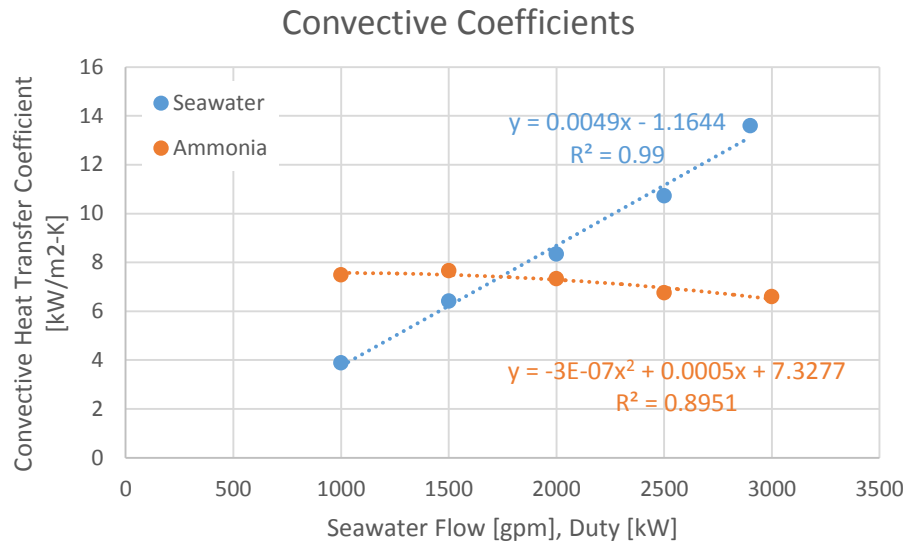
In the tested range, the overall heat transfer coefficient was mainly influenced by the seawater convective heat transfer coefficient which varied from 4 to 14 kW/m<sup>2</sup>-C whereas the ammonia convective heat transfer coefficient showed little change (6.5 to 7.5 kW/m<sup>2</sup>-C).

**Figure 3-3. Ammonia and seawater convective heat transfer coefficients fitting the equation  $1/U = 1/h_{sw} + dx_w/k + 1/h_{NH3}$  solved for using the least-squares method.**

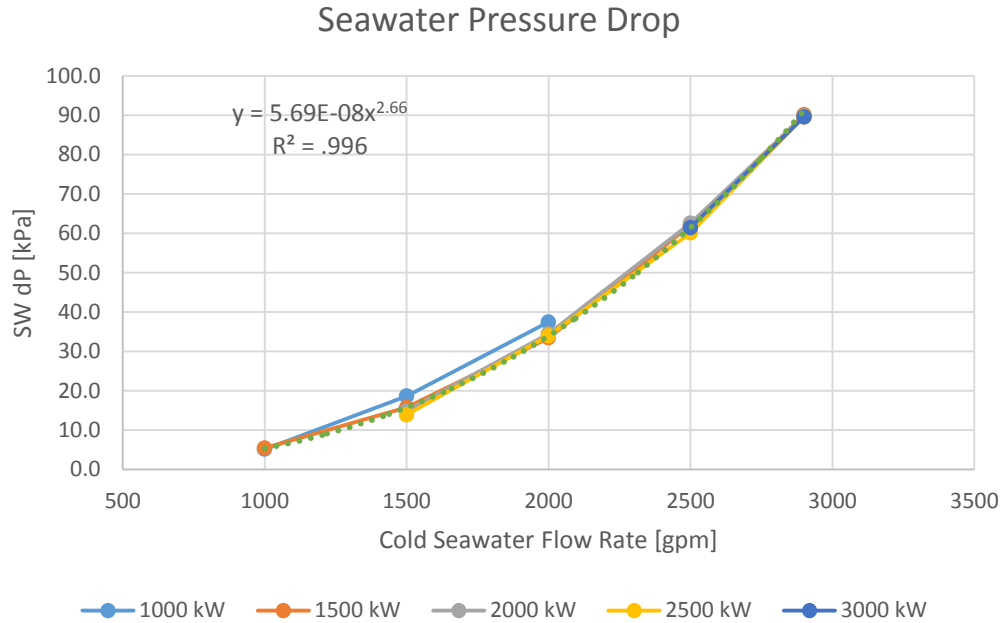
The seawater-side pressure drop is independent of duty and has a power-law relationship to water velocity. The power-law relationship has an exponent of ~2.7. Pressure drop increases exponentially with increased water flow, opposite to the trend of U value, which shows diminishing increases with increased flow. These opposing trends imply there is an optimum water velocity that balances increased U value with increased pressure drop across the condenser.

**Figure 3-4. Seawater-side pressure drop**

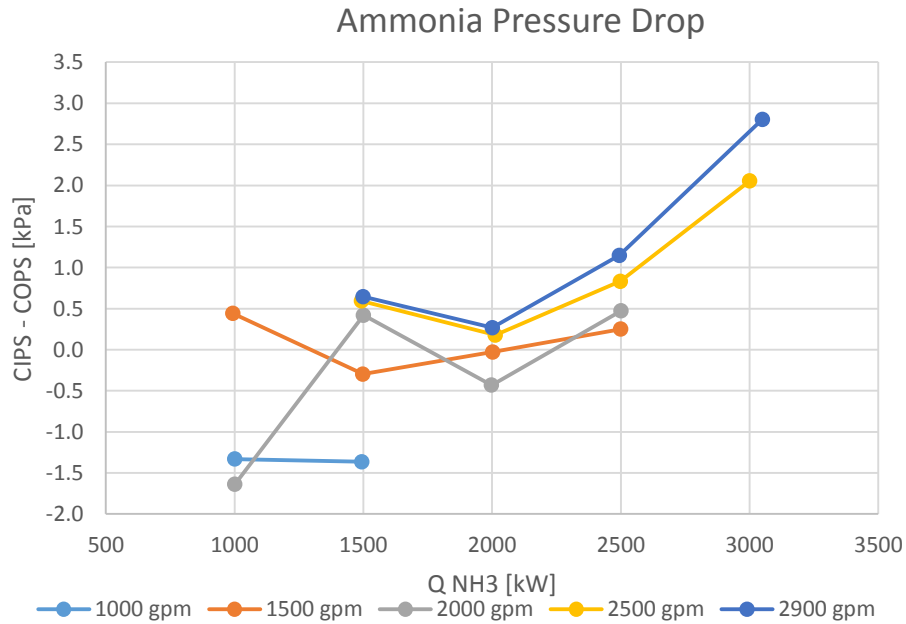
The magnitude of the pressure drop on the ammonia side is much smaller than the pressure drop on the seawater side. Also, one of the ammonia pressure sensors may be faulty – the dP across the condenser should never be negative.

**Figure 3-5. Ammonia-side pressure drop**

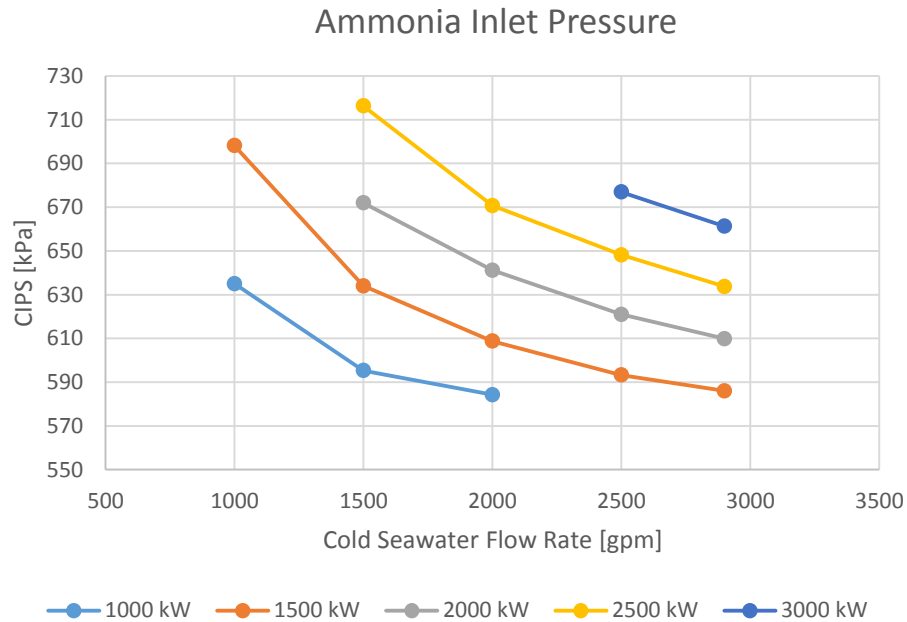
For a given duty, the condenser pressure decreases with increased seawater flow rate. This means that the power output should be greater for higher water flow rates. However, the increased power with increasing seawater flow will eventually be offset by the increased pumping power at higher flows (due to the increase in seawater-side pressure drop).

***Figure 3-6. Ammonia absolute pressure at condenser inlet***

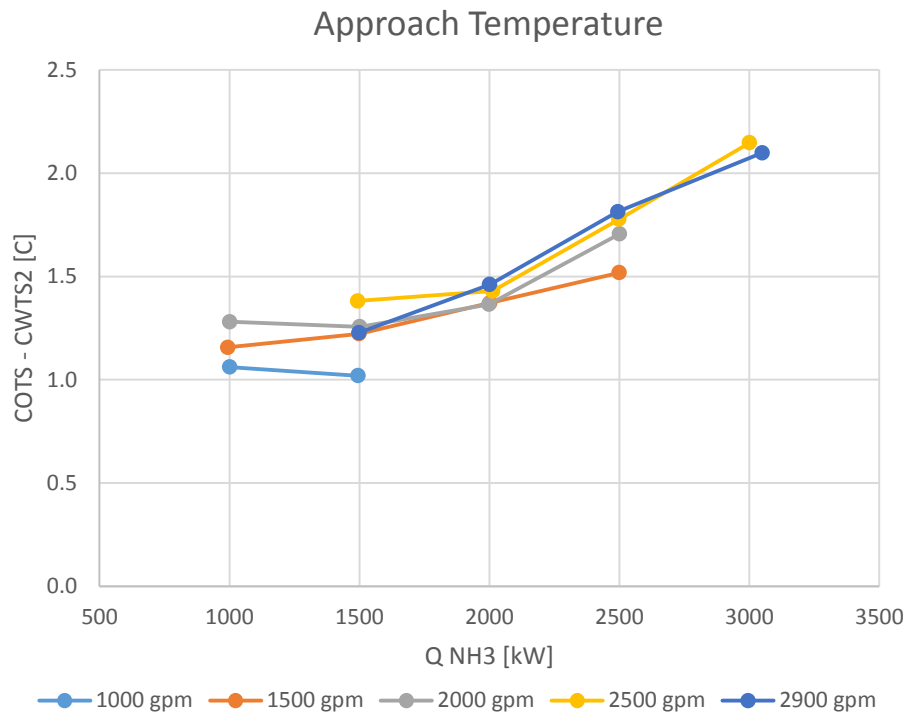
Ammonia duty is used in this calculation because the ammonia pressure sensors are used to calculate the ammonia temperature at saturation and provide a more accurate temperature measurement than the temperature sensors on the seawater side.

**Figure 3-7. Approach temperature**

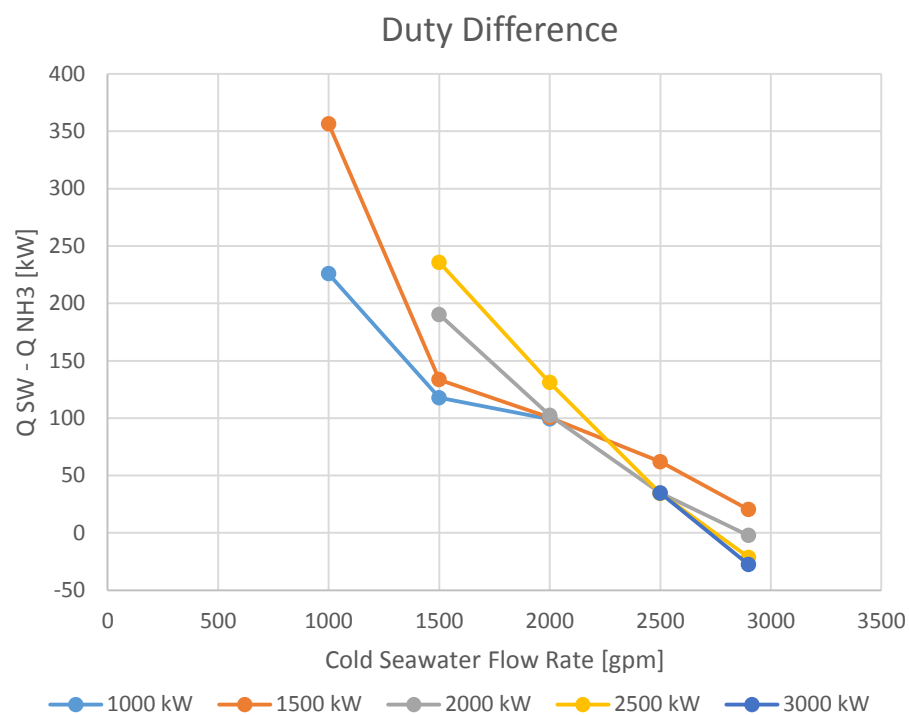
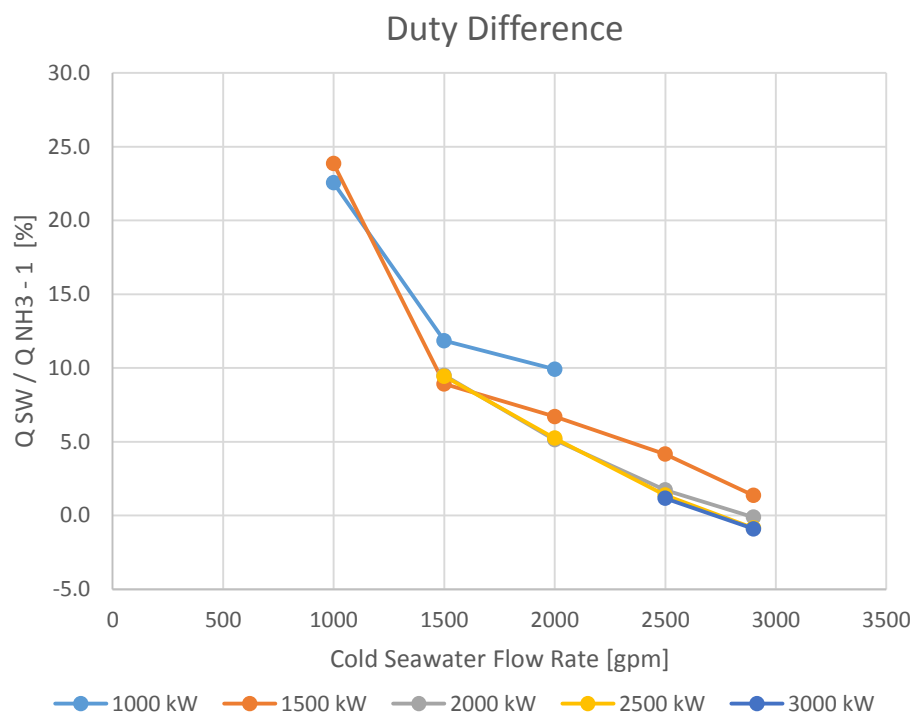
Theoretically, if the condenser was perfectly insulated, the ammonia duty should be identical to the seawater duty. However, during testing heat from the outside environment and sensor accuracies can cause the two duties to be unequal. In general, the agreement between the two duties was very good. At flow rates higher than 2500 gpm duties were within 5% (Figure 3-8). At lower duties and low flow rates, the discrepancy between the two measured values is magnified, with the worst being 22% off.

**Figure 3-8. Difference between ammonia duty and seawater duty**

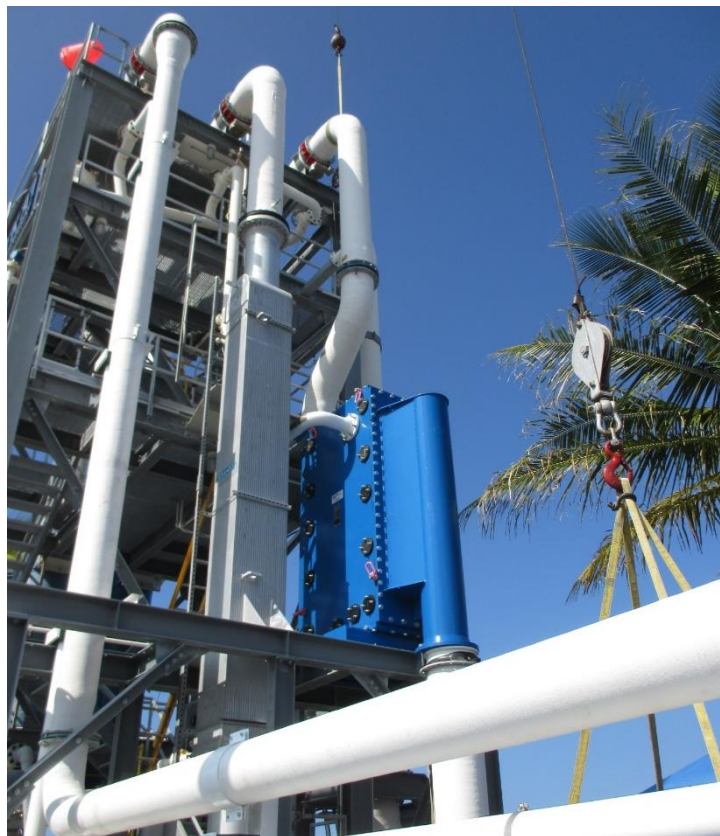
**Figure 3-9. APV Cross Flow Heat Exchanger installed at the OERC HX Performance Testing Facility.**

The APV cross-flow evaporator was installed and tested in October 2014. A total of 21 operating points were tested (Table 3-4). Each operating point was held at steady state for at least ten minutes. Steady state was defined as being within +/- 3% for duty, +/- 2% for seawater flow rate, +/- 0.1°C for seawater inlet temperature, +/- 0.1°C for seawater temperature difference, and +/- 2% for LMTD.

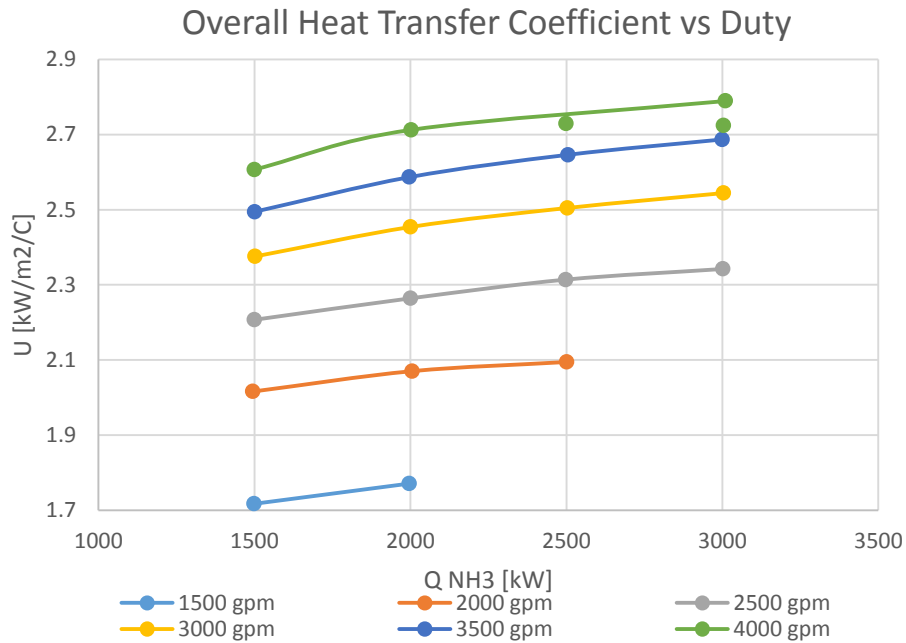
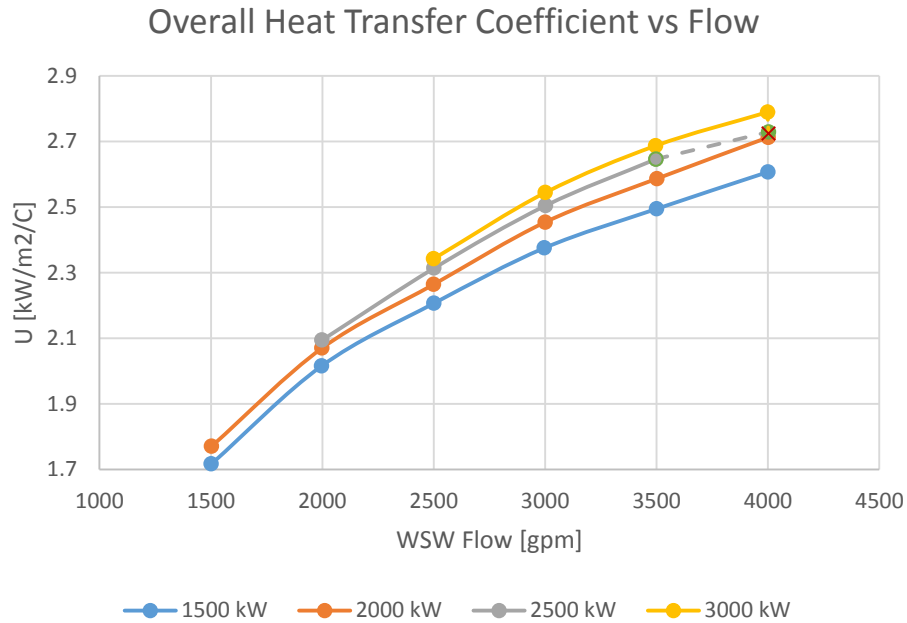
The effect of quality on U was not explicitly tested but two test points collected at different qualities illustrate U is lower for high qualities. The 4000 gpm – 2500 kW (green filled circle) operating point and one of the 4000 gpm – 3000 kW (red “x”) operating points were collected at high quality (82% and 94%, respectively) compared to the other points at ~ 60 % quality. At 4000 gpm – 2500 kW, the U value at 82% quality is slightly lower than expected from the trend at ~60% quality; the slope of the gray dashed line is not as steep as the solid gray line. U value for the 94% quality point at 4000 gpm – 3000 kW is 2% lower than for the 60% quality point at 4000 gpm – 3000 kW. Previous testing indicated U is mostly independent of quality variations between 30-80% but decreases with increasing quality at qualities higher than 80%.

**Figure 3-10. Overall heat transfer coefficient**

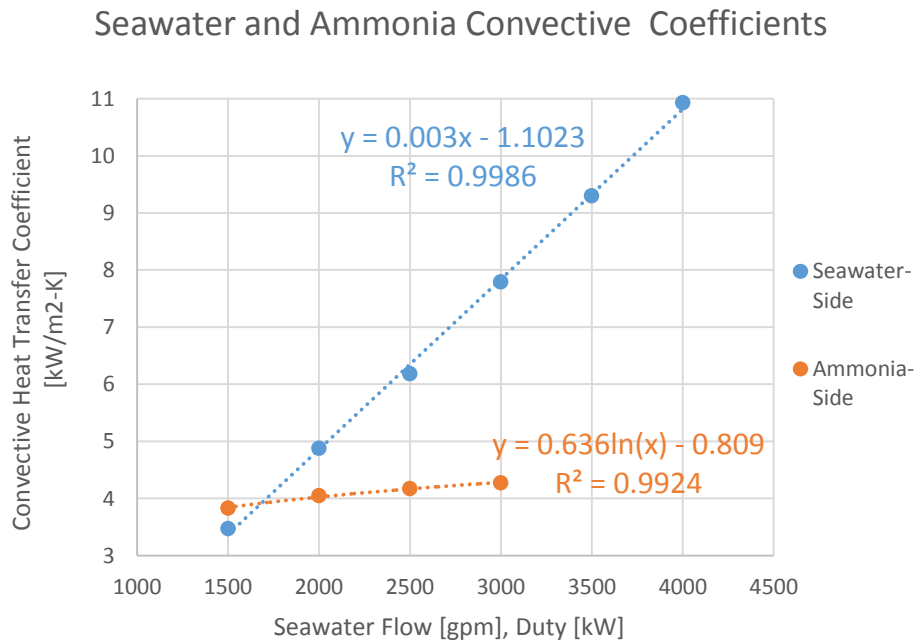
In the tested range, the overall heat transfer coefficient was mainly influenced by the seawater convective heat transfer coefficient which varied from 3.5 to 11 kW/m<sup>2</sup>-C whereas the ammonia convective heat transfer coefficient showed little change (3.8 to 4.3 kW/m<sup>2</sup>-C).

**Figure 3-11. Ammonia and seawater convective heat transfer coefficients fitting the equation  $1/U = 1/h_{sw} + dx_w/k + 1/h_{NH3}$  solved for using the least-squares method.**

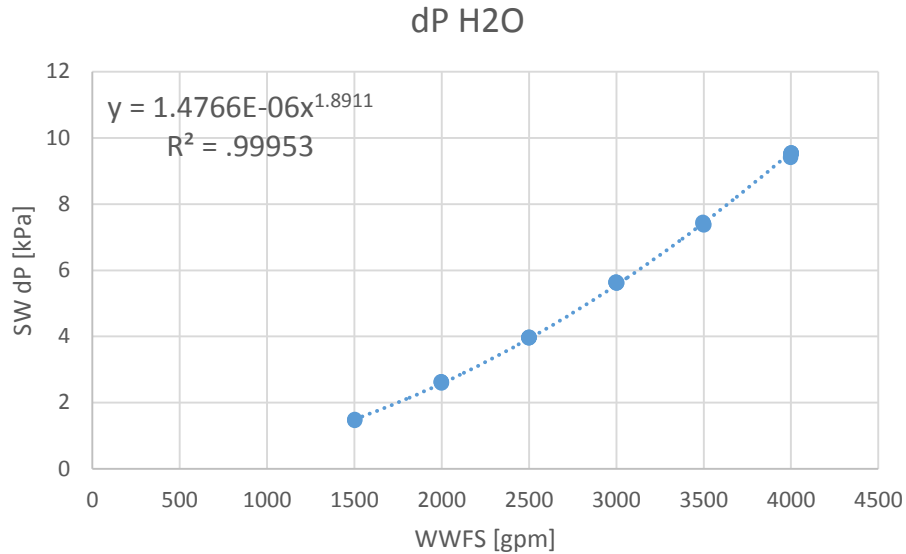
The seawater-side pressure drop is independent of duty and has a power-law relationship to flow rate with an exponent of  $\sim 1.9$ . However, with less than 10 kPa pressure drop at 4000 gpm, the pumping power requirement is quite low.

***Figure 3-12. Seawater-side pressure drop***

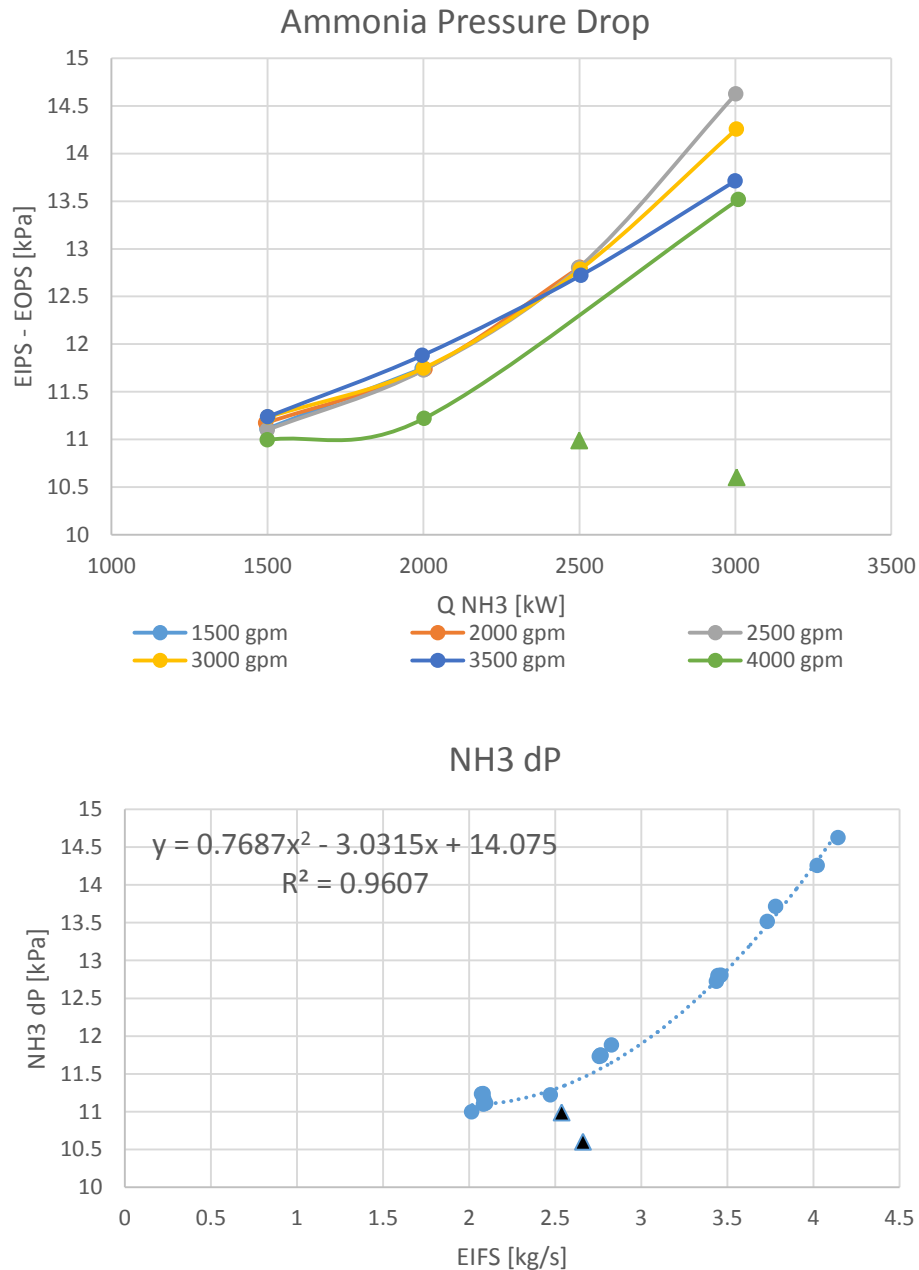
Ammonia-side pressure drop is independent of seawater flow, increases with increasing duty, and decreases with increasing quality because it is dependent on ammonia mass flow rate (Figure 3-13). The black triangles are points collected at high quality (82% and 94%).

**Figure 3-13. Ammonia-side pressure drop. Triangle data points were collected at higher quality than the other points. Since quality effects were not specifically tested, the high quality points are considered outliers, shown for completeness but not included in analysis.**

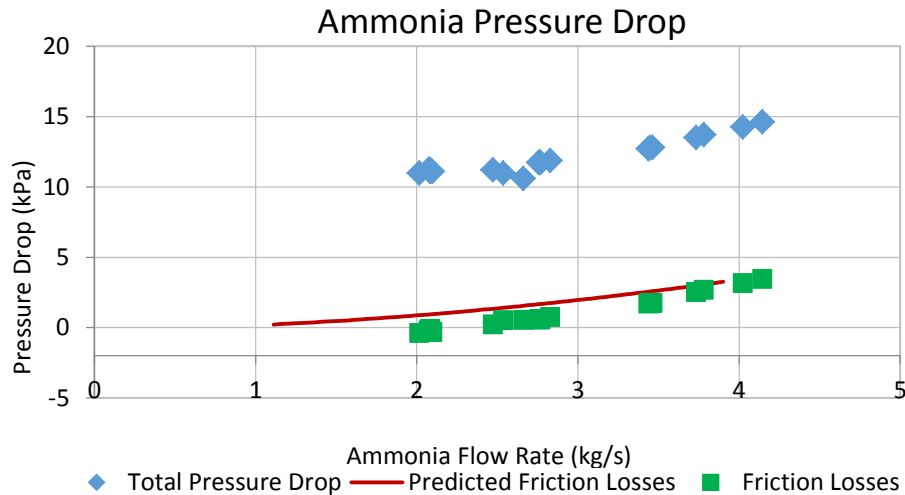
As measured, ammonia-side pressure drop is 5 times higher than the predicted but the as-measured pressure drop also includes the effects of static head and momentum head along with frictional head loss. By solving for the void fraction at different heights along the evaporator, the static head and momentum head contribution to the total pressure drop can be calculated, leaving the only the pressure drop due to frictional losses (Figure 3-14).

**Figure 3-14. Ammonia-side frictional losses.**

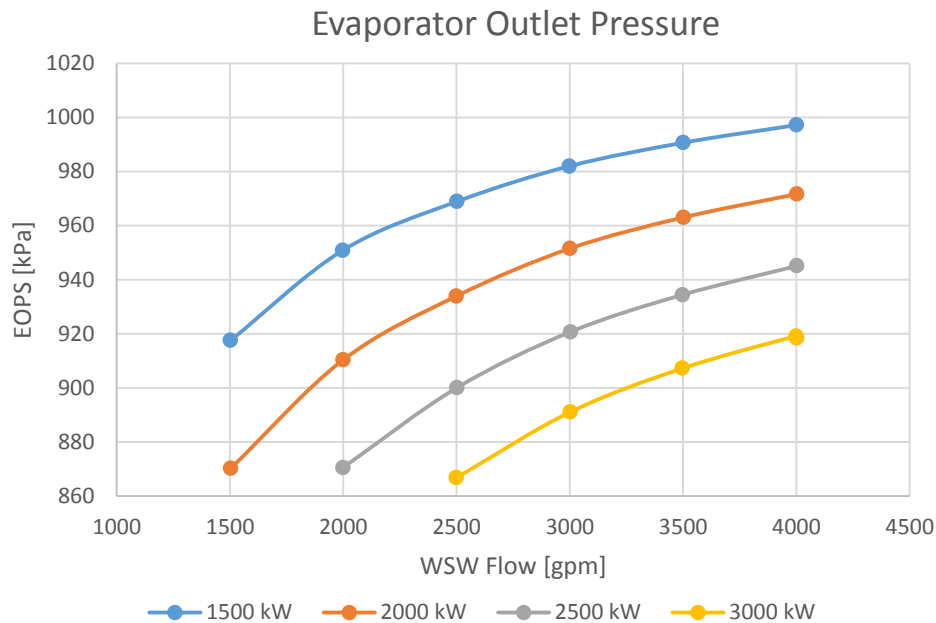
For a given duty, the evaporator pressure increases with increasing seawater flow. This means that gross power is greater for higher seawater flow rates; however, seawater pressure drop increases exponentially with increasing seawater flow which increases pumping power and ultimately reduces net power. As with the overall heat transfer coefficient, there is an optimum point which maximizes the gain in power output with increased seawater flow while accounting for the increase in pumping power required at higher seawater flow rates to produce the maximum net power.

**Figure 3-15. Ammonia absolute pressure at evaporator outlet increases with increasing seawater flow rates.**

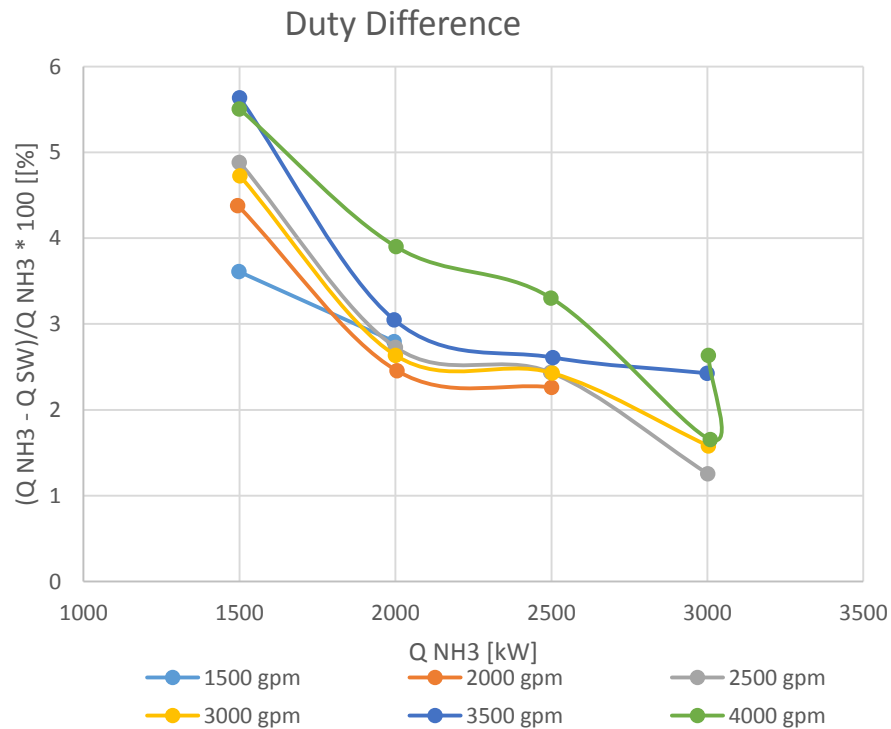
Theoretically, if the evaporator was perfectly insulated, the ammonia duty should be identical to the seawater duty. However, environmental input and limitations in sensor accuracy can cause the two duties to be unequal. The two duties were within 6% (Figure 3-16). Previous testing showed greater duty discrepancy at lower flow rates and lower duties. Duty discrepancy is greater at lower duties but contrary to previous testing, higher flow rates also resulted in higher discrepancies for the same duty.

**Figure 3-16. Difference between ammonia duty and seawater duty**

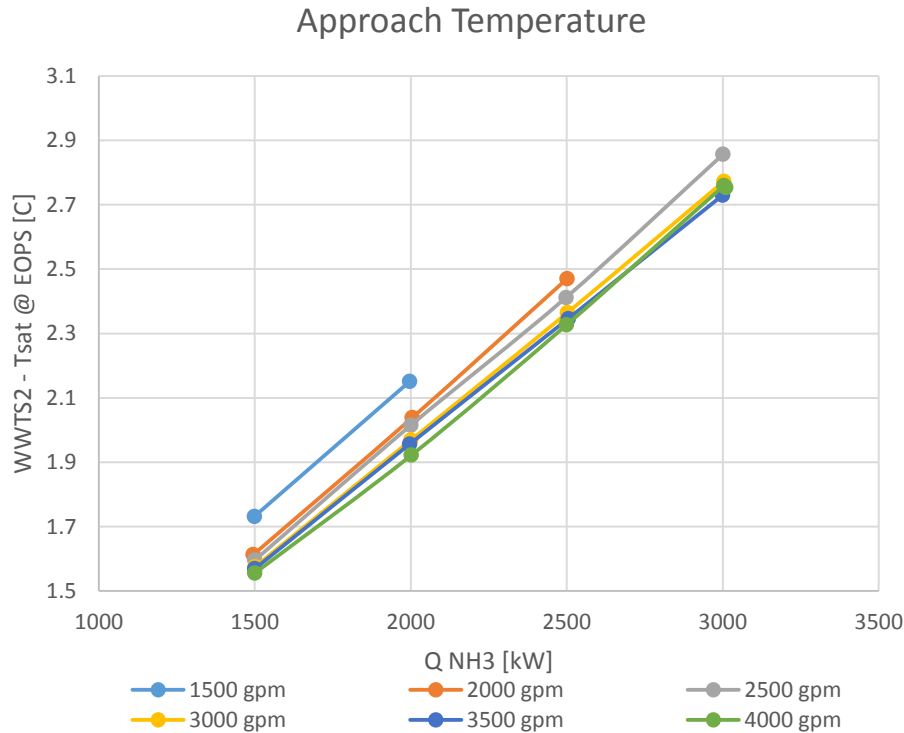
The data shows a linear relationship between duty and approach temperature, with the slope of the line dependent on the water velocity. The approach temperature increases with duty because higher duty corresponds to higher ammonia operating pressure, and thus a higher saturation temperature.

*Figure 3-17. Approach temperature*

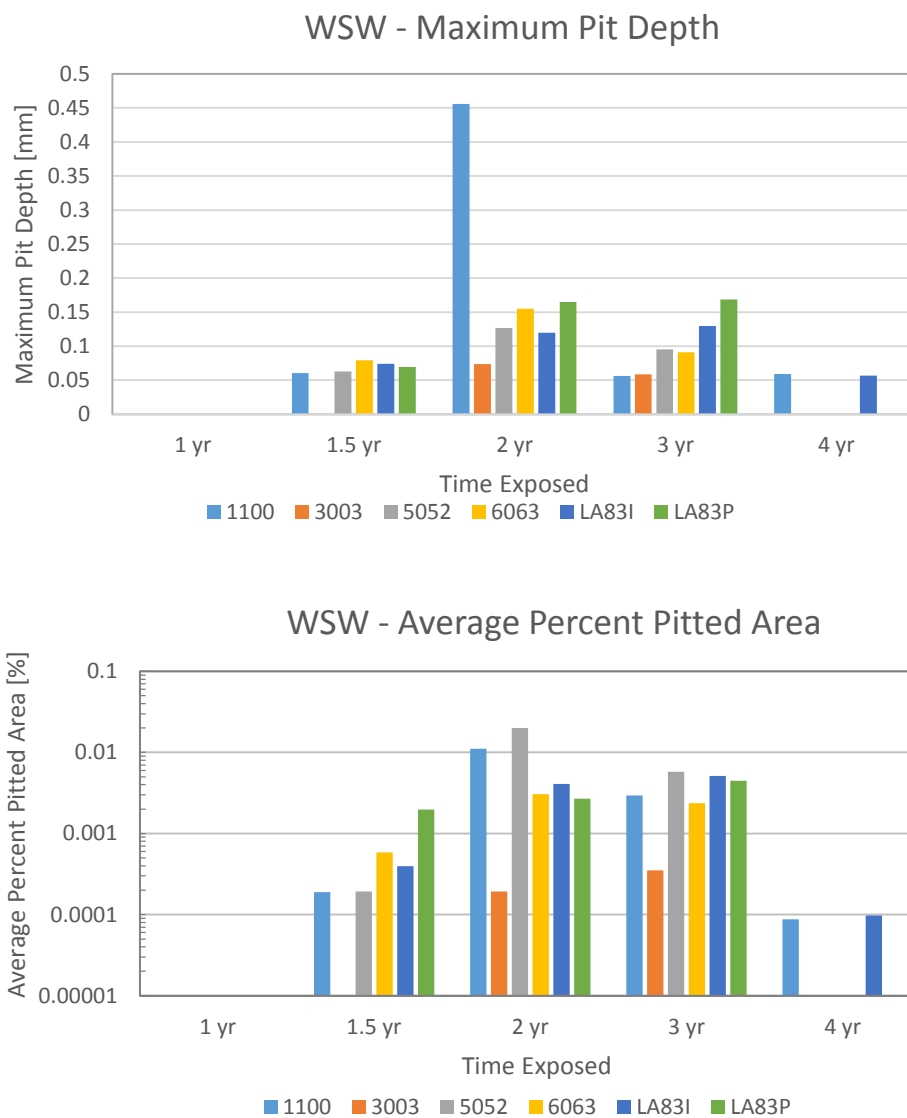
For the four-year samples, profilometer scans identified one pit each on two samples (one of Alloy 1100 and one of Alloy LA83I, Figure 4-1) although the pits could not be visually identified under a microscope. No pits were observed on the remaining 22 samples.

**Figure 4-1. Maximum pit depth and average percent pitted area (per alloy, per exposure time) for samples exposed to WSW. There are no scan data for 1-yr exposure samples of Alloys 1100, 3003, 5052, LA83I and LA83P.**

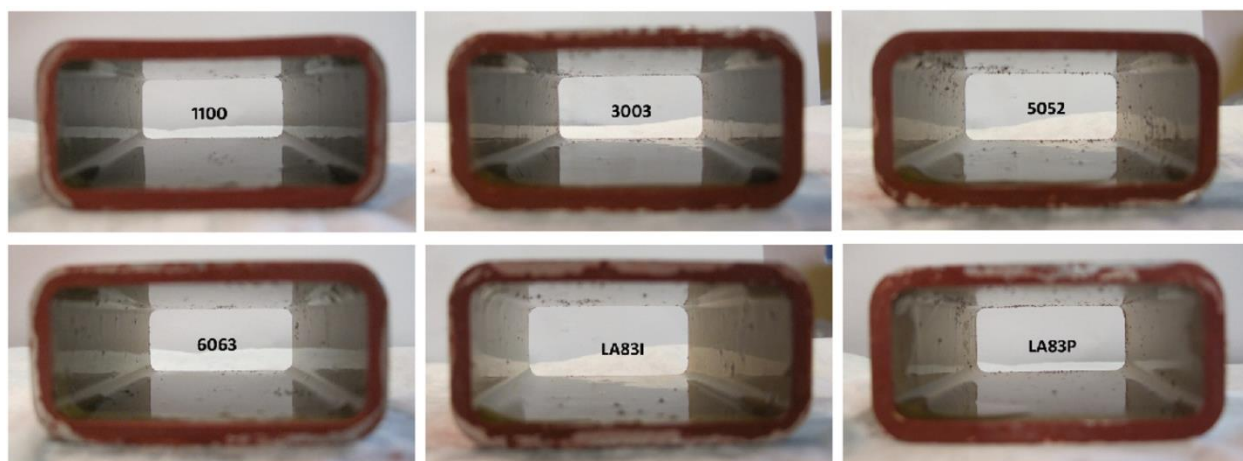
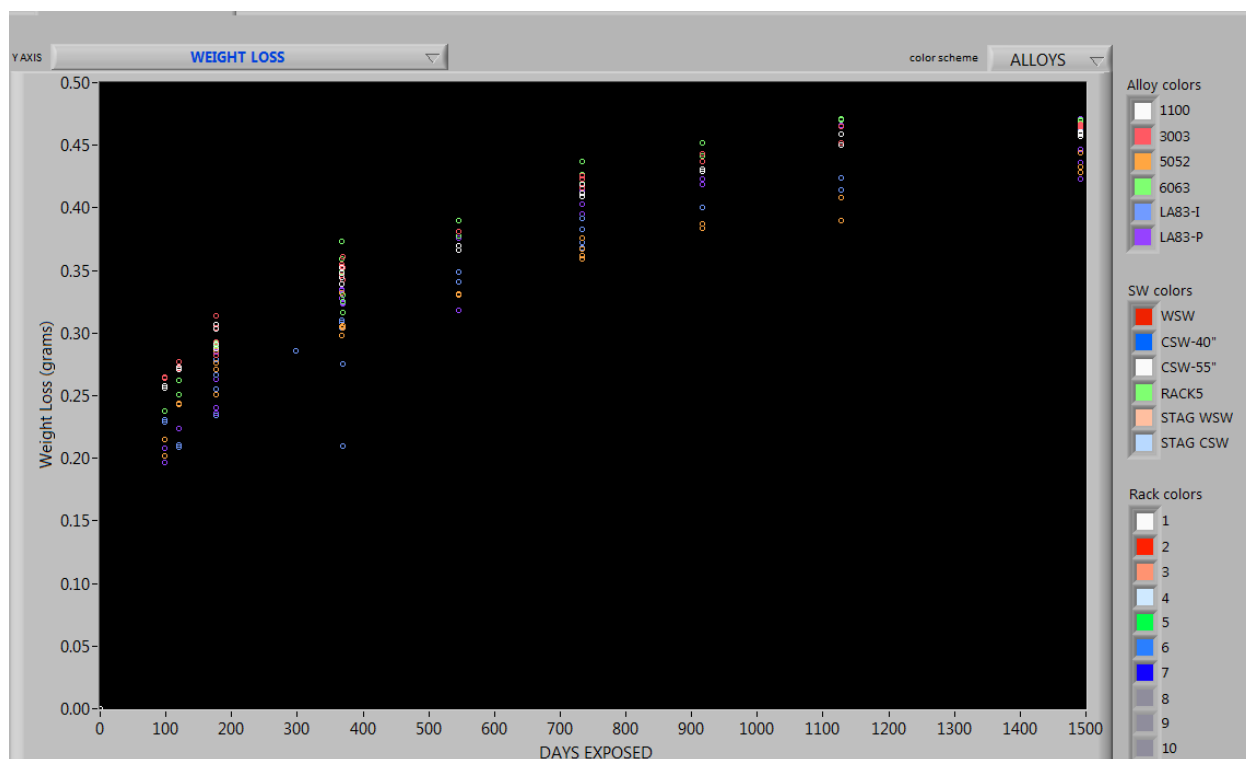
**Figure 4-2. (a) Representative images and (b) weight loss results of samples exposed in WSW for four years.**

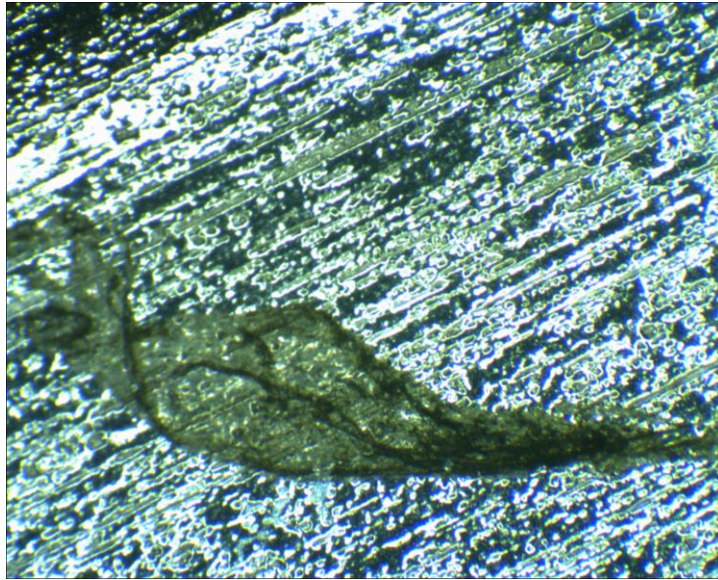
For the 4-yr samples, some discrepancies between the profilometer analysis and microscope inspection were identified. Pits identified on LA83I-35 correspond to a relatively large area where the sample surface appears gouged (Figure 4-3). Profilometer scans cannot distinguish between scratches or other pre-existing surface defects and pits. Some variability is expected due to surface imperfections. For both Alloy 5052 samples, profilometer scans identified several shallow pits but visual inspection identified one pit on one Alloy 5052 sample and no pits on the other sample. With Alloys 3003 and LA83P, pits identified on profilometer scans were also not identified visually. Rescanning the samples did not resolve the discrepancy; however, since the maximum pit depth for all four alloys was  $\sim 0.1$  mm, it is more likely the pits were not discernible under the microscope or some surface features biased the algorithm for pit identification. Pitting was not severe in the four-year samples of Alloys 3003, 5052, LA83I, and LA83P.

*Figure 4-3. Pitted area identified in profilometer scan on LA83I-35. Under microscope inspection, the area does not display characteristics of pitting, rather the surface appears gouged or eroded.*

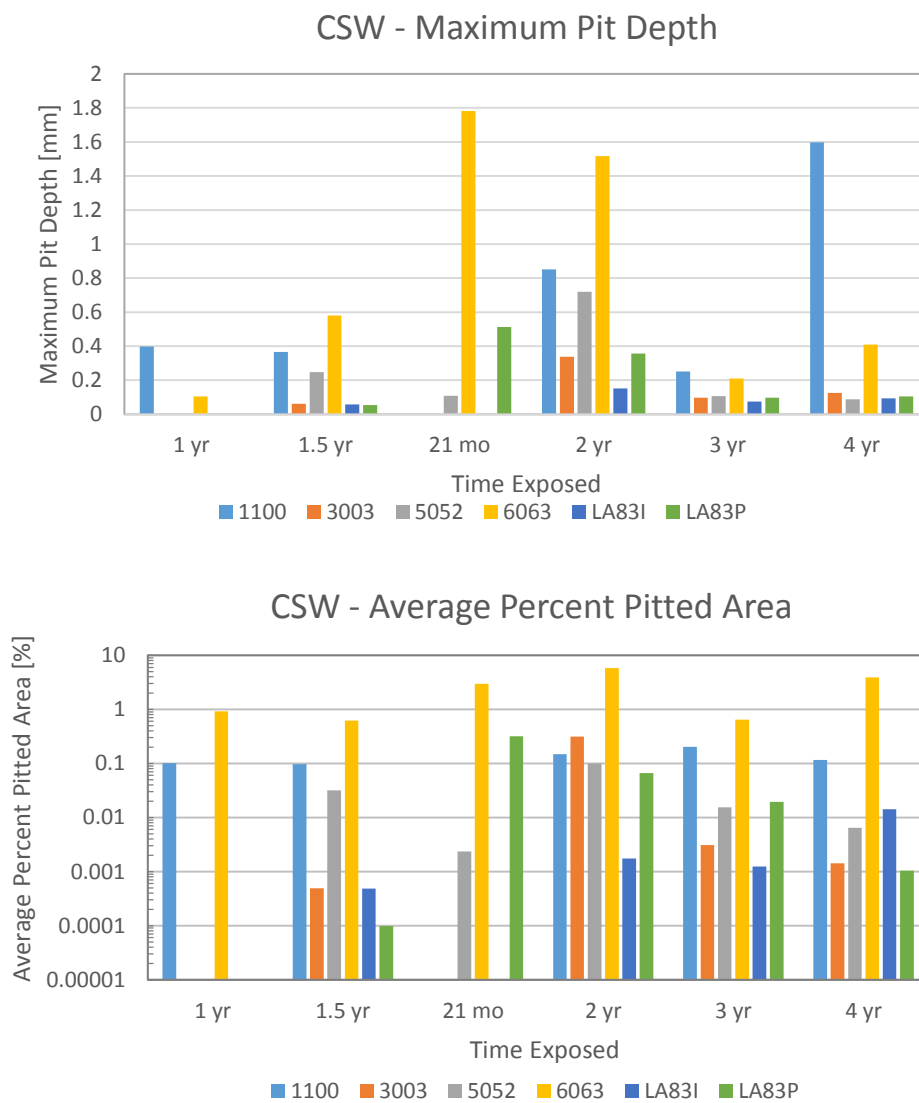
**Figure 4-4. Maximum pit depth and average percent pitted area (per alloy, per exposure time) for samples exposed to CSW. There are no scan data for 1-yr exposure of Alloys 3003, 5052, LA83I, and LA83P and 21-month exposure of Alloys 1100, 3003, and LA83I.**

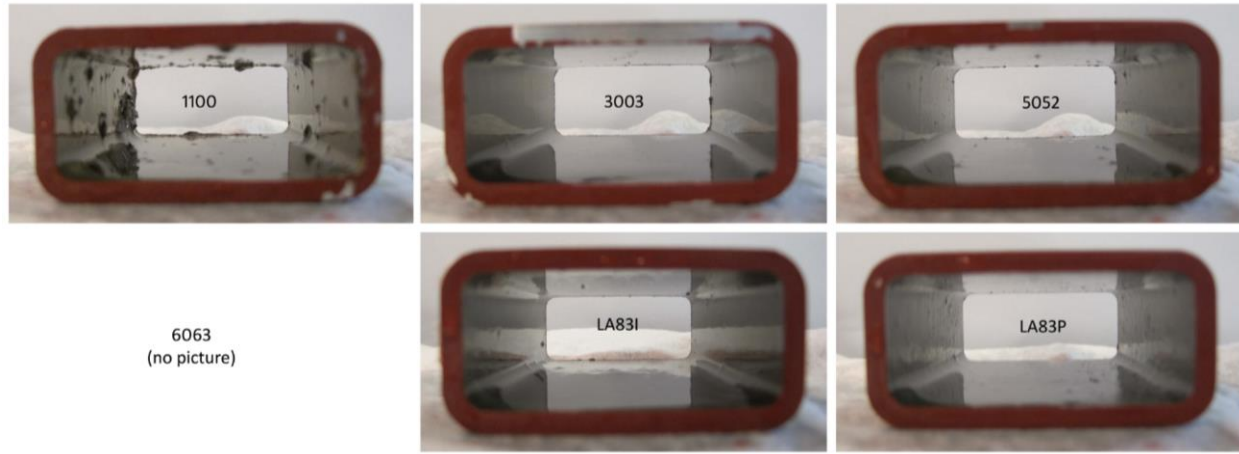
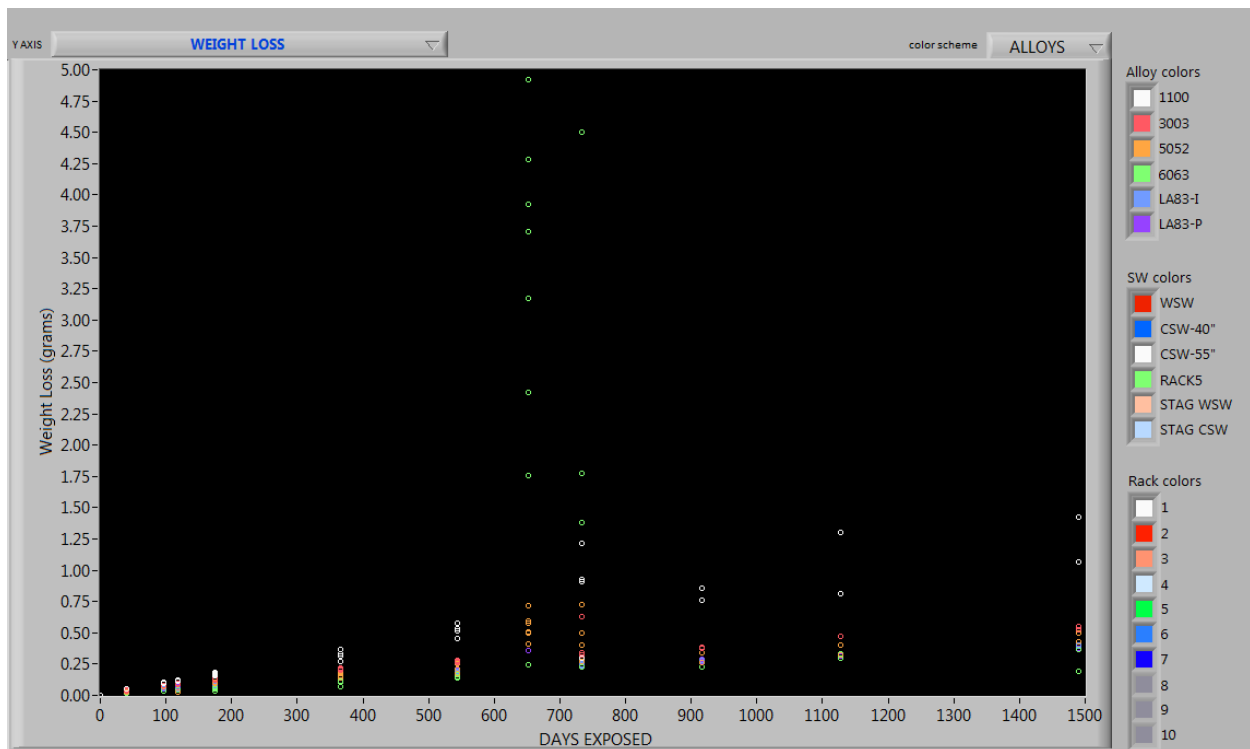
**Figure 4-5. (a) Representative images and (b) weight loss results of samples exposed in CSW for four years.**

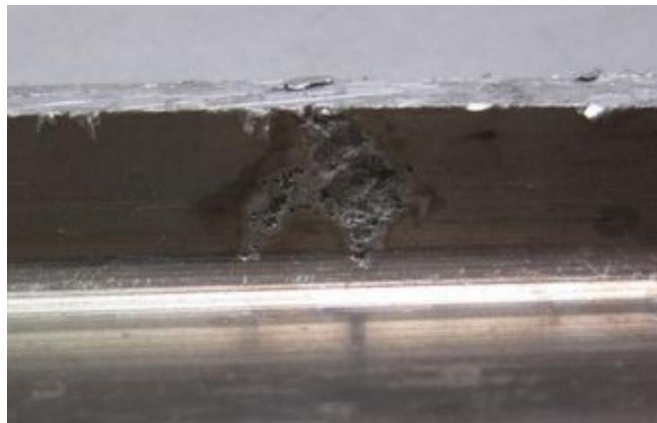
Both LA83P samples also had large pits on the sides of the samples which could not be scanned by the profilometer.

*Figure 4-6. One of several large pits on LA83P samples in DSW. These pits are located along the sides of the sample and cannot be scanned by the profilometer.*

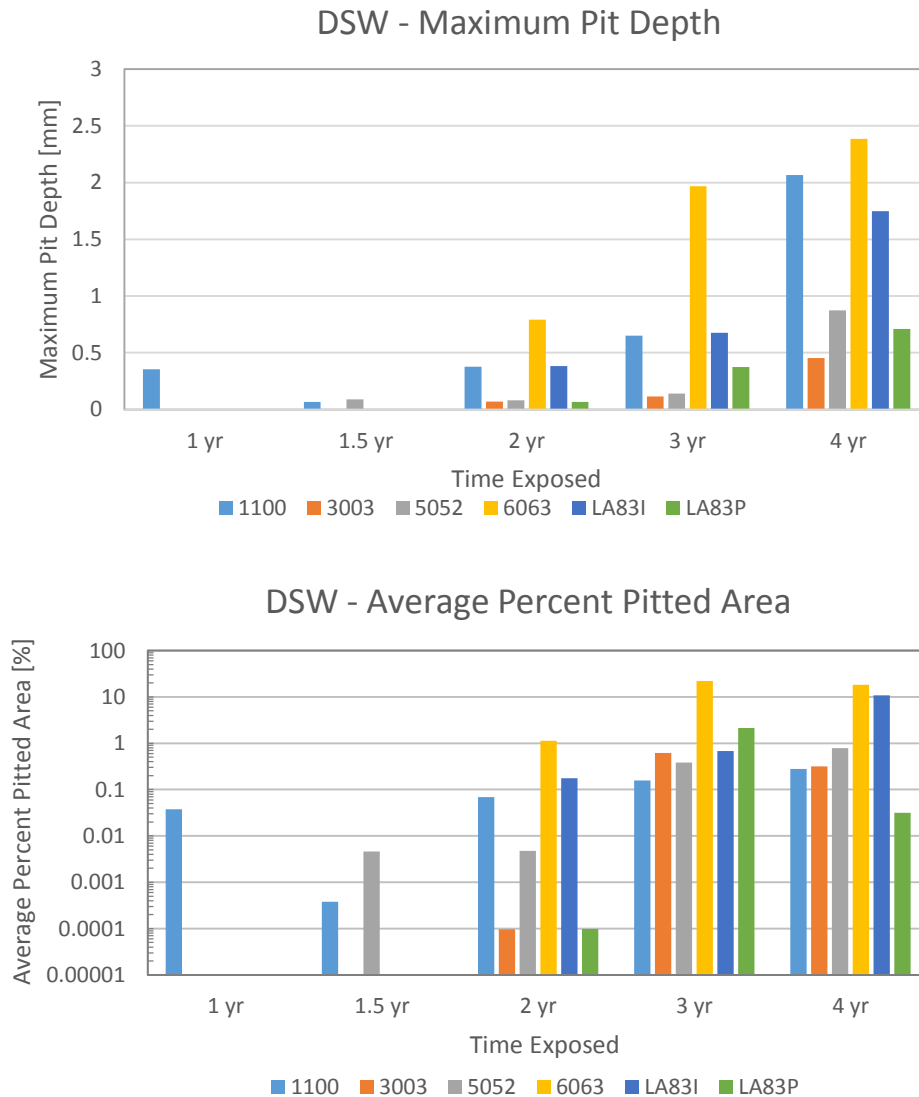
Compared to other water sources, pitting and crevice corrosion was worst in DSW; nearly all samples had pits and crevice corrosion. Several samples were so severely corroded that corrosion product removal was incomplete; the actual maximum pit depth and pitted area is higher than that recorded by the profilometer. Useful profilometer scans are limited to the flat coupon surfaces, away from sides and edges; hence the extent of crevice corrosion is not entirely captured by a scan and visual observations are required.

**Figure 4-7. Maximum pit depth and average percent pitted area (per alloy, per exposure time) for samples exposed to DSW. Pits were prevalent on DSW samples. Only Alloy 1100 1-year samples were scanned. No profilometer data is reported for the 1-year samples of the other alloys. (No pits were observed, only two of Alloy 5052 samples had small blisters but no pit craters). Many of the 4-year samples had pits on the edges and sides of the coupon that could not be captured in the profilometer scans.**
