# **Asia Pacific Research Initiative for Sustainable Energy Systems 2011 (APRISES11)**

## **OTEC Heat Exchanger Development and Testing Task 4.1**

# **OTEC HX TESTING PROGRAM**

## **2014 ANNUAL REPORT**

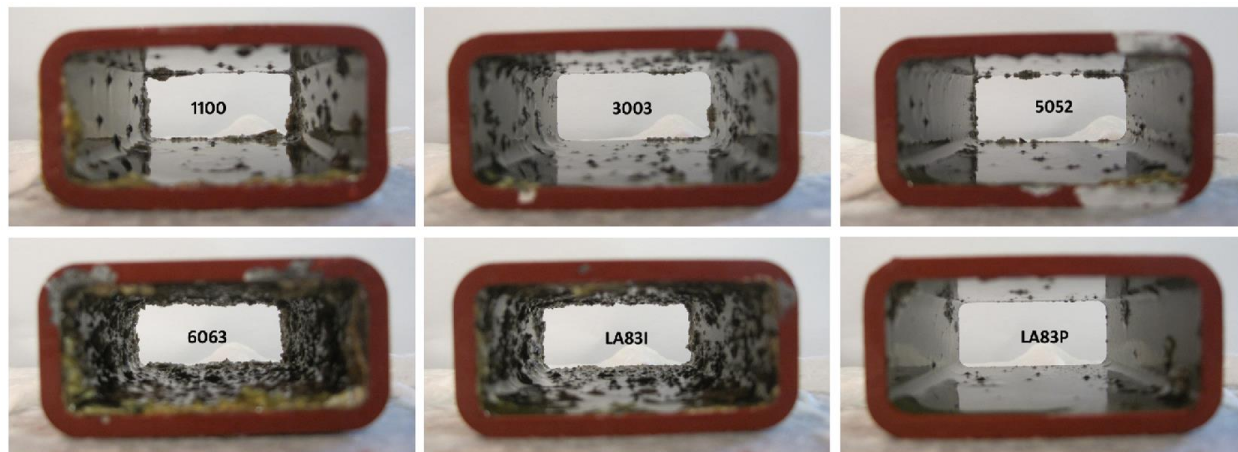
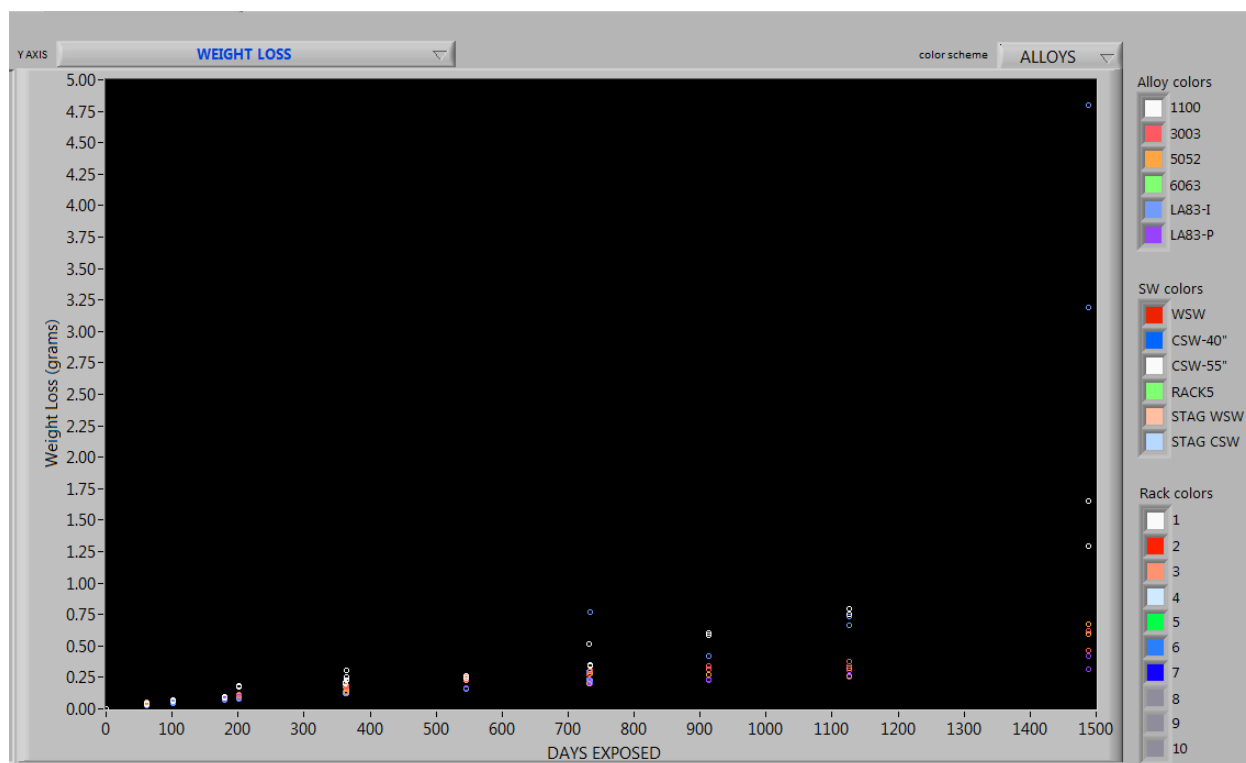
**Figure 4-8. (a) Representative images and (b) weight loss results of samples exposed in DSW for four years. Results for Alloy 6063 are not shown. Alloy 6063 exhibited severe pitting along extrusion lines. Both samples removed after four years exposure had weight loss over 9.5 grams.**

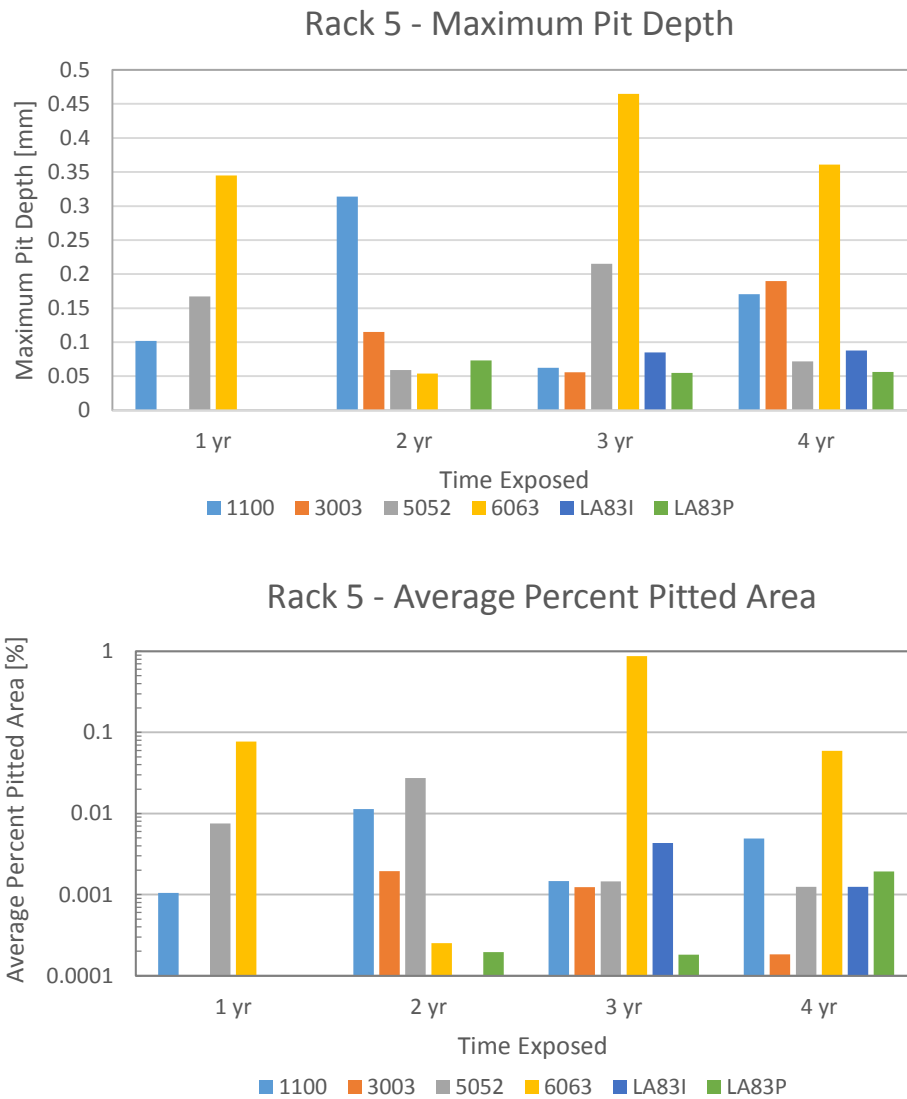
Of the 4-year samples, Alloys 3003, LA83I, and LA83P had little to no pitting. One sample of Alloy 5052 had extrusion defects and many small pits were concentrated within the extrusion defect channel. The other Alloy 5052 sample did not have extrusion defects and no pits were found. Alloys 1100 and 6063 continue to perform poorly. The maximum pit depth data for Alloy 1100 and 6063 samples are inaccurate due to incomplete corrosion product removal. On Alloy 6063, the pits appeared large and shallow. Both samples of Alloy 1100 also had severe crevice corrosion.

**Figure 4-9. Maximum pit depth and average percent pitted area (per alloy, per exposure time) for WSW pre-treated samples exposed to CSW.**

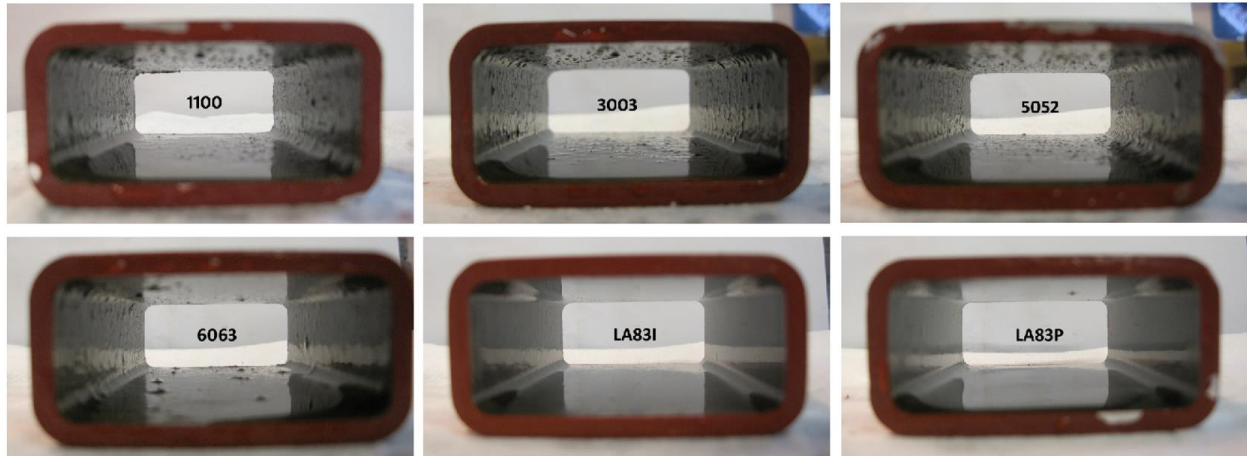
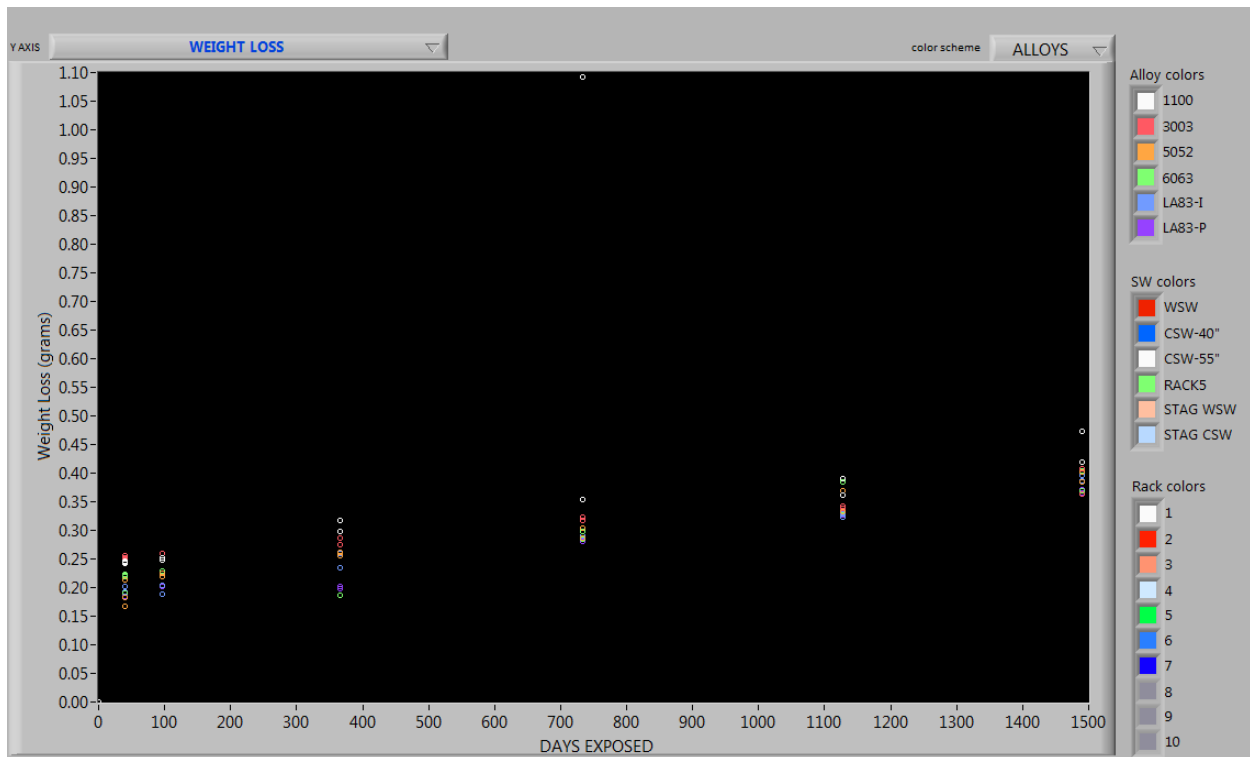
**Figure 4-10. (a) Representative images and (b) weight loss results of samples exposed in WSW for 40 days, then moved to CSW for four years.**

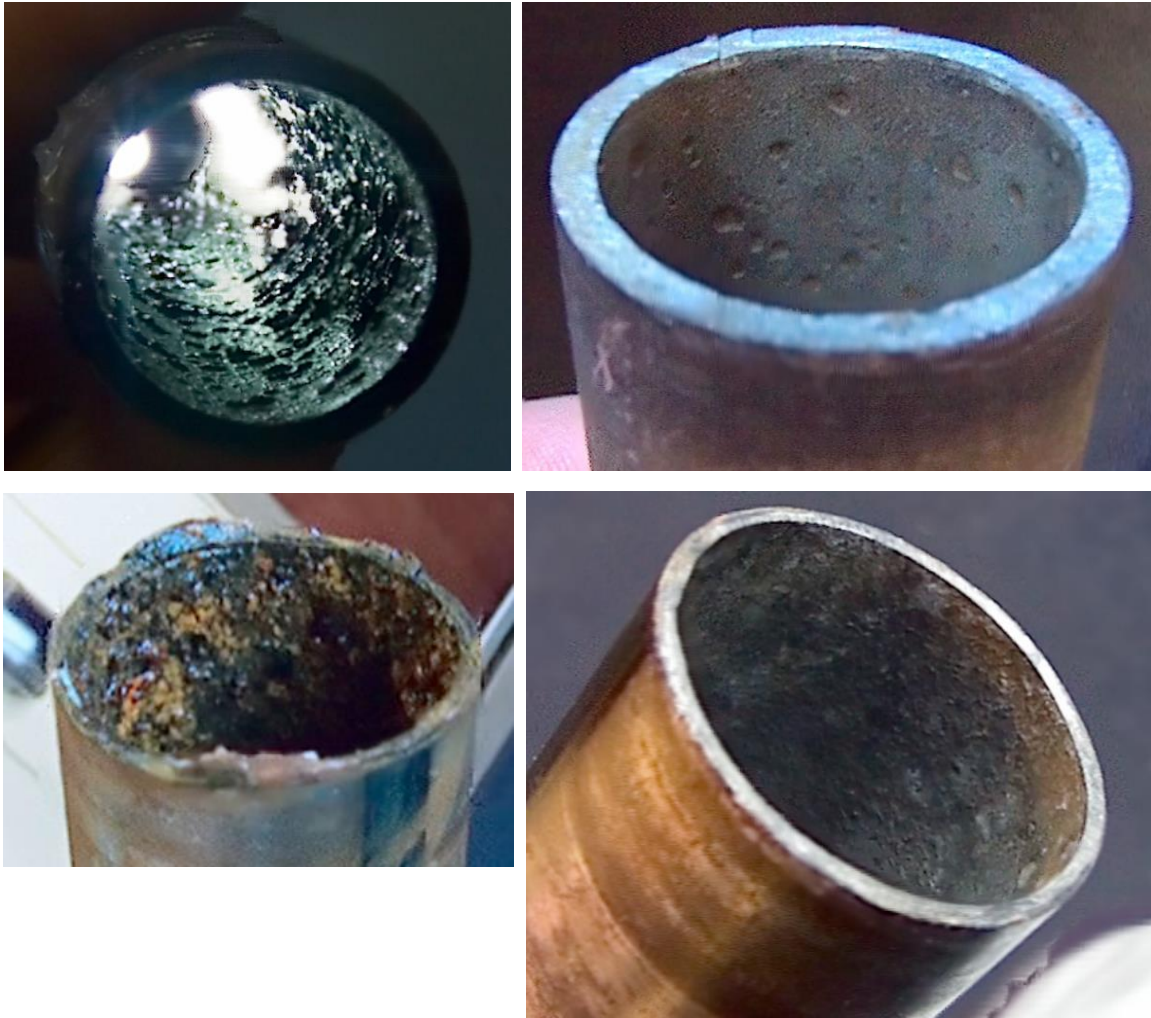
*Figure 4-11. Certified steel sample after six months in CSW post-removal (top left) and post-processing (top right). Non-certified steel sample after one year in CSW post-removal (bottom left) and post-processing (bottom right). Post-processing reveals a relatively smooth wall with large shallow pits in the certified steel sample and a rough wall with few visible pits in the non-certified steel sample.*

The inner surfaces of both types of tubes were roughened by corrosion product. Some corrosion product also began to flake off. Post-processing revealed certified steel samples still had relatively smooth walls that were covered with large shallow pits. The non-certified samples did not have large shallow pits, but the wall surface was no longer smooth.

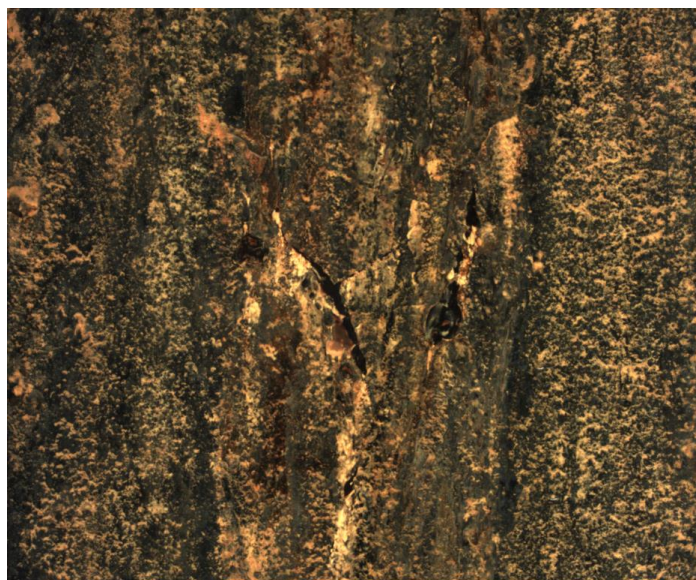
*Figure 4-12. Corrosion product beginning to flake on a steel sample tested in the CSW MCIR.*

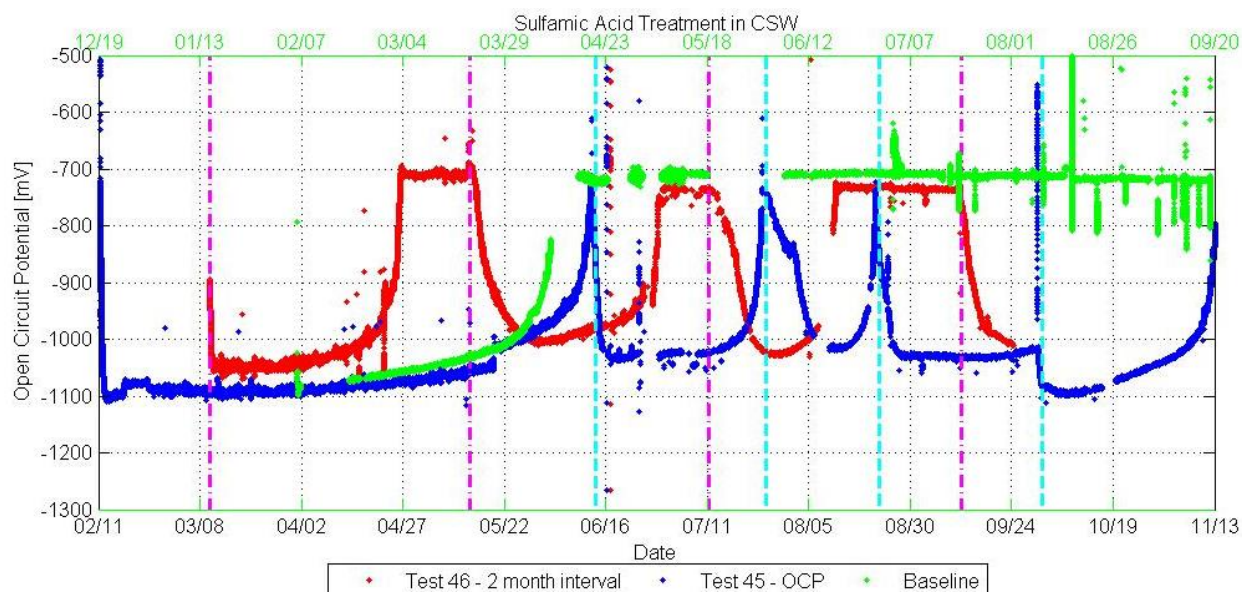
In Test 46, the sample OCP rose to the steady state value of the baseline sample (~ -720 mV) within 45 days, almost three months sooner than the baseline sample. After the two-month treatment, OCP dropped to ~ -1000 mV but immediately began to increase. OCP reached and remained at -720 mV two weeks prior to the four-month treatment. The four-month treatment dropped OCP to ~ -1000 mV, but OCP returned to -720 mV within 30 days. Corrosion product

was observed on the trailing edge of the sample after two months. The sample was removed on 9/24/14.

**Figure 4-13. Sulfamic acid treatment in CSW. Test 46 2-month treatment dates are indicated by magenta lines and Test 45 OCP-based treatment dates are indicated by cyan lines. Only the first 275 days of exposure are shown for the baseline coupon (actual date is on upper x-axis in green). Treatments have been successful in lowering OCP to  $\sim -1000$  mV. Test 45 was in stagnant fresh water for several hours due to a flow disruption on 10/1/14.**

In Test 45, the OCP has followed the baseline sample, reaching  $-700$  mV after 120 days, when it was given the first treatment. After the first treatment, OCP remained  $\sim -1020$  mV for 30 days before beginning to increase rapidly. The second treatment was performed 40 days after the first treatment. After the second treatment, OCP was lowered to  $-1000$  mV but began increasing immediately. The second treatment lasted for 7 minutes instead of the standard 2 minutes. The third treatment was performed 30 days after the second treatment. OCP after the third treatment is currently steady at  $\sim -1020$  mV.

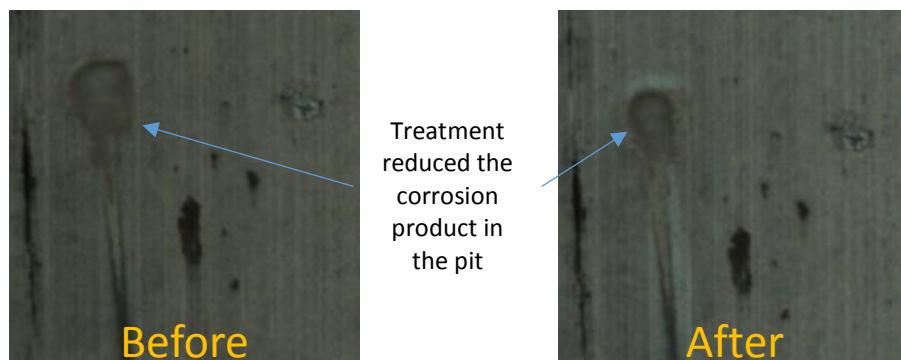
**Figure 4-14. Before and after sulfamic treatment. Corrosion product buildup was lessened in this pit, but result was not observed for all pits.**

Some reduction in corrosion product buildup was observed post-treatment for some pits (Figure 4-14) but not all pits. Removal of corrosion product is believed to prevent the development of localized environments which could further accelerate pitting.

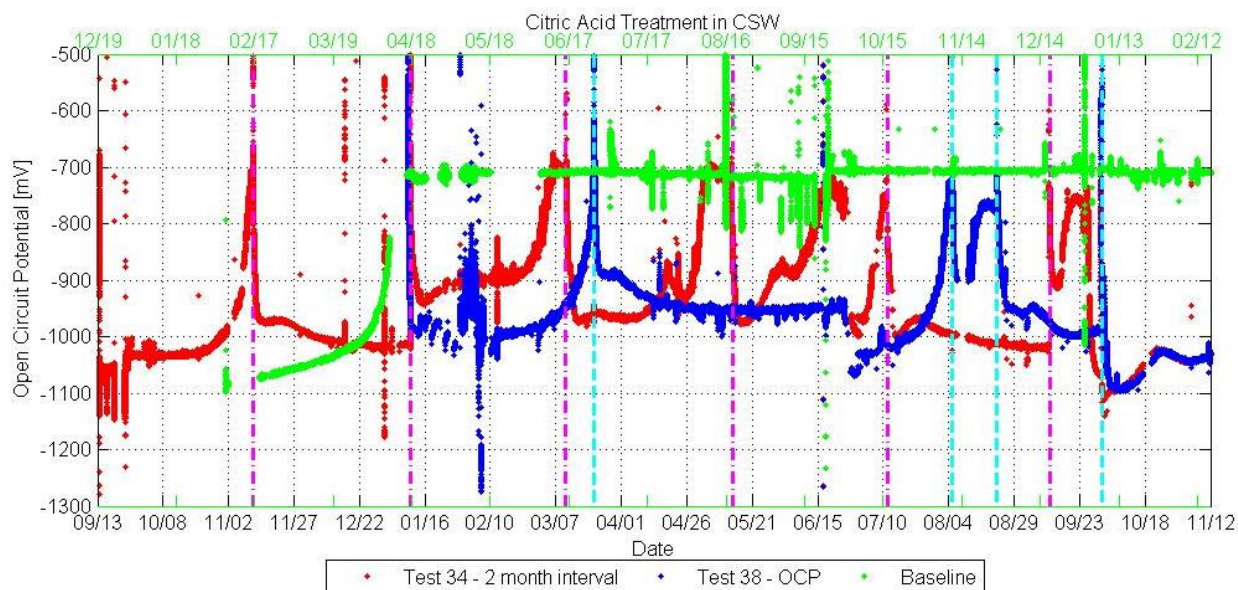
**Figure 4-15. Citric acid treatments in CSW. Test 34 2-month treatment dates are indicated by magenta lines and Test 38 OCP-based treatment dates are indicated by cyan lines. Only the first 425 days of exposure are shown for the baseline coupon (actual date is on upper x-axis in green). Treatments have been successful in lowering OCP to between -900 mV and -1000 mV. Test 38 was in stagnant fresh water for several hours due to a flow disruption on 10/1/14.**

For Test 34, the first treatment was given just prior to starting CSW flow. The two-month treatment coincides with OCP starting to rise towards pitting potential. Although this is ~60 days faster than the baseline sample, the treatment suppressed OCP to below the baseline sample. The four-month treatment resulted in an OCP above the pre-treatment value. OCP continued to rise until it reached OCP of the baseline sample, where it remained until the six-month treatment (~10 days). After the six-month treatment OCP dropped below the pre-treatment value and slowly began to increase after 40 days. Pits on the trailing edge of the sample and some corrosion product buildup were observed at eight months of exposure (Figure 4-16). The eight-month treatment dropped OCP but it began to rise immediately. The ten-month treatment dropped OCP and OCP remained around -1000 mV until the twelve-month treatment. The sample was removed on 11/4/2014. The pits that were observed at eight months do not appear to have worsened.

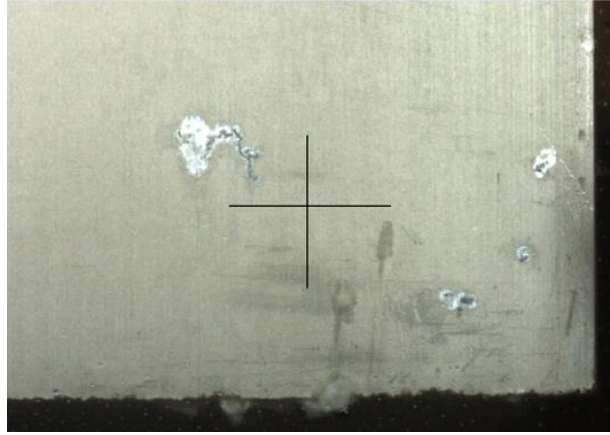
**Figure 4-16.** After eight months of exposure, pits and corrosion product buildup were observed on the trailing edge of the sample receiving citric acid treatment every two months.

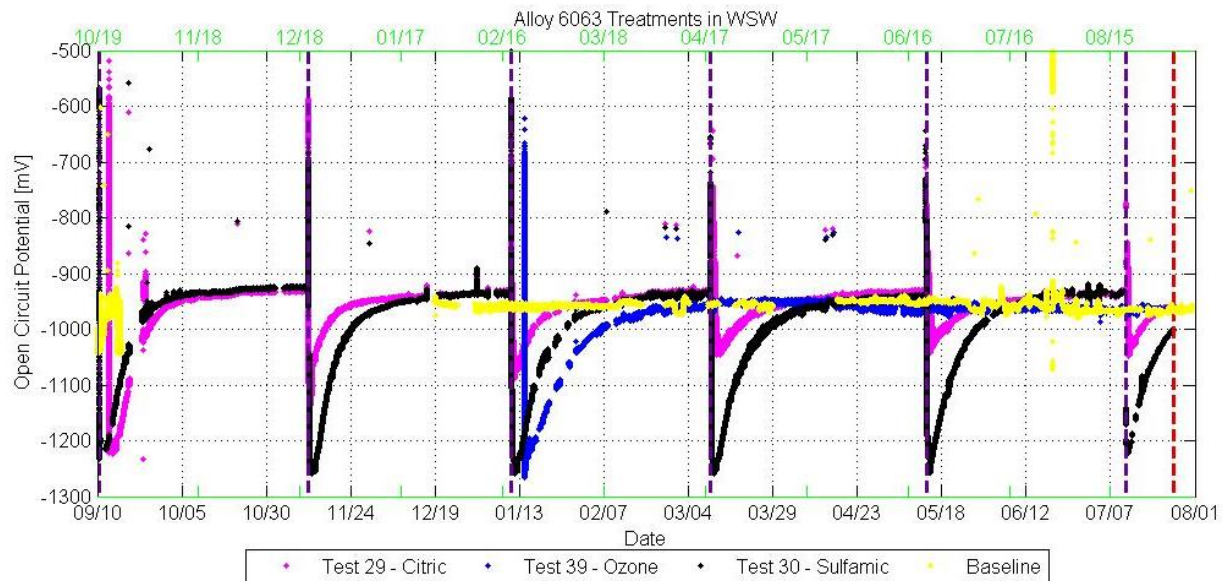
In WSW, all samples, including the baseline sample, have OCP below -900 mV (Figure 4-17). Samples were removed on 7/25/14 due to space constraints. No significant observations on treatment effects could be made.

**(a) Alloy 6063-T52 coupons in WSW.** Treatment intervals are 2 months; dates are indicated by purple dashed lines. No ozone treatment was performed on 3/14/2014. Only first 325 days of exposure are shown for the baseline coupon (actual date is on upper x-axis in green). Treatment coupons were removed on 7/25/2014 (red line). Baseline coupon is still installed.

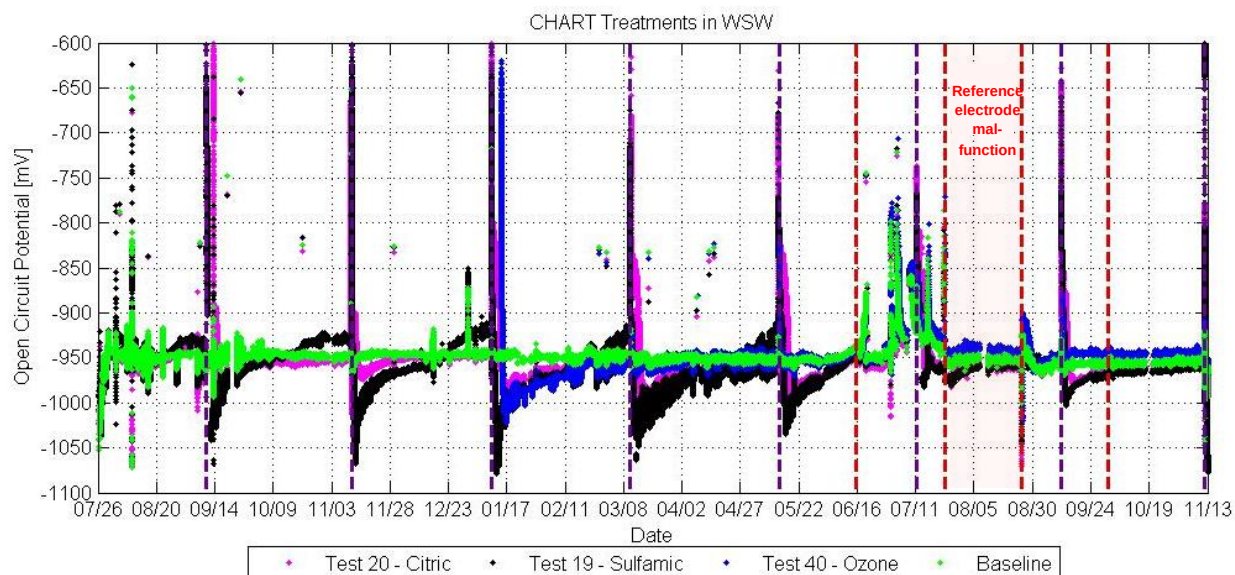
**(b) CHART samples (heat treated Alloy 3003).** Treatment intervals are 2 months; dates are indicated by purple dashed lines. No ozone treatment was provided on 3/14/14. OCP measurements between 6/15/14 – 7/23/14 (pink shaded box) should be ignored due to malfunctioning reference electrode. Flow disruption on 8/23/14 and 10/1/14 (third and fourth vertical red lines) resulted in samples being held in stagnant freshwater for several hours.

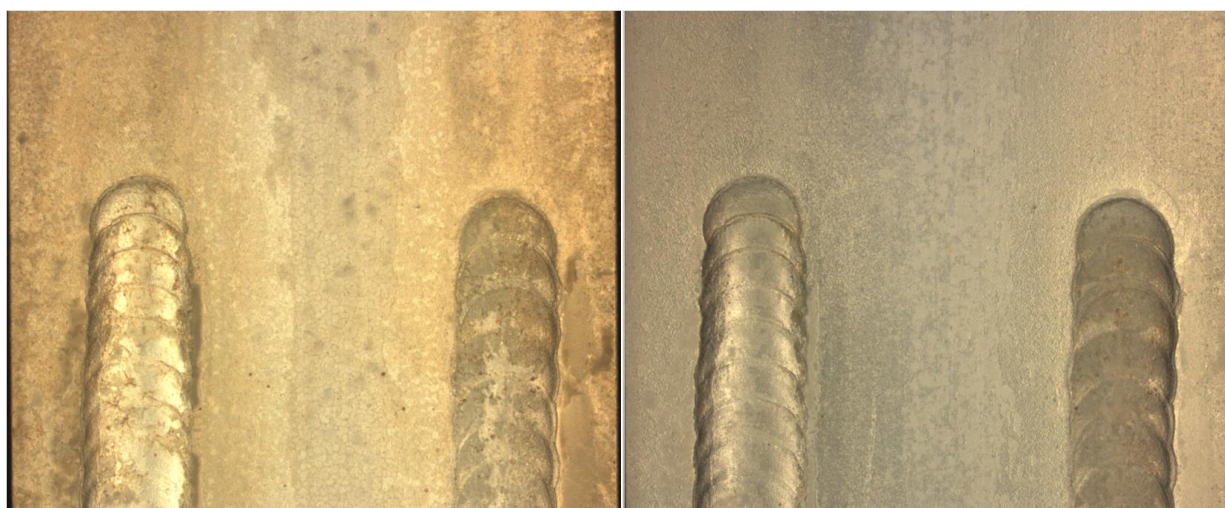
**(c) During sulfamic acid treatment on 11/11/14, the bio-slime layer peeled off the surface of the CHART coupon, resulting in changes in color and a cleaner coupon surface.**

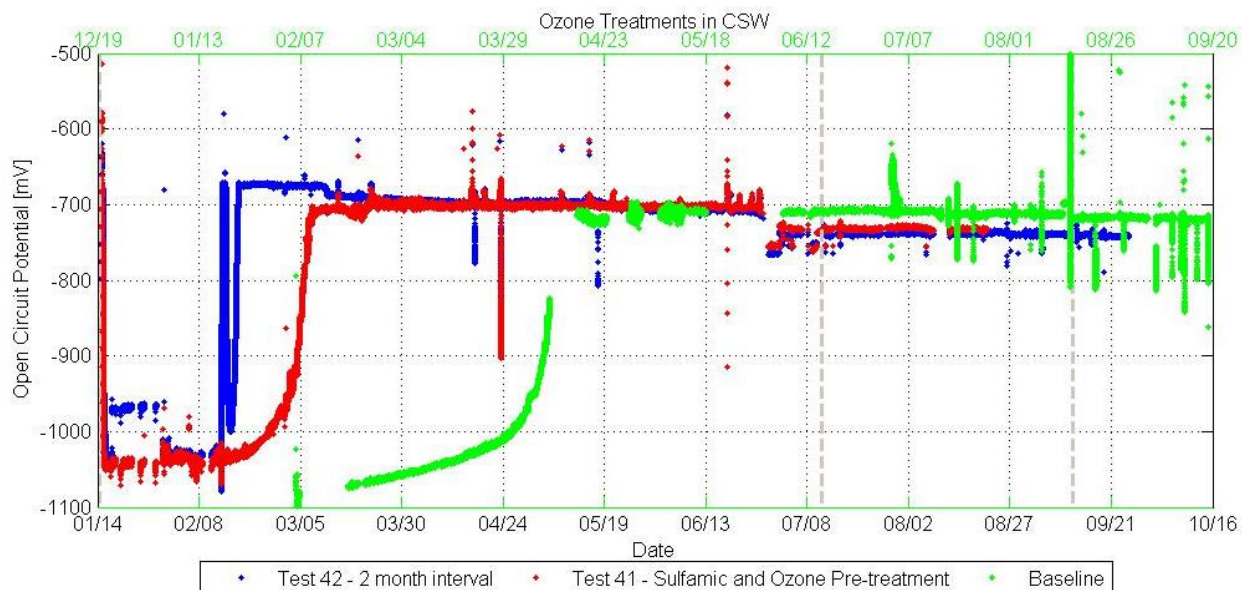
In CSW, one sample is being treated every 2 months. Similar to the acid treated samples, OCP of ozone treated sample reached  $\sim -700$  mV almost 90 days earlier than the baseline sample (Figure 4-18). Small pits were observed 45 days after exposure. The two-month treatment was mistakenly missed and the four-month treatment was intentionally skipped to observe pit development. The six-month treatment was provided on 7/11/2014. The sudden drop in OCP on 6/26/2014 coincides with the removal of a steel sample from the MCIR.

**Figure 4-18. OCP of ozone treated samples reached steady-state 70 days (Test 41) and 90 days (Test 42) before the baseline sample. Ozone treatment dates for Test 42 are indicated by vertical gray lines. Treatments were planned but not performed on 3/10/2014 and 5/13/2014. Small pits were observed on 2/25/2014. Only first 275 days of exposure are shown for the baseline coupon (actual date is on upper x-axis in green). Test 41 was removed on 8/20/2014 and Test 42 was removed on 9/24/14.**

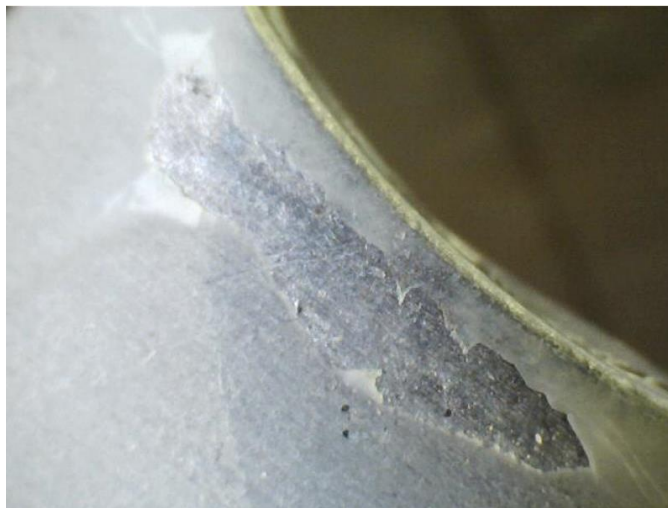
In general, SiloXel coating integrity was unreliable. Several samples exhibited coating failures as shown in Figure 4-19.

*Figure 4-19. Typical SiloXel coating defect on in-line plate. Samples were still tested.*

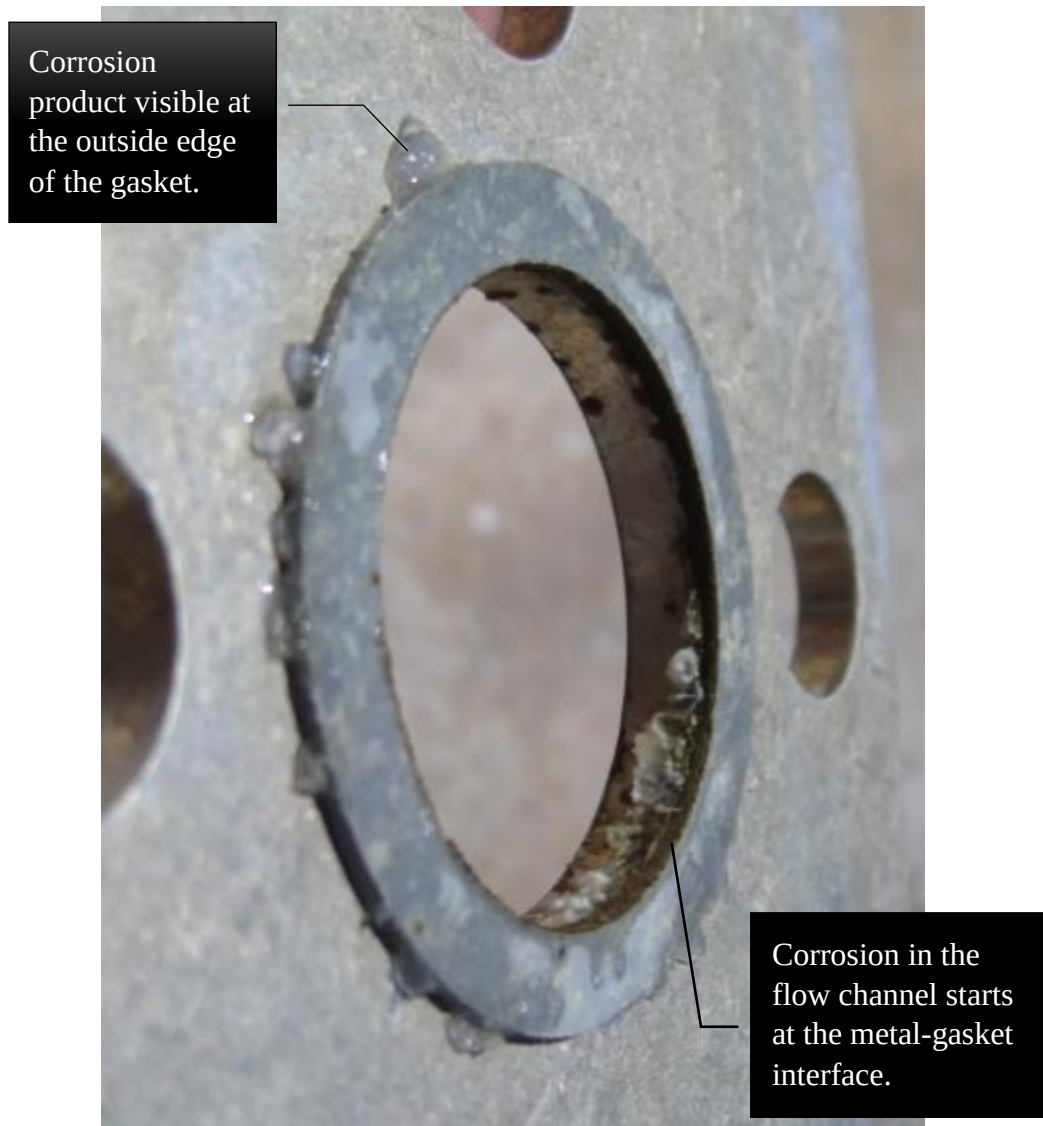
The CSW unit was decommissioned in March 2014, after 13 months of exposure. Corrosion was present in all samples except for Alloy 3003 coated with SiloXel and sealed with polyurethane. Corrosion occurred in the flow channel, starting from the metal-gasket interface, or on the outside edge of the gasket (Figure 4-20). Coatings provided some degree of protection. For Alloy 6063, Alodine, Alodine with polyurethane, and SiloXel with polyurethane had at least one sample that was free of corrosion. For Alloy 3003, all the control and polyurethane coated samples had corrosion; all other coating combinations protected at least one sample from corrosion.

**Figure 4-20. In-line sample showing corrosion in the flow channel starting at the metal-gasket interface and on the outside edge of the gasket.**
