Toward the Instrumentation and Data Acquisition of a Tidal Turbine in Real Site Conditions

National Renewable Energy Laboratory, 15013 Denver West Parkway, Golden, CO 80401, USA

Abstract: The National Renewable Energy Laboratory manufactured, instrumented, and deployed thermoplastic composite blades and a data acquisition system (NDAQ) on one of Verdant Power's Gen5d 5 m diameter tidal turbines in New York's East River. The thermoplastic blades had internal strain gages, and the NDAQ was a stand-alone system for monitoring and recording the strain and angular position of the blades. The turbine with thermoplastic blades operated and produced power successfully for 3 months, contributing energy to the New York City electric grid. The NDAQ hardware, instrumentation, and structure all survived the deployment and were still functional upon retrieval of the system, but no data were collected. Even though the data retrieval was not a success, data acquisition for deployed subsea marine renewable structures is a new undertaking, and it is critical to share lessons learned from national laboratory experiences. The successful deployment of thermoplastic composite blades marks a significan

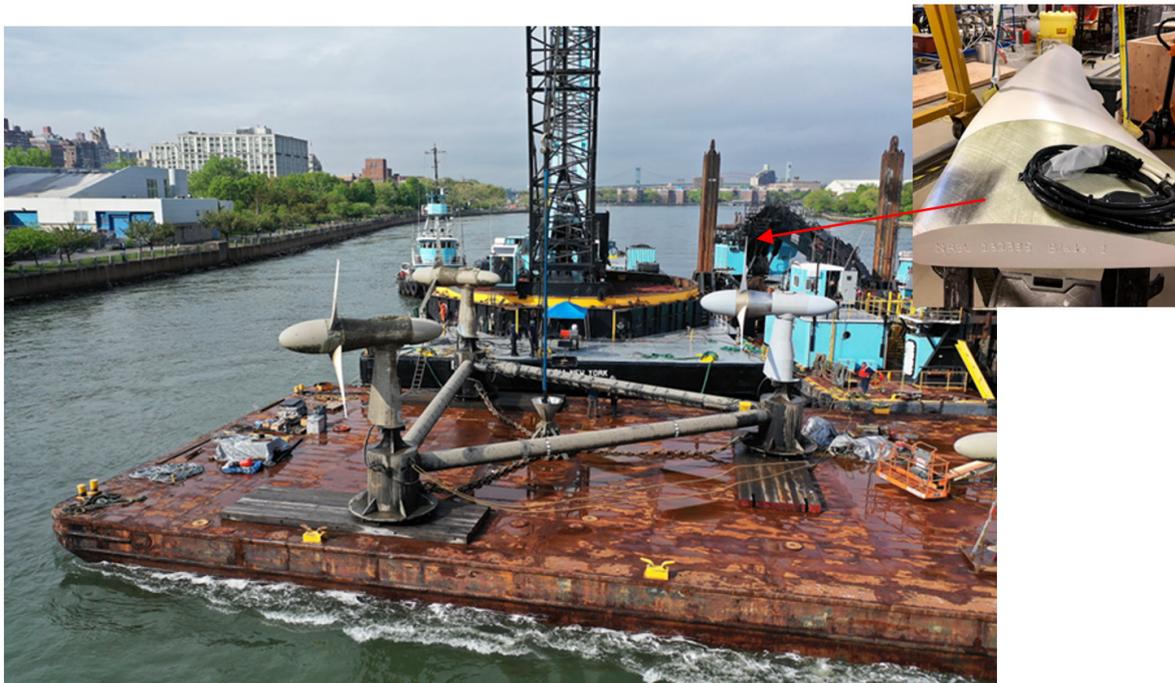
Figure 1. Verdant Power's TriFrame being deployed in the East River in New York, with the National Renewable Energy Laboratory's (NREL's) thermoplastic blades on the turbine in the right side of the photograph. A close-up photograph of one thermoplastic blade is shown, indicated by the arrow.

The National Renewable Energy Laboratory (NREL) worked with Verdant Power to manufacture, characterize, and deploy both traditional epoxy composite blades and novel thermoplastic composite blades on Verdant Power's Gen5d 5 m diameter turbines at the Roosevelt Island Tidal Energy (RITE) site in the East River in New York, enabling a side-by-side comparison of these materials and advancing the state of the art for better-performing composite materials. The secondary goal of this study was to enable blade and turbine models to be validated using operational load data correlated to the blade design. Epoxy blades were deployed on all three turbines on Verdant's TriFrame in October 2020. In April 2021 one of the turbines with epoxy blades was replaced with a turbine with NREL-built and -instrumented thermoplastic composite blades. The thermoplastic turbine operated and produced power successfully for 3 months, contributing 31.8 MWh of energy into the New York City electric grid. In October 2021, the TriFrame, including an NREL-built data acquisition system (NDAQ) and thermoplastic rotor, were retrieved from the East River. Figure 1 shows the retrieve-and-replace operation, with the thermoplastic blades on the turbine in the right side of the photograph.

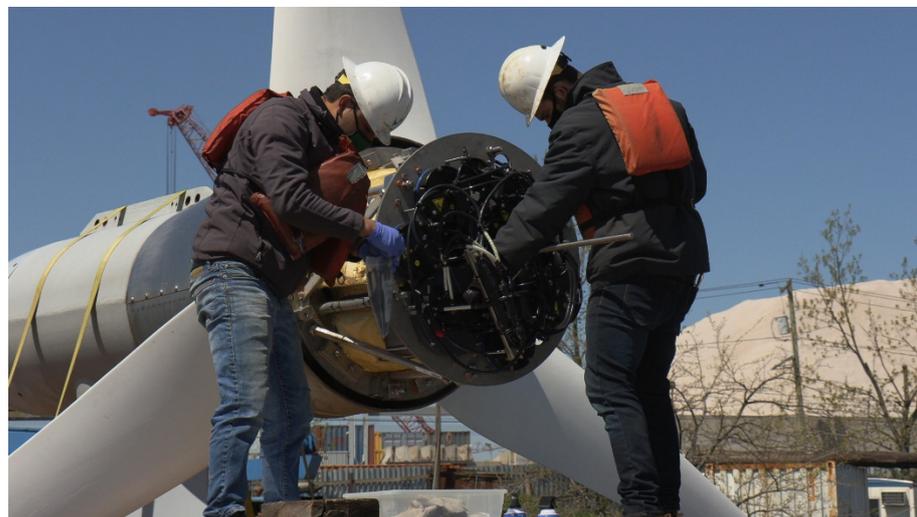
Figure 2. Verdant Power turbine with NREL thermoplastic blades and the NREL data acquisition system (NDAQ).

Figure 2 shows the Verdant Power turbine with the NREL-built thermoplastic blades and NDAQ being installed prior to the deployment.

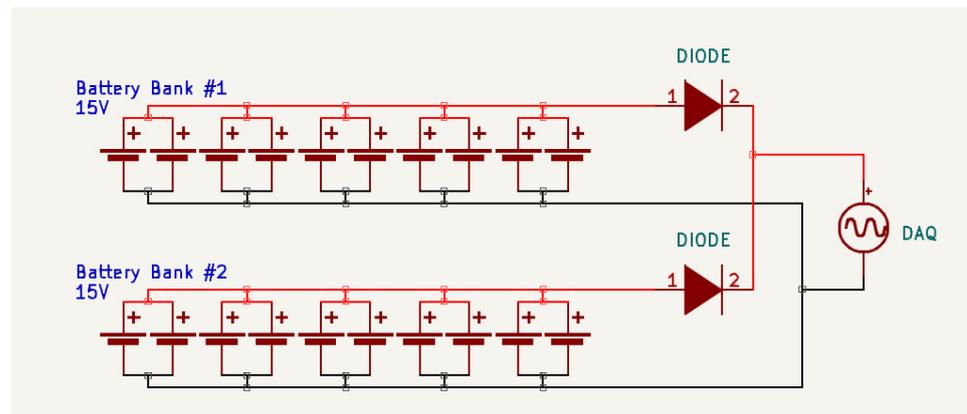
Figure 3. 15 V Nortek Battery Bank configuration for the Data Acquisition system.

To monitor and record data for 16 strain gages and one IMU, the total power draw was estimated to be 6.2 W continuous, including power for all sensors based on the device specifications. This gave a battery capacity requirement of $\sim 27,000$ Wh to run the system for the 6-month deployment. Nortek 15 V, 1800 Wh battery packs based on Tadiran lithium-thionyl-chloride primary cells were used to supply power to the NDAQ. The total battery bank for the deployment consisted of 20 Nortek battery packs, giving a total rated capacity of 36,000 Wh. This additional capacity accounted for environmental factors affecting the capacity and allowed for additional deployment time if weather delayed the turbine retrieval. For example, supplier data sheets provided estimates of ~ 85 – 90% of rated battery capacity at the expected cooler East River water temperature, giving an estimated battery bank capacity of $\sim 31,000$ Wh when deployed in East River conditions. This capacity provided safety against battery pack failure while still fitting into the Verdant turbine hub. The battery bank was wired with each pack in parallel, creating a large capacity with isolating diodes restricting current flow out of individual battery packs and separating the total battery bank into two sections (Figure 3).

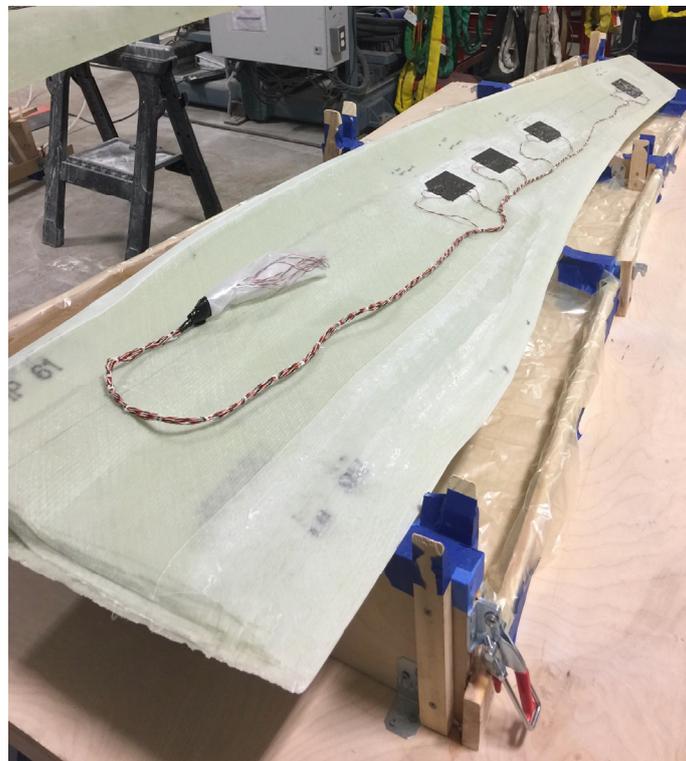
Figure 4. Blade 2 high-pressure skin with strain gage instrumentation for Channels 8–10 (given in Table 1). From left to right these are named SG07-BL2-1100-FB-SC, SG08-BL2-1300-FB-SC, SG09-BL2-1575-FB-SC, and SG10-BL2-2200-FB-SC.

Vishay Micro-Measurements CEA-13-250UW-350 resistance strain gages were installed on the 2.5 m long internal skins of all three thermoplastic blades for strain measurement in both the flapwise and edgewise blade orientations in accordance with the requirements stated in IEC TS 62600-3 marine turbine measurement loads. All the strain gages had a nominal 350-ohm resistance and were connected in a three-wire configuration. Spar cap strain gages were orientated at 0 degrees (parallel with the spar cap) and mounted on the center of the spar caps on both the high- and low-pressure sides of the blade. Leading-edge (LE) and trailing-edge (TE) strain gages were positioned 50 mm in from the edge and oriented perpendicular to the local radial line. The radial line originates at the rotor center of rotation. Table 1 shows the gage locations and names, and Figure 4 shows the internal strain gages on the inside of one of the thermoplastic blade skins.

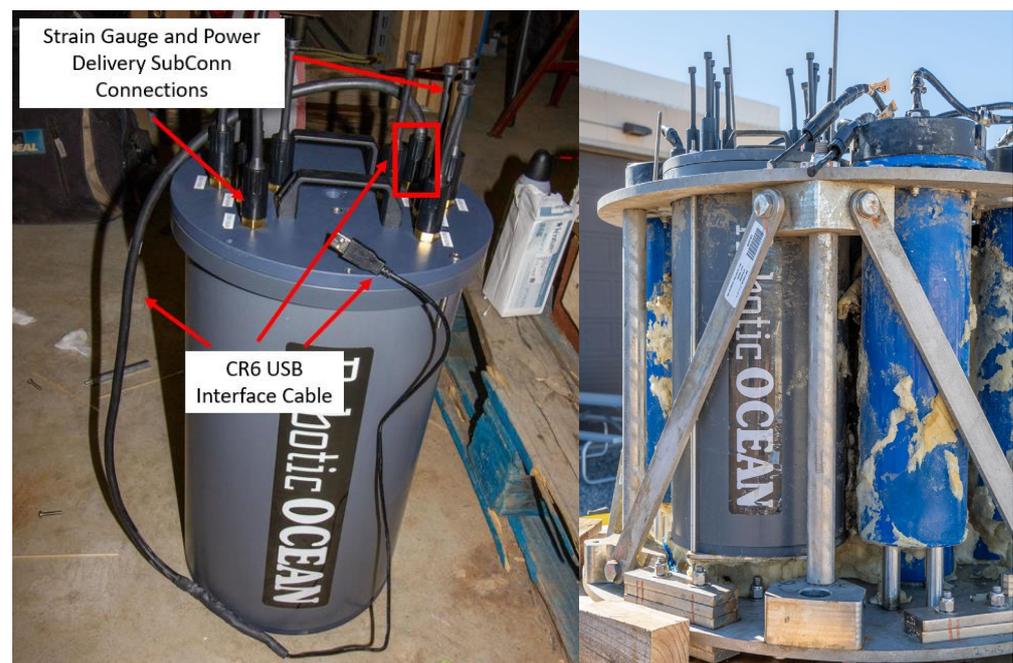
Figure 5. Robotic Ocean DAQ canister (**left**) before deployment and (**right**) after deployment. All seals and the internal vacuum remained intact for the duration of the deployment.

Figure 5 shows the Robotic Ocean canister (before and after deployment) used to house the Campbell Scientific data logger, analog-to-digital converter, strain gage bridge completions, power distribution circuitry, and IMUs. SubConn depth-rated bulkhead connectors (two-pin connectors for power and eight-pin connectors for strain gages) were wired through the lid to external sensors, batteries, and a USB. This canister had an applied vacuum and was sealed and remained under vacuum until it was recovered after the deployment. The wiring was designed to allow a user to operate and monitor the system without needing to remove the canister lid to connect directly to the data logger, allowing it to be used for dockside calibrations and monitored during start-up.

The NDAQ structure was completely intact upon retrieval, including the foam, tail cone, and supports. All cable connections were still secure and had not been damaged during deployment. The NDAQ canister that housed the Campbell Scientific data acquisition system still had the vacuum seal, which was implemented by NREL prior to shipping in February 2021 (Figure 9). However, there was no power being drawn from the batteries and 0 V were measured coming to the DAQ from the batteries.

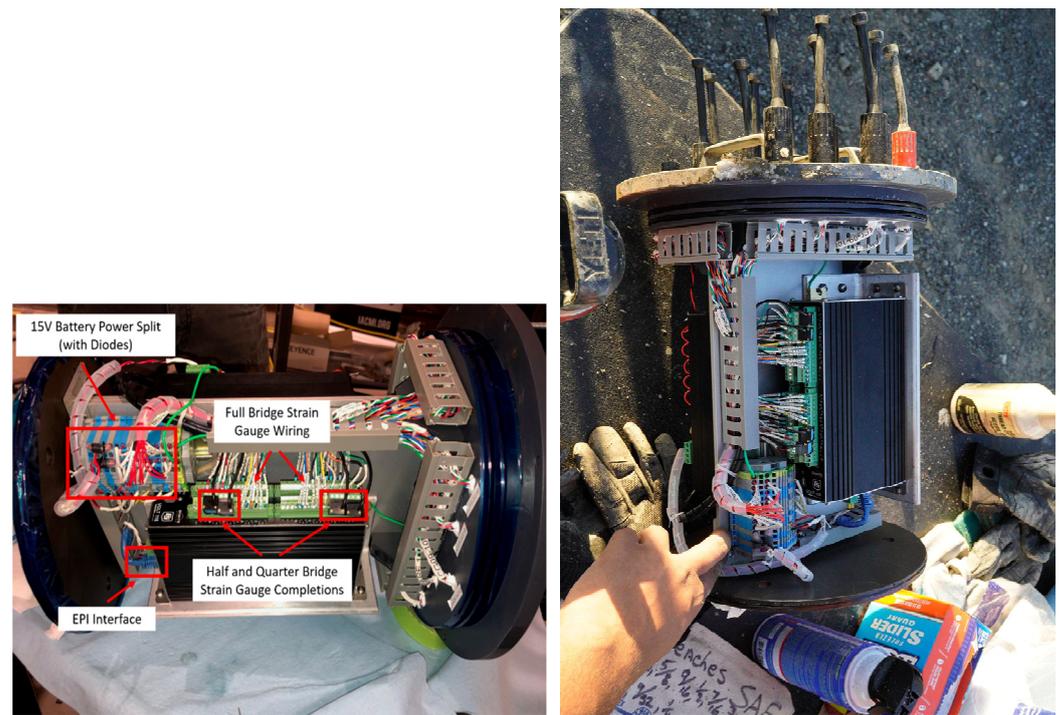
Figure 7. The Campbell Scientific Volt 116 data logger mounted in the canister with strain gage wiring (**left**) before deployment and (**right**) after deployment. The power terminal block can be seen next to the ADC.

The CR6 data logger and Volt 116 ADC were connected via the Campbell Scientific proprietary Ethernet Peripheral Interface (EPI) which allowed the two devices to be mounted on custom brackets on the backplane within the canister (shown in Figures 5–7). Strain gage sensor wiring was routed directly to the ADC where the bridge completions were

made, measured, and transferred to the data logger via ethernet to be saved. The IMUs (based on the MPU-6050 chipset) were powered and monitored with the data logger. A tight-fit brace was mounted at the base of the backplane to provide extra stability to the entire system within the canister and reduce any loading on the end cap, which could induce leaks during the deployment.

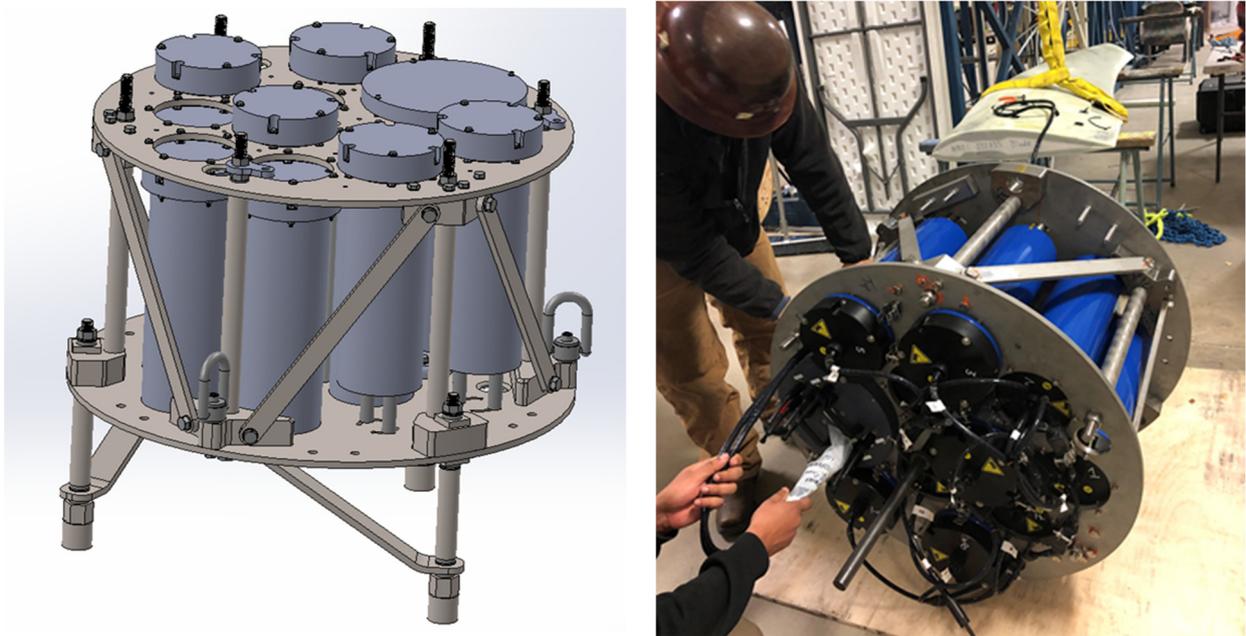
Figure 8. (left) 3D image of NDAQ structure; (right) thermoplastic blade being connected to NDAQ.

The NDAQ structure was designed based on a structural analysis of the expected loads and modeled in SolidWorks with the turbine tail cone to ensure a proper fit. The array of 10 Nortek battery canisters, the Robotic Ocean canister containing the data logger, and the structure itself all had to fit within the tail cone of the rotor. Because the turbine has a relatively low rotational speed and all components are close to the center of rotation, the structural design was more space-constrained than strength-limited. Ultimately, a wrapped-truss design was chosen to transfer the rotational loads to the hub. The final structure comprised round plates at the top and bottom, threaded rods inside compression tubes connecting the plates, and diagonal braces forming the truss. The structure was mounted to the hub using three existing bolts located on the hub in a rotationally symmetric pattern.

The entire structure, including the hardware, was constructed using 316 stainless steel components. Additional features included pass-through holes for wiring, removable lifting fixtures for rotation and installation, and a sacrificial anode to minimize galvanic corrosion during deployment. Figure 8 shows a SolidWorks model of the NDAQ and a photo of the NDAQ being connected to one of the thermoplastic blades.

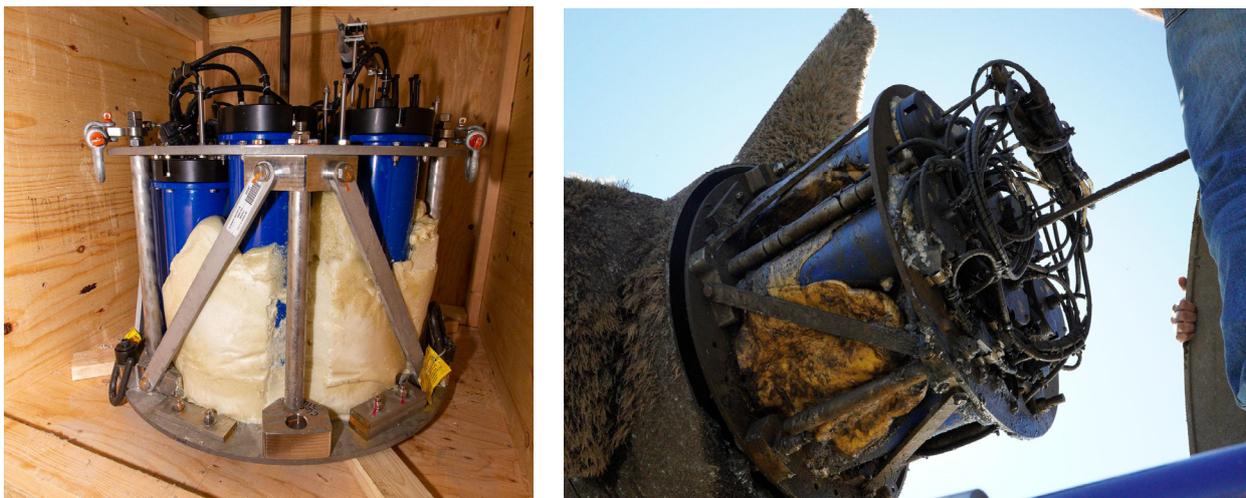
Figure 9. NDAQ with foam fill (left) before deployment and (right) after deployment.

For the NDAQ to not introduce excessive cyclic loads on the turbine shaft, it was rotationally balanced by adding weights circumferentially. This was performed by placing a solid steel shaft through the center of the structure (coincident with the rotor axis) and suspending the steel shaft on roller bearings. Weights were added to the top side of the structure; then, the light and heavy sides of the structure were reevaluated until there was little to no rotational bias. After completing the NDAQ build-out and validating that it was working properly, the team filled the voids between battery canisters with a FiberGlast polyurethane expanding foam to help increase buoyancy and reduce the in-water weight of the NDAQ. Figure 9 shows the NDAQ with the foam both before and after deployment.

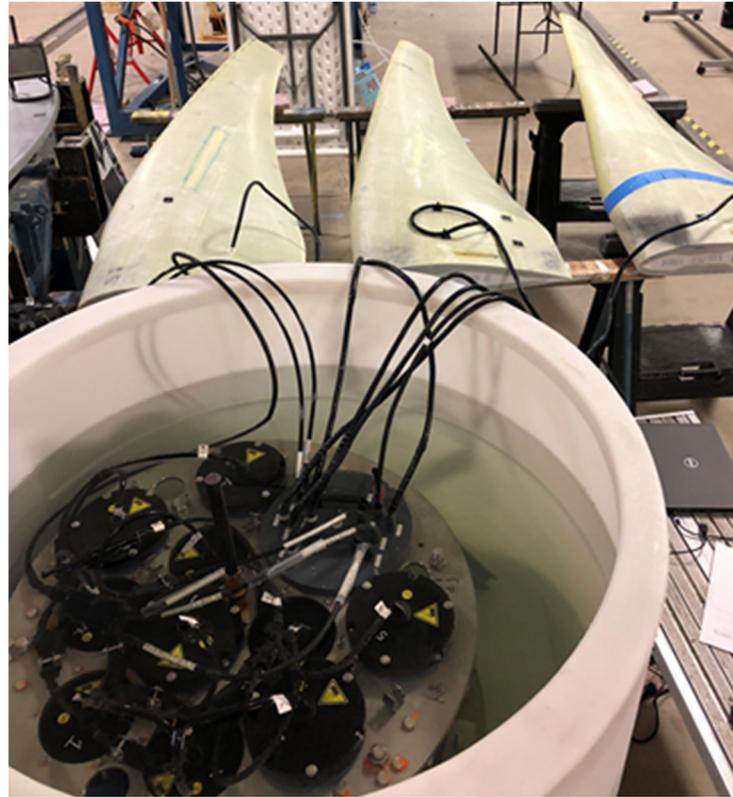
Figure 10. Three thermoplastic blades connected to the NDAQ, and the NDAQ submerged in water.

Once testing was complete, the NDAQ was connected to all three blades and submerged in a tank of water for 3 days to test the canister seals and vacuum applied to the

NDAQ canister (Figure 10). At this time, a submerged weight was taken and compared to the normal weight to determine the structure's buoyancy. The submergence test confirmed that all wired connections and seals were installed correctly and functioned well under water for the limited duration of the test.

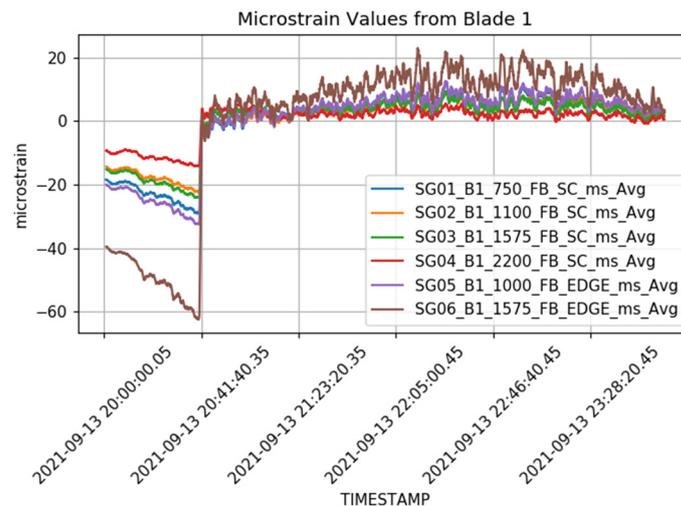
Figure 11. Strain gage data for thermoplastic Blade 1 during deployment, showing 4 h of data collected in September when the rotor was parked due to the junction box failure. The step change shows the rotor going from parked to operating.

All strain gages and IMUs were found to be operating within acceptable ranges after deployment once external power was applied. This means that all connections between the blade strain gage locations and the NDAQ survived the deployment. Four hours of data (strain gages and IMU) were recorded by the NDAQ on 13 September 2021, as shown in Figure 11. Upon post-deployment verification, the NDAQ recorded ~242 million iterations of the sampling, equating to 3.7 billion data points total, and it powered down between hours 3370 and 3372 of operation (140 days). This suggests that the NDAQ was fully functional up until this date.

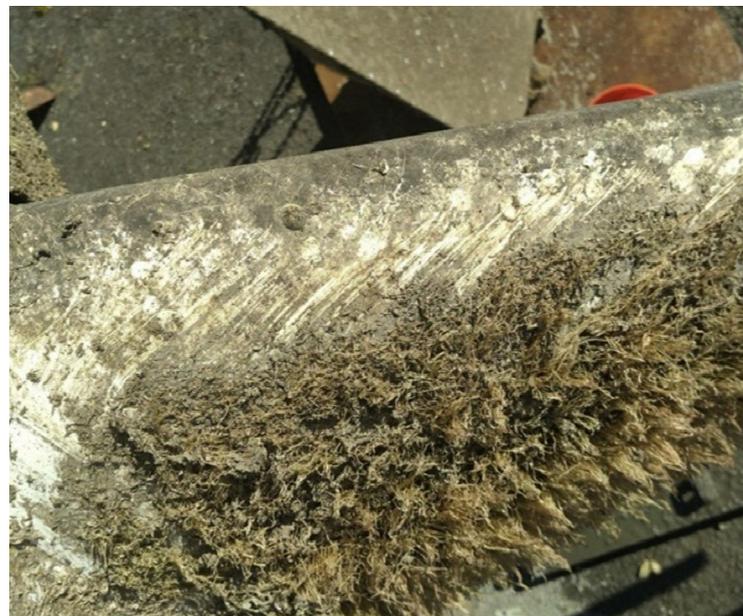
Figure 12. Marine growth on blade.

Furthermore, the thermoplastic blades were completely intact with no signs of structural damage. The blades had approximately 1 inch (25.4 mm) of marine growth, mud, and barnacles, which is attributed to the parked conditions of the rotor after the junction box failure. All blades, including the epoxy blades, had similar levels of growth, as shown in Figure 12. The team is conducting post-deployment structural validation of both thermoplastic and epoxy blades to further assess the structural and material state of the blades after the deployment.
