Biofouling Analysis for Wave Energy Piston Design

Post-Access Test Report

Awardee: Triton Systems, Inc.

Facility: Pacific Northwest National Laboratory – Marine and
Coastal Research Laboratory

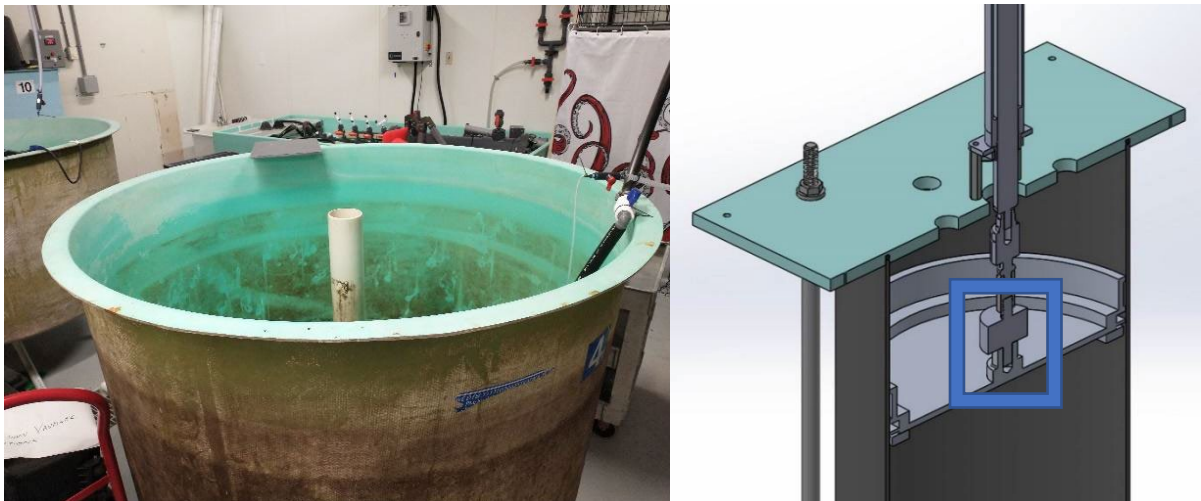
Figure 4: MCRL Wet Lab flow-through tank; Right: Device under test with load cell framed in blue

Testing will occur in the PNNL Marine and Coastal Research Laboratory (MCRL) wet laboratory space. The devices under test will be mounted to and operated in a seawater flowthrough tank (Figure 4) 1.5 m in diameter and 0.91 m deep. Unfiltered seawater from Sequim Bay is pumped into and drained from the tank at a fixed rate to ensure circulation. Growth of marine organisms is uncontrolled and entirely dependent on the natural biota within the water, which varies with season and other exogenous conditions in the bay.

PNNL will provide testing apparatus to measure piston force of the devices under test. Tension and compression of the pistons will be measured with Omega LC203-200 hermetically sealed 200 lbf capacity load cells (Figure 4) excited and amplified with Omega DMD4059 load cell amplifiers. Amplified load measurements will be acquired by a Measurement Computing USB-1608G (or similar) USB data acquisition unit and logged on a computer. Data will be saved as raw .csv files, archived using Microsoft OneDrive, and analyzed using Matlab.

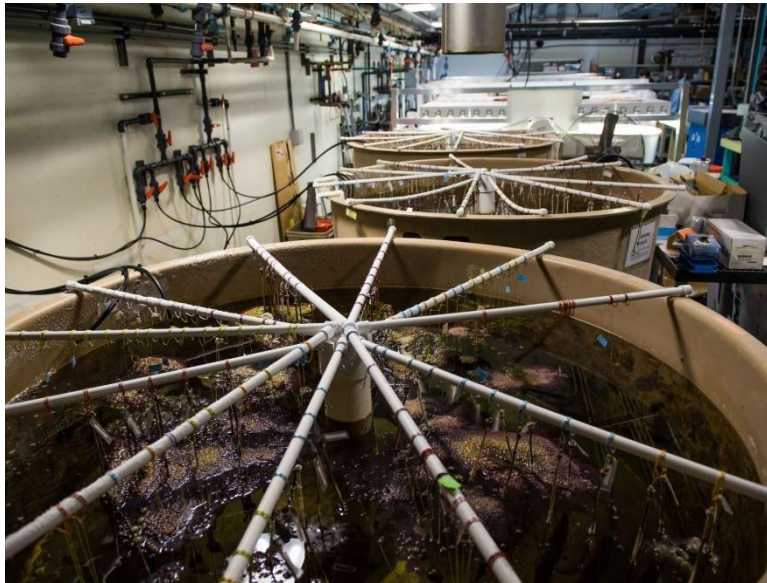
Figure 5: PNNL-MCRL active biofouling experiment

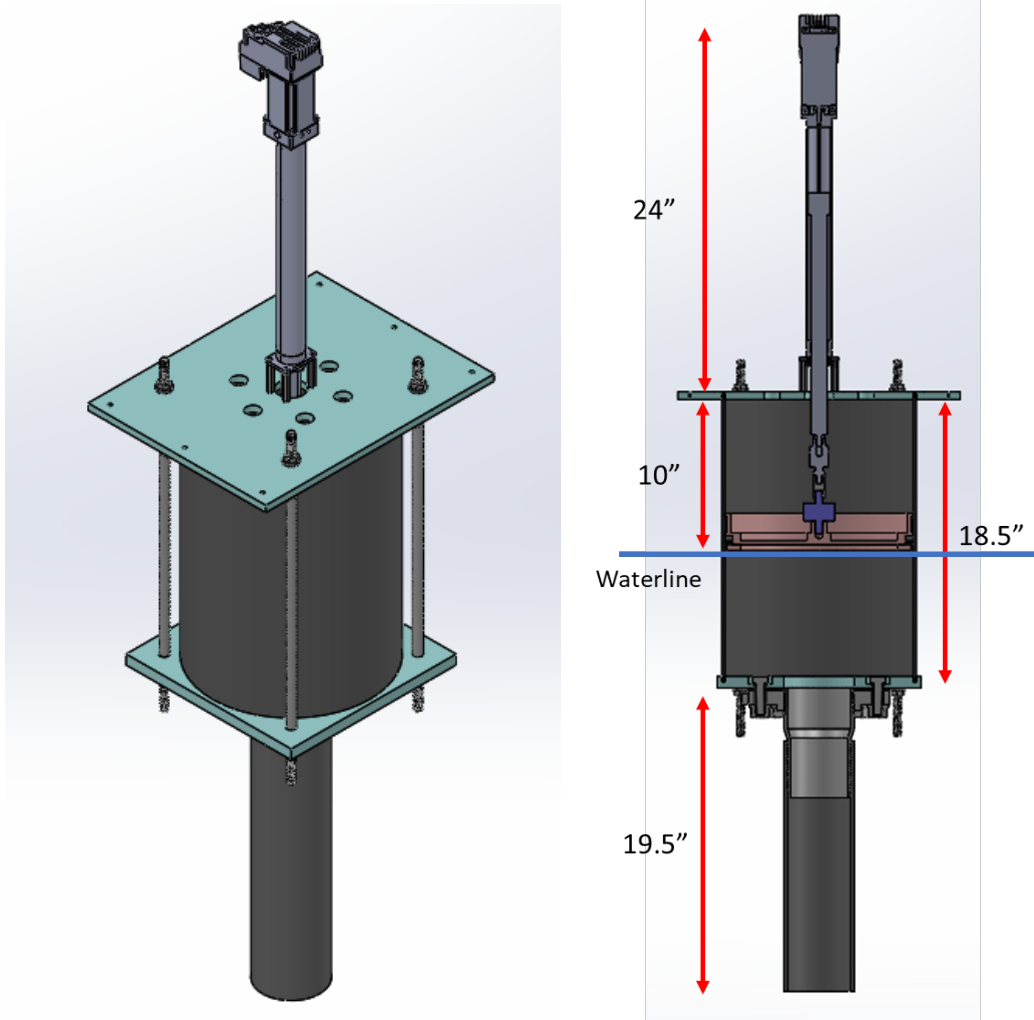
Figure 6: Device Under Test

The device under test is a half scale Power Take Off based on Triton's conceptual design. It will consist of a linear actuator, piston head, composite epoxy cylinder, and biofouling mitigation seals. (Figure 6). A short section of SBR rubber hose is mounted to the bottom of the cylinder to simulate Triton's depth tube. Coupons of composite epoxy cylinder sections and SBR rubber hose sections will additionally be installed to study biofouling accumulation of the raw materials.

This test article would be installed in a PNNL Biofouling tank to study the results of biofouling over time. Two identical articles will be installed in the tank. One of the systems will have a biofouling mitigation seal and the other will not, allowing for an evaluation of the seal's effectiveness

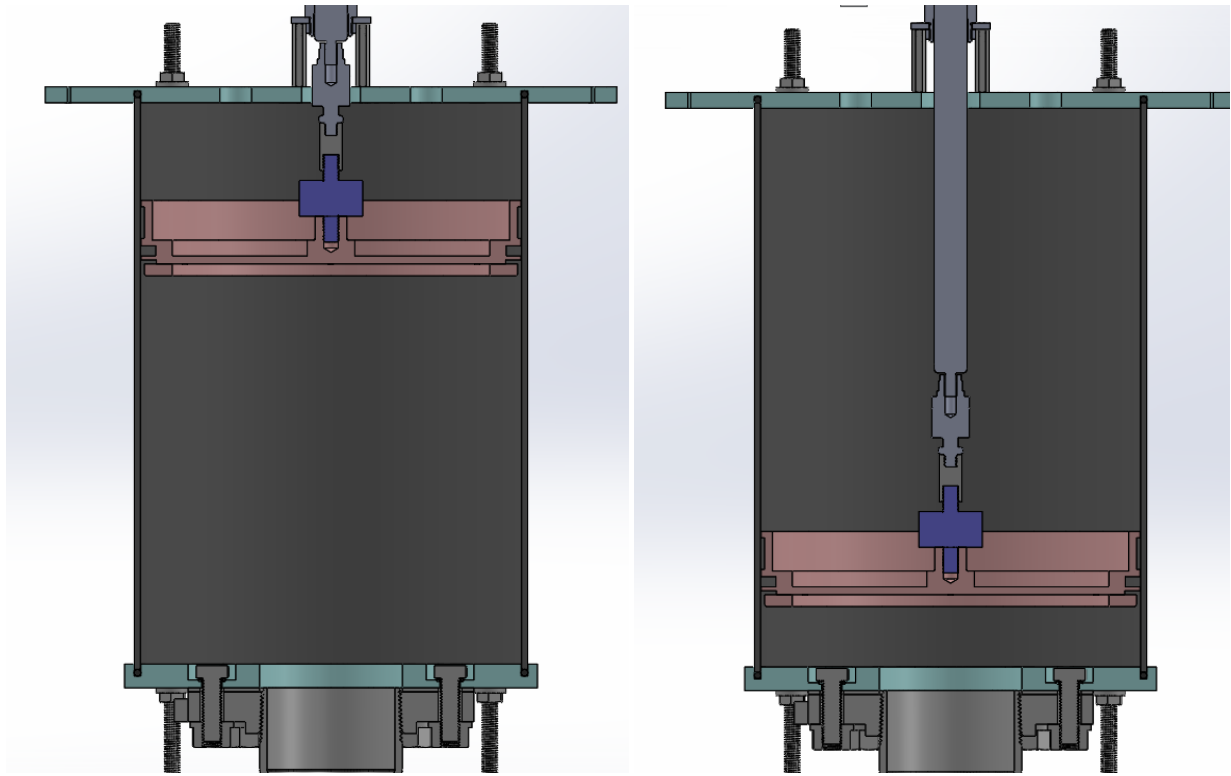
Figure 13: Stroke of actuator during test

Figure 14 shows the limit of the actuator stroke during test. This leaves space both above and below the stroke limit for evaluation of growth.

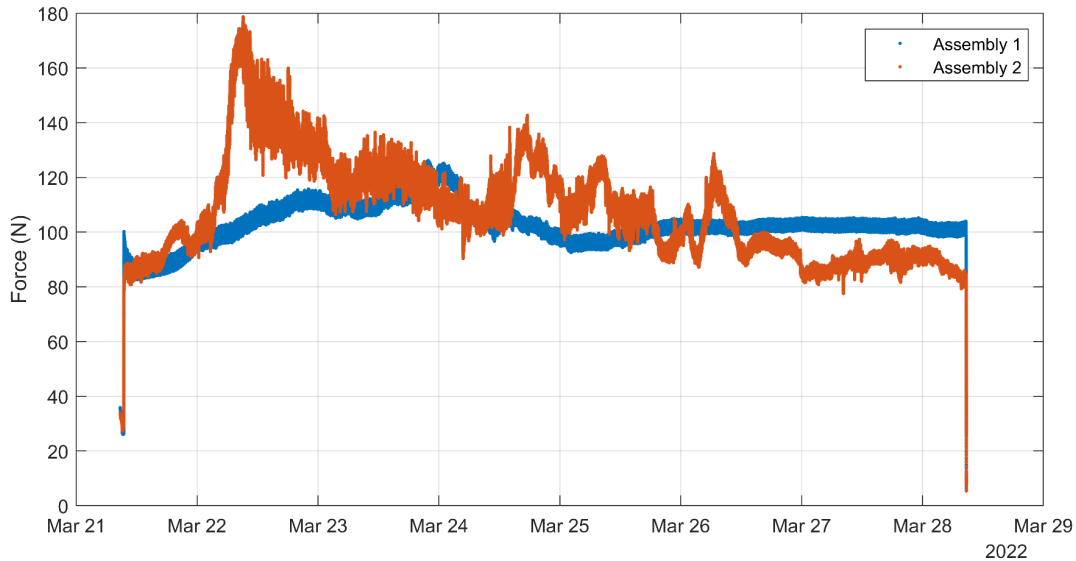
Figure 15: Moving RMS-filtered load cell force with a 100 s filtering window for baseline (top) and core (bottom) testing duration. Low-force spikes are filtering artifacts at startup and shutdown

Baseline/burn-in testing over one week of continuous operation in filtered seawater shows assemblies commenced with similar load profiles before Assembly 1 assumed a more variable and generally higher force trend. Both assemblies reached a similar force level and relatively consistent operation by the end of the baseline period, with Assembly 2 maintaining more consistency.

During core testing, two key trends were shared between assemblies: a strong diurnal cycle of RMS force and lower force after shut-down, removal, inspection, and restart cycles. Diurnal periodicity was

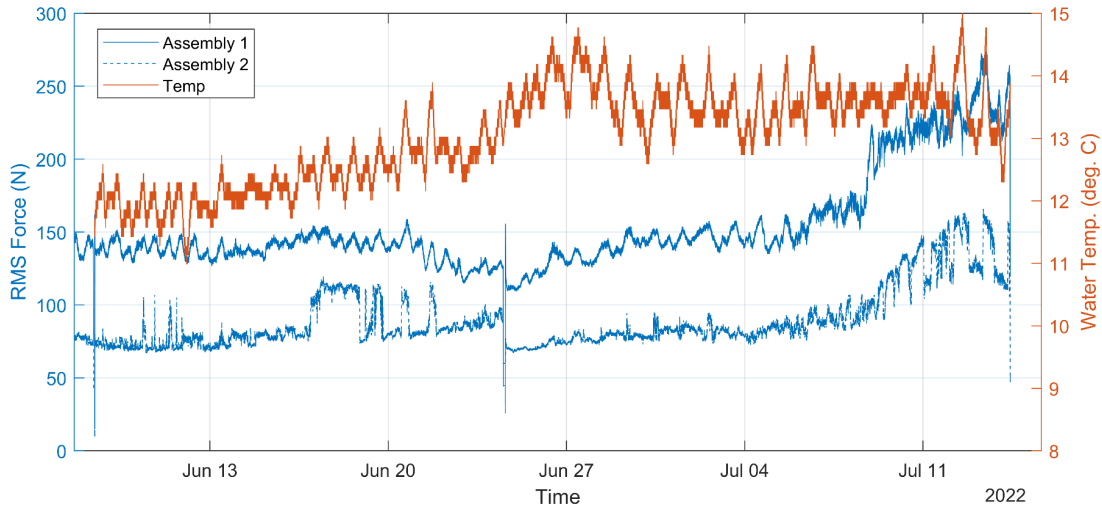
Figure 16: Moving RMS-filtered load cell force with a 100 s filtering window and tank water temperature for partial months 3 and 4 of core testing

shown to be linked to water temperature during the period in which it was concurrently measured (Figure 17). Assembly 1 experienced higher piston force throughout the majority of the testing period. Summary force data are presented in Table 5.

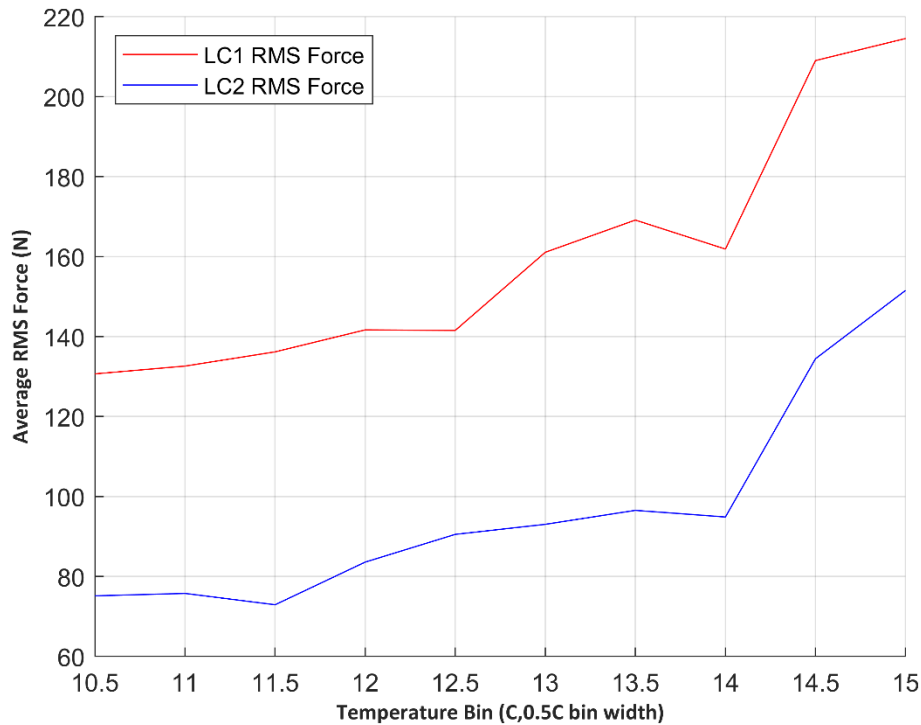
Figure 17: Average RMS force by temperature bin for assembly 1 (LC1) and assembly 2 (LC2)

Load cell force was binned based on corresponding temperature readings, and the results are plotted in Figure 18. The general trend demonstrates increasing forces for both assemblies with increasing

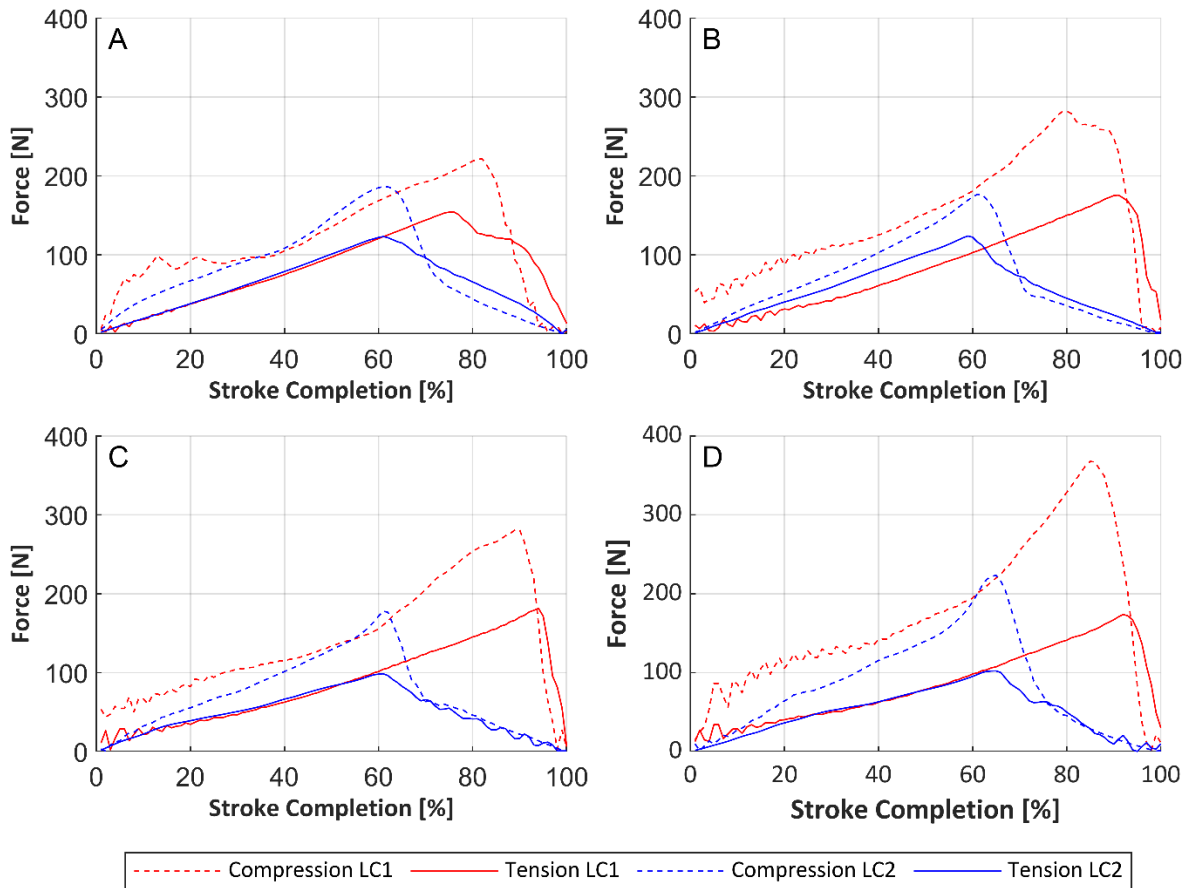
Figure 18: Average tension and compression forces per assembly for months 1, 2, 3, and 4 (A, B, C, and D respectively)

An additional analysis was conducted to characterize the mean force associated with piston tension and compression across the four months of testing. Raw data were divided into cycles by identifying instances when force transitioned between tension (upstroke) and compression (downstroke) utilizing zero crossings. The average duration of a stroke was calculated to be 10 seconds, so datasets between 5 and 15 seconds in length were selected for analysis. In order to avoid identifying the jitter at beginning and ends of cycles as stroke-transition zero crossings, a mean filter of 2 seconds was applied to raw data. Filtered data were only used to identify cycle transitions; raw force was analyzed during these identified cycles. Next, each stroke's measurements were resampled so they contained an equal number of datapoints regardless of duration. An average stroke was calculated for each month by averaging all cycles within the month for each standardized phase (i.e., datapoint) of the stroke. Results are depicted in Figure 19.

Some of the jitter at the beginning and end of cycles are evident in the results, particularly in the beginning of assembly 1's strokes. Notably, oscillations increase in the last two months of testing in the falling end of assembly 2's tension strokes. Assembly 2's dynamic seal failed in month 4 leading to the termination of the experiment.

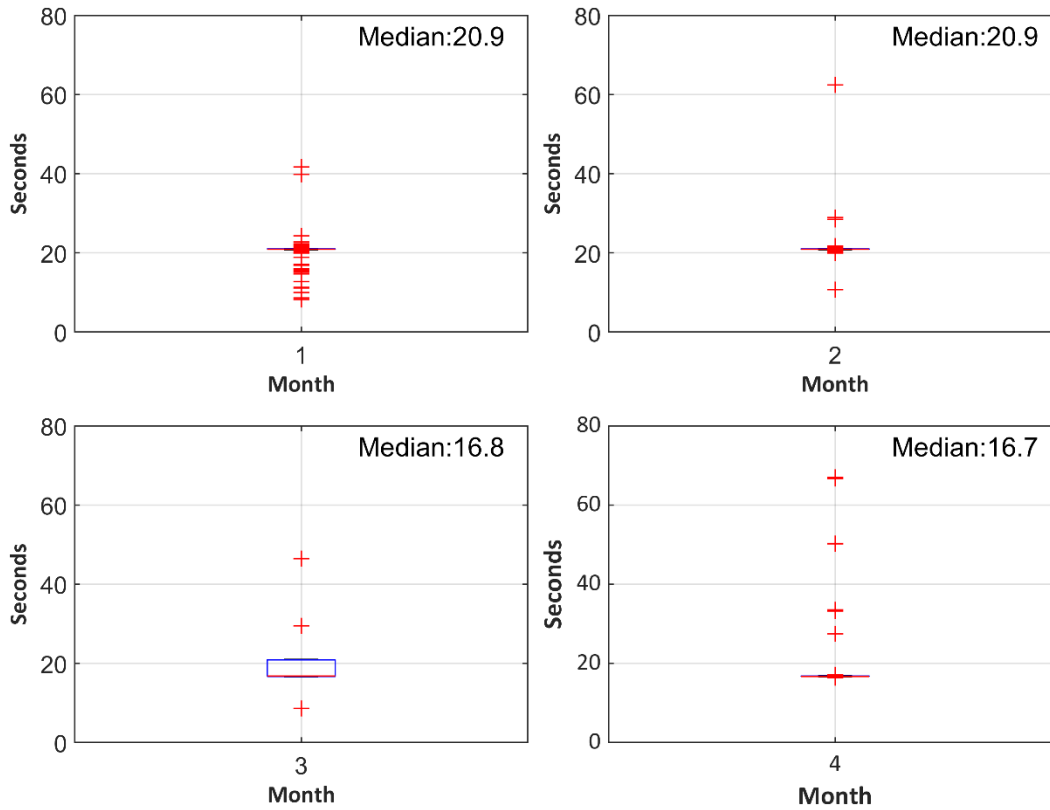
Figure 20: Boxplots of stroke time in seconds of a full tension-compression cycle per month

The length of time each piston took to complete a full tension-compression cycle decreased from 21 to 17 seconds in months 3 and 4.

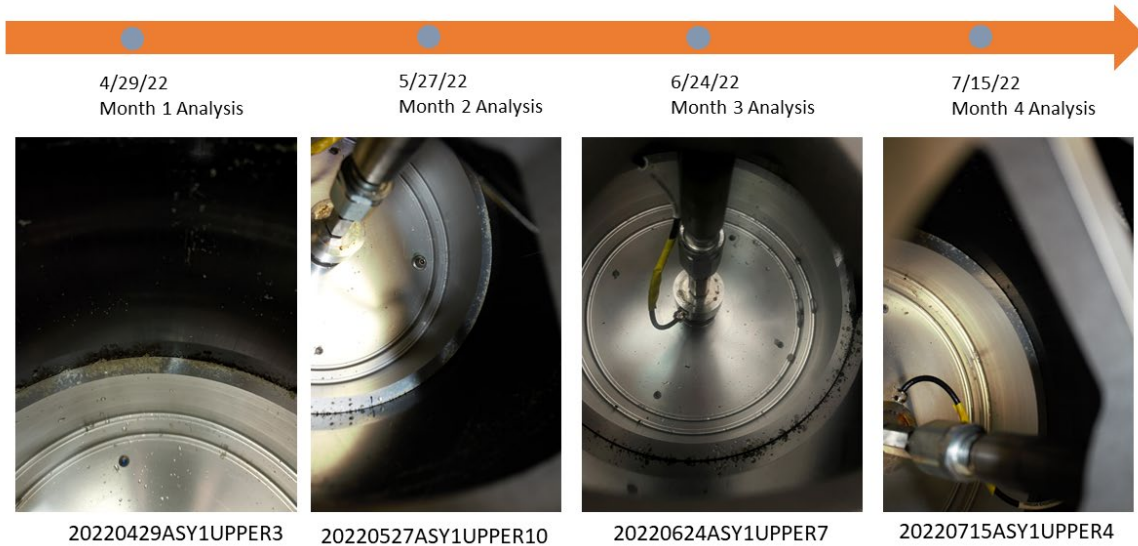
Figure 22: Top of piston 1 before removal of assembly from tank, photographed at 1 month intervals over 4 months of testing

additional barnacles were observed growing on the interior of the piston tube but below the stroke of the piston for both assemblies. This qualitative trend was observed to a lesser extent on assembly 1 than assembly 2. At this point a biofilm was also gathering on the top of the piston heads, seen in Figure 17. The biofilm indicated some amount of dynamic seal underperformance, allowing seawater and biofouling to gather on the piston above the seal.

Continuation of the described trends was observed until the assemblies were pulled from the tank for the final time in month 4. Barnacles were more numerous and larger than previously observed, with some measuring as large as 10 mm in diameter. The biofilms interior to the tube and above the piston head continued to grow, as did the white/clear nodules forming in void spaces.

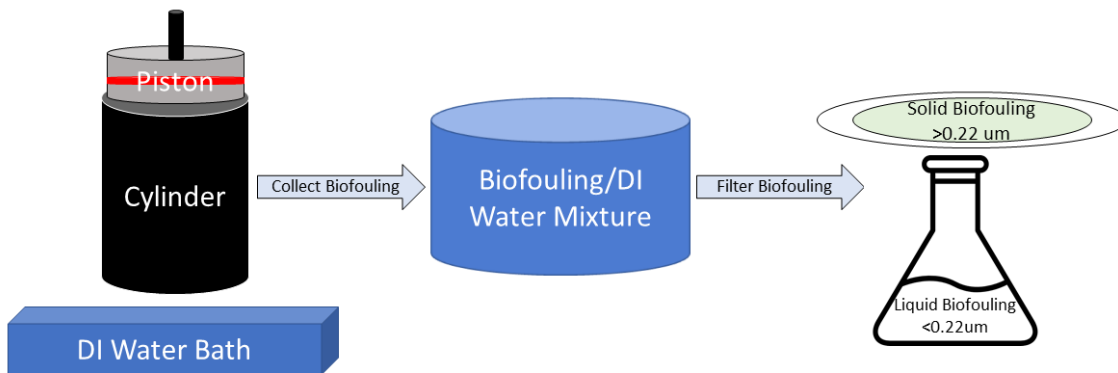
Figure 25: Final biofouling analysis collection process: remove biofouling from piston and cylinder with DI water bath. Collect and filter this mixture to isolate solid material from liquid filtrate.

Final biofouling buildup on the interior of cylinders and piston surfaces was characterized by weight and by carbon and nitrogen content. Cylinders and pistons were disassembled and rinsed in deionized water, and the resulting mix of water and biofouling was filtered through 0.7 μm then 0.22 μm filters to isolate solid material from liquid for separate analyses (depicted in Figure 26).

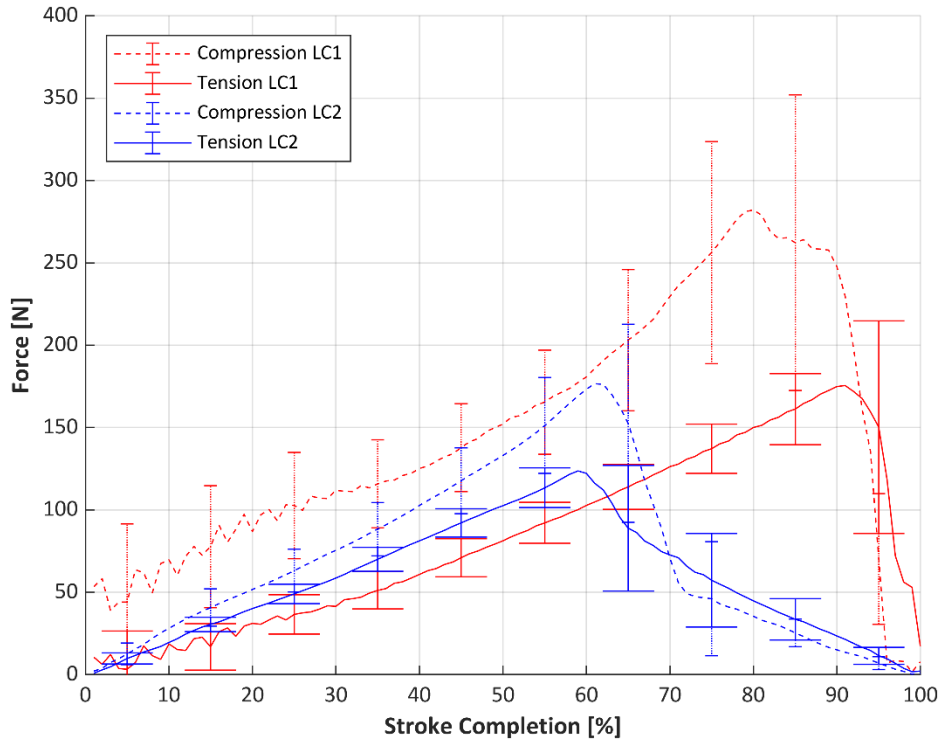
Figure A2: Average absolute load cell force with error bars indicating standard deviation of 10 datapoints for assembly 1 and assembly 2, tension and compression strokes during month 2

Standard deviation was also calculated for each datapoint in a cycle and is depicted as errorbars representing average standard deviation per 10 datapoints in similar figures for all months, which are included in the appendix.
