# Antifouling and Anticorrosive Protection of Renewable Energy Marine Structures with TiO<sub>2</sub>-Based Enamel

D.S. Sanz<sup>1</sup>, S. García<sup>1</sup>, L. Trueba-Castañeda<sup>1</sup>, D. Boullosa-Falces<sup>2</sup> & A. Trueba<sup>1</sup>

**ABSTRACT:** Biofouling is a significant problem that affects renewable energy marine structures (REMS), such as wind turbines and those designed for wave or tidal energy exploitation. Marine organisms, including algae, barnacles, and mollusks, attach themselves to the surface of these structures, which can lead to reduced efficiency and increased maintenance costs. In addition, biofouling can also cause corrosion, which can compromise the structural integrity of the offshore platforms. To combat this problem, several methods have been developed, including anti-fouling coatings, physical methods, and biological methods. Each method has its advantages and disadvantages, and the most effective solution often depends on the specific type of fouling and the location of the offshore structure. Effective biofouling prevention is essential for the safe and efficient operation of offshore structures and the protection of marine ecosystems. To

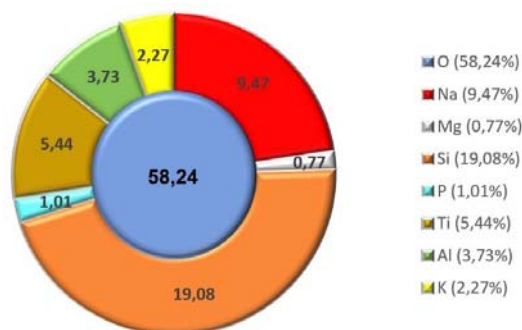
Ceramic coatings and autorelease paints exhibit similar anti-fouling properties. The antifouling action of enamels is mainly based on four pillars: the chemical composition, the surface roughness, the contact angle (CA) and the thickness of the coating. The studied ceramic coating has titanium dioxide as one of its key components. Figure 1 shows the chemical composition of the ceramic coating. The use of titanium in the composition of the coating also provides enhanced strength, durability, and resistance to high temperatures.

Figure 1. Titanium-based ceramic coating composition.

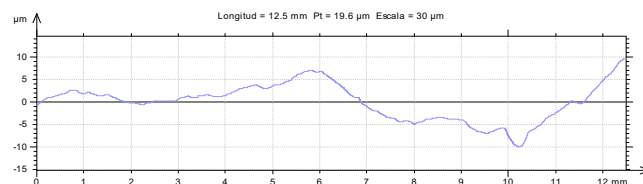
Once the titanium-based ceramic coating was applied to the experimental samples, the surface roughness and the degree of hydrophilicity were checked according to ASTM D7490-13. Figure 2 shows a graph of the roughness spectrum measured on the x-axis of the sample. The measurements were taken three times on the x-axis and three times on the y-axis, so that the arithmetic mean of the six measurements equals 0.188 µm. On the other hand, three measurements of the drop angle were taken to confirm the degree of hydrophilicity of the sample. The results of the measurement are presented in Table 1.

Figure 2. Titanium-based ceramic coatings surface finish metrology.

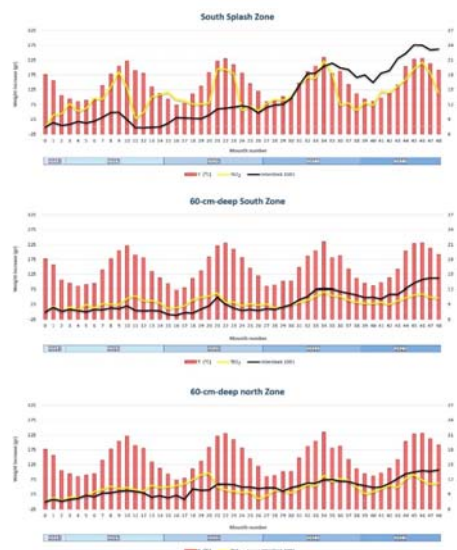
Figure 3 shows the quantitative evolution of the weight increase of the samples exposed in a real marine environment over a span of four years. Furthermore, the aforementioned data is overloaded onto a bar chart that visually depicts the seawater temperature during the course of the experiment. As shown in Figure 3, the highest values of seawater temperature occur in the summer months, while the lowest values are reflected in the winter months, in fact, February 8, 2020, recorded the lowest seawater temperature value (11.9°C), whereas the highest temperature value (21.6°C) were observed on August 9, 2021.

Regarding the growth of biofouling in the splash zone, it was observed that the titanium-based ceramic coating showed significantly higher biological growth than the antifouling paint during the first nine months of exposure, in fact, the performance of the paint was commendable, even for an autorelease paint that was tested under static conditions, and it was in this month of experimentation when the ceramic coating exhibited a much greater difference in mass increase compared to the paint. In fact, the biofouling attached to the ceramic coating was 276.32% more than that attached to the Intersleek 1001 paint, making the difference in growth between the two quite substantial. From the eleventh to the fourteenth month, the investigation showed that the antifouling paint experienced mass increase values slightly below zero, meaning that at this point in the investigation, some of the paint had disappeared, which subsequently affected its antifouling performance. The graph in Figure 3, specifically in the "south splash zone," indicates that the growth of biofouling on the

ceramic coating is strongly linked to the temperature of the seawater, as also exemplified by the research conducted by [5]. During the summer months, there was a higher increase in mass, while the increase was lower during the winter months. The growth pattern was observed to be stable and cyclical, with very similar values between the same months of 2020, 2021, and 2022. The highest value of biofouling was achieved on August 9, 2021 with a mass increase of 222.0 g. However, the behavior of the Intersleek 1001 paint was very different and, coinciding with [7], the increase in biofouling gradually increased, reaching much higher values in the last year of experimentation. In fact, the biofouling increase in the antifouling paint was 129.76% greater than in the titanium-based ceramic coating in the last month of experimentation and it is expected that this difference will continue to grow over time.

Figure 3. Relationship between the mass increase of ceramic coatings and the temperature of seawater over time.

Regarding the results obtained in the experiment 60-cm-deep south zone and 60-cm-deep north zone, a much lower biological development can be seen compared to the splash zone in both antifouling coatings. Although there is a direct relationship between temperature and biofouling growth, it is much weaker than the relationship observed in the splash graph. Towards the end of the experiment, it was found that in the 60-cm-deep south zone and 60-cm-deep north zone, the titanium-based ceramic coating experienced 141.85% and 69.41% less mass increase, respectively, compared to the Intersleek 1001 paint.
