Post Access Interim Report

Wave Powered Oceanographic Gliders

Navigation Assessment

Awardee: Moye Consultants on behalf of
Team "Wave Powered Oceanographic Gliders"

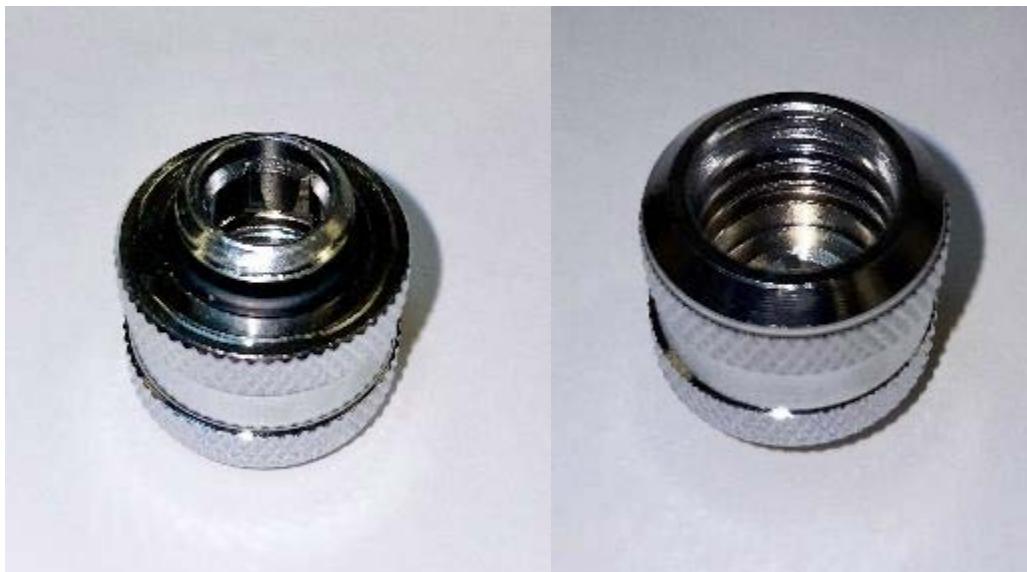
Figure 5. Picture of the G1/4" plumbing fitting used for cable penetrations. Left: external G1/4" thread with o-ring seal. Right: Internal grooves. The fitting is sold for liquid cooled computers. See section 7.2 for further details.

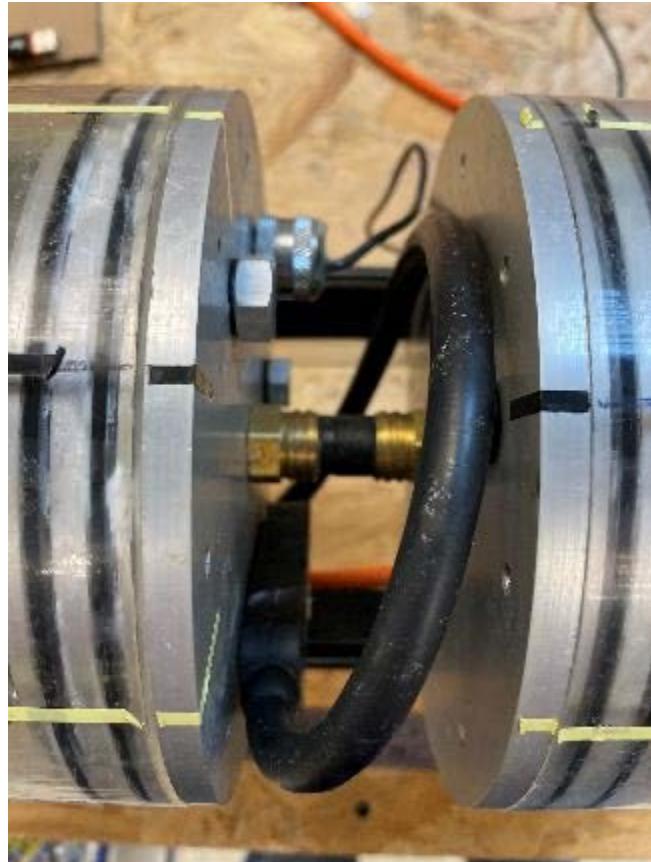
Figure 6. View of electronics enclosure assembly showing tube end cap with all connectors in place. Centre is the McArtney bulkhead connector. Top is a USB penetrator made in the same way as is shown in Figure 3 to Figure 5. Bottom is the McArtney connector for the thruster motors.

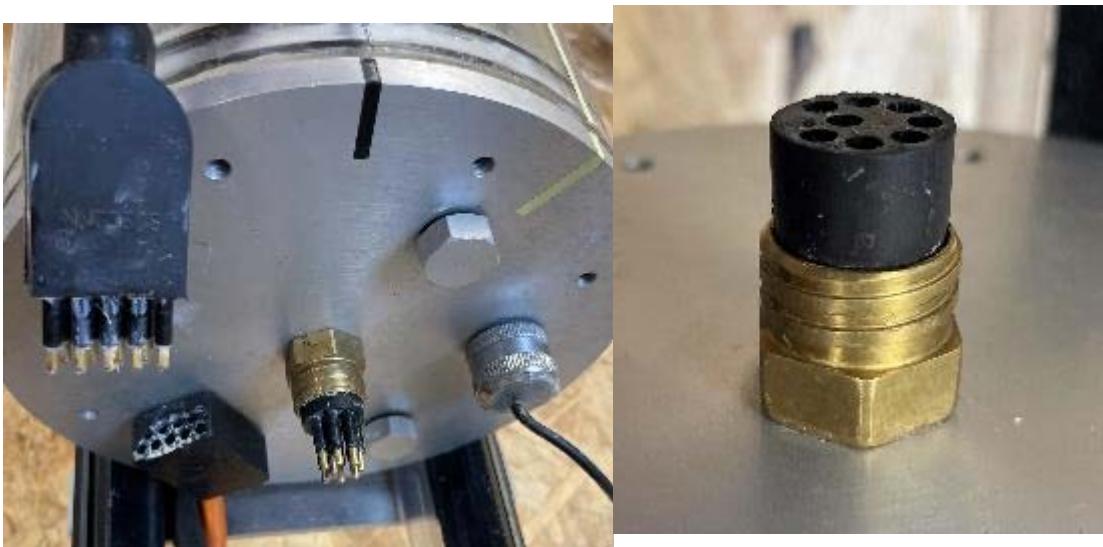
Figure 7. Electronics enclosure assembly showing Mcartney connectors opened.

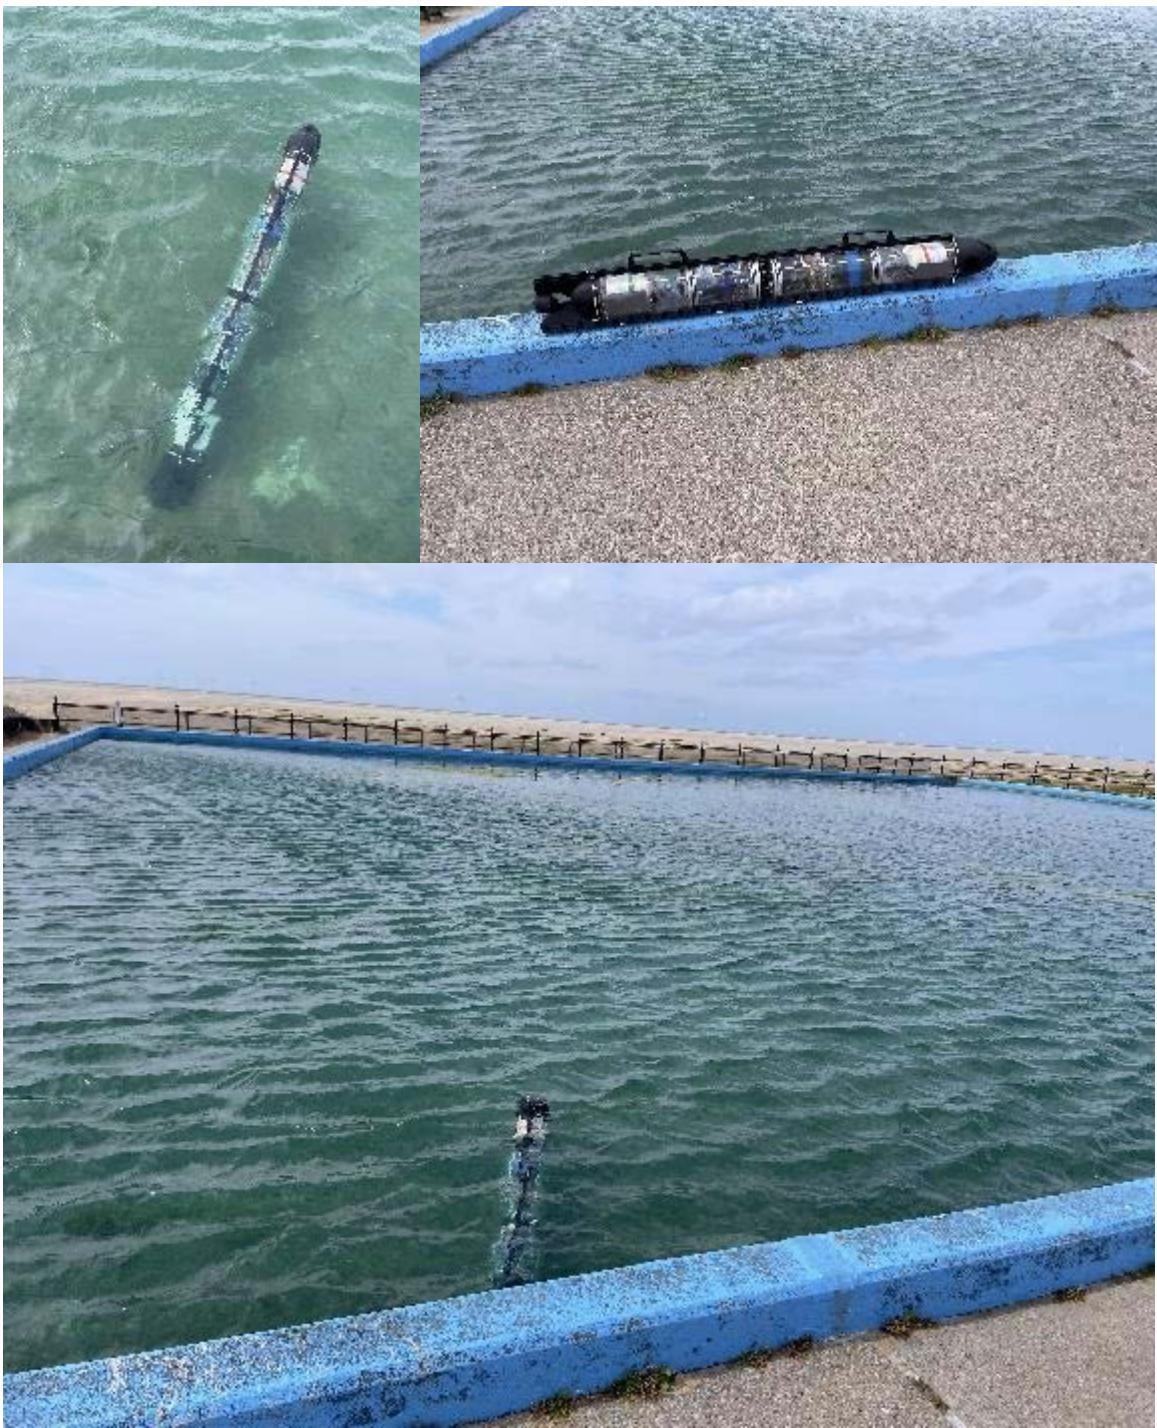
Figure 10: Navigation and maneuvering tests. Top left submerged; Top right drying out after test; Bottom test start position.

The navigation tests depend on yaw control and depth control. Initial depth and yaw control tests were done in the in house tank shown in Figure 8. The navigation tests were done in a local boating lake near the Wave Venture offices at Hoylake RNLI near Liverpool UK, see Figure 9 to Figure 10.
