# Destructive testing and failure analysis of a full-scale composite tidal turbine blade

Fergus Cuthill, Sergio Lopez Dubon, Christopher Vogel, Miguel Valdivia Camacho, Conchúr Ó Brádaigh and Eddie McCarthy

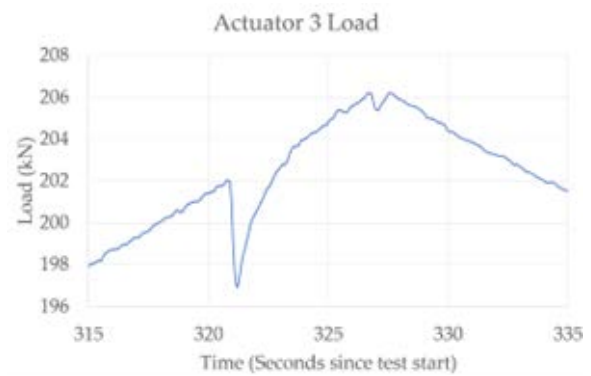
described in the timeline of blade testing above, the first detectable failure occurred at the root of the blade. The failure initially appeared as a debond between the glass fibre skin of the blade and the steel root connection, as shown in Fig 7. The failure occurred during a static test, targeting an actuator load of 220 kN at a loading rate of 1.467 kN/s; during the ramping, failure in the root occurred at 200.3 kN, with an average load drop of 5 kN on each of the 3 actuators. Nevertheless, the test was continued, as the load appeared to recover and stabilise after the initial failure; however, after a further failure at 206.2 kN, it was decided to stop the test for inspections. A graph showing the initial load drop for a single actuator can be seen in Fig 6. After the inspections identified the delamination root failure, the test was repeated, and the load of 220 kN was achieved and held for 150 seconds with no further failures detected. After this test, the decision was made to attempt to initiate a crack failure in the blade, as the first failure mode had been identified, and it was believed that pushing further would have resulted in further failures at the root with little extra information gathered about other areas of the blade.

Fig. 7. Graph showing 5 kN load drop during root failure, followed by further cracking and subsequent test halt.

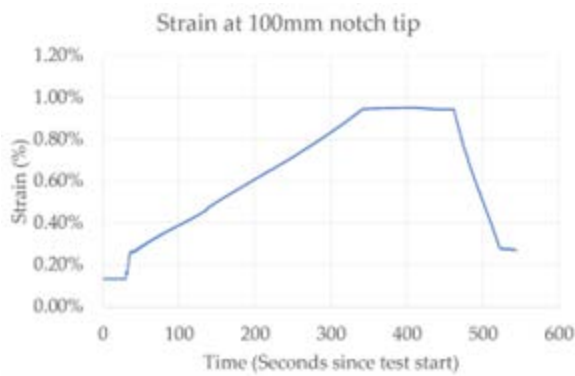
After the series of static tests and small fatigue tests, no failure or crack propagation from the edge of the 100 mm notches was detectable with imaging or DIC results. Although the strain level measured at one of the notches in the  $0^\circ$  direction (longitudinally down the blade) was measured to be 0.95 %, the other notch showed a strain of 0.5 %; thus, the decision was made to extend the notches to further accelerate failure. A graph showing the strain rise throughout a static test reaching a peak strain of 0.95 % can be seen in Fig 8.

Fig. 8. Strain at notch closest to blade trailing edge in the 0° (longitudinal) direction reaching a peak of 0.95 % strain.

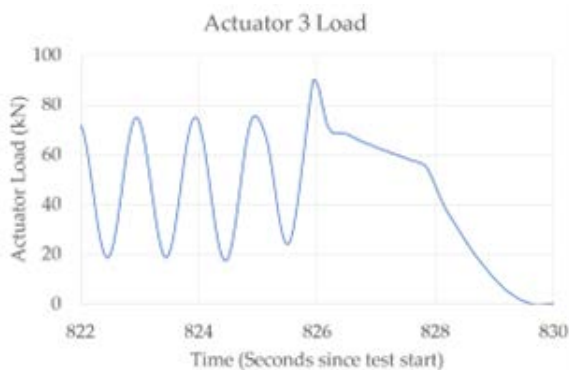
The final failure of the blade occurred during fatigue testing, where the aim was to further progress the cracks that had been detected at the notch tips. The bonded seam between the top and bottom skins of the blade, along the leading edge, suffered catastrophic debonding, with approximately 1 m of seam bursting open in less than 0.1 seconds. This seam then continued to open until the clamping force of the loading saddle restricted its further propagation along the leading edge. The seam burst on the cycle before the test was stopped, meaning the reduction in stiffness of the blade

Fig. 9. Graph showing load during blade seam failure, failure happened before peak load is reached causing control system to ramp up to compensate for failure, resulting in the measured peak load of 90.26 kN.

resulted in the control system increasing the oil flow required to deliver the additional displacement of the actuators. This resulted in an overshoot of the target load as seen in Fig. 9, with the test system reaching a limit state and shutting down. The seam failure near the leading edge of the blade is shown in Fig 10.
