Effects of Strain Gauge Coatings on Water Intrusion in Submerged Composite Coupon Testing

Ariel Lusty, National Renewable Energy Laboratory
 Paul Murdy, National Renewable Energy Laboratory

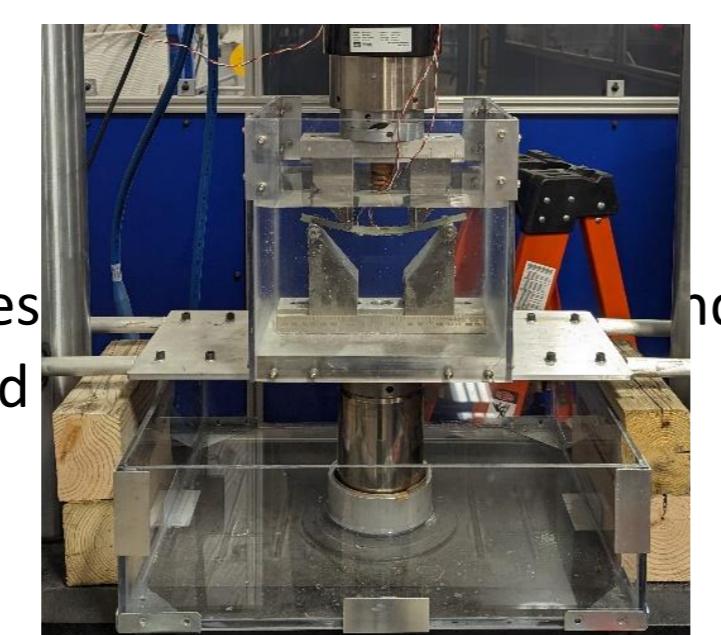
Figure 1. Submerged four-point bend load frame assembly.

- Submerged instrumentation is needed to validate marine energy component loads.
- Strain gauges were fixed to composite coupons, and coupons were submerged fatigue four-point bend tested in the load frame setup in Figure 1.

- Specimens were tested in submerged fatigue conditions using the load frame setup in Figure 1.
 - Test frequency: 0.65 Hz
 - All coupons were tested at 75% of the flexural strength of the thermoplastic composites.
- Cycles to SGF were compared for the two coatings and three composite types. SGF was determined in three steps (Figure 4):
 - The ratio R of peak-valley strain and peak-valley displacement was calculated (Figure 4c).
 - The slopes of R between each cycle were calculated and plotted (Figure 4d).
 - Strain gauges were considered failed when the plot of the slopes of R spiked (arrow in Figure 4d).

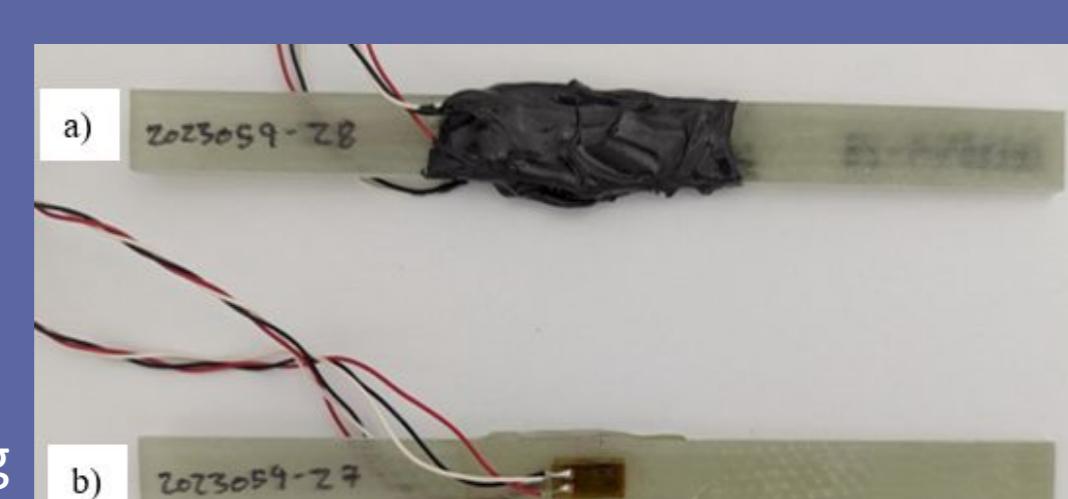
Figure 2. Composite coupons with (a) polysulfide and (b) polyurethane strain gauge coatings.

- Glass fiber reinforced polymer composite coupons with three different resin systems:
 - Epoxy
 - Thermoplastic
 - Vinyl ester.
- Manufactured at NREL's Composites Manufacturing Education and Technology Facility (CoMET) using Vacuum Assisted Resin Transfer Molding (VARTM).
- Strain gauges were coated with two different coatings (Figure 2):
 - Polysulfide
 - Polyurethane.

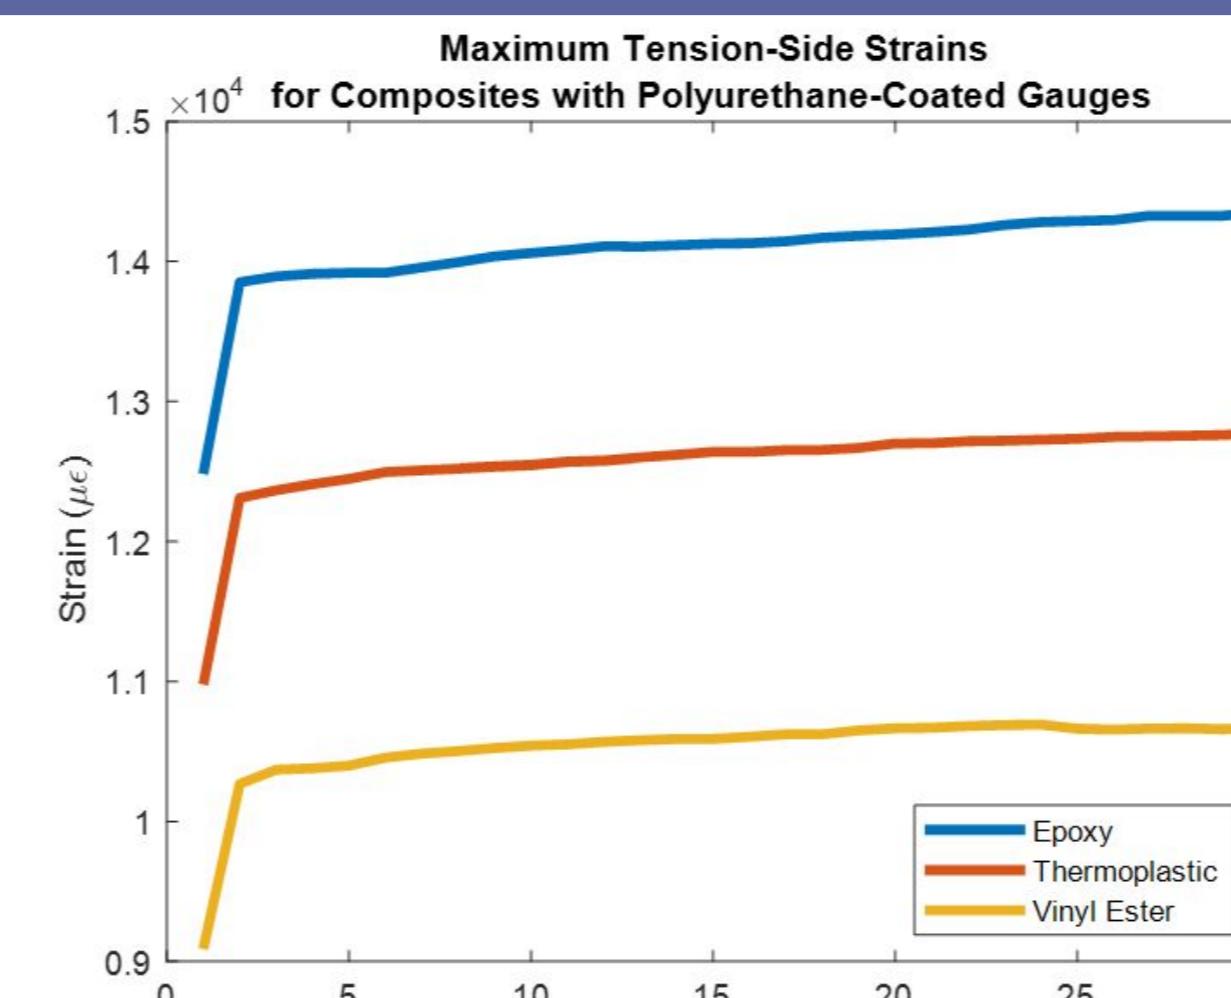
Figure 3. Maximum strain values for each submerged composite type for the first 30 cycles.

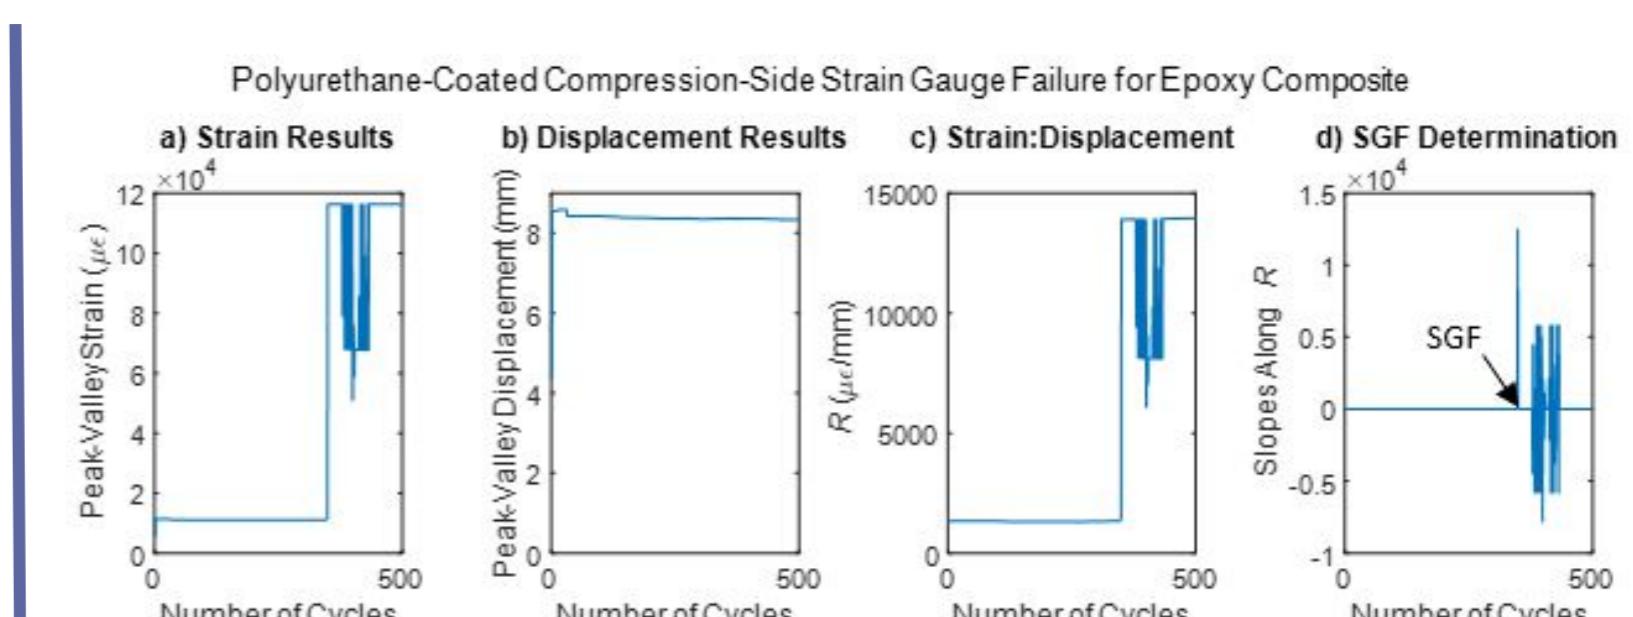
Figure 4. Plots of (a) peak-valley strain, (b) peak-valley displacement, (c) the ratio of peak-valley strain and peak-valley displacement (R), and (d) the slopes along R . The number of cycles to SGF was determined by the initial spike in plot (d).

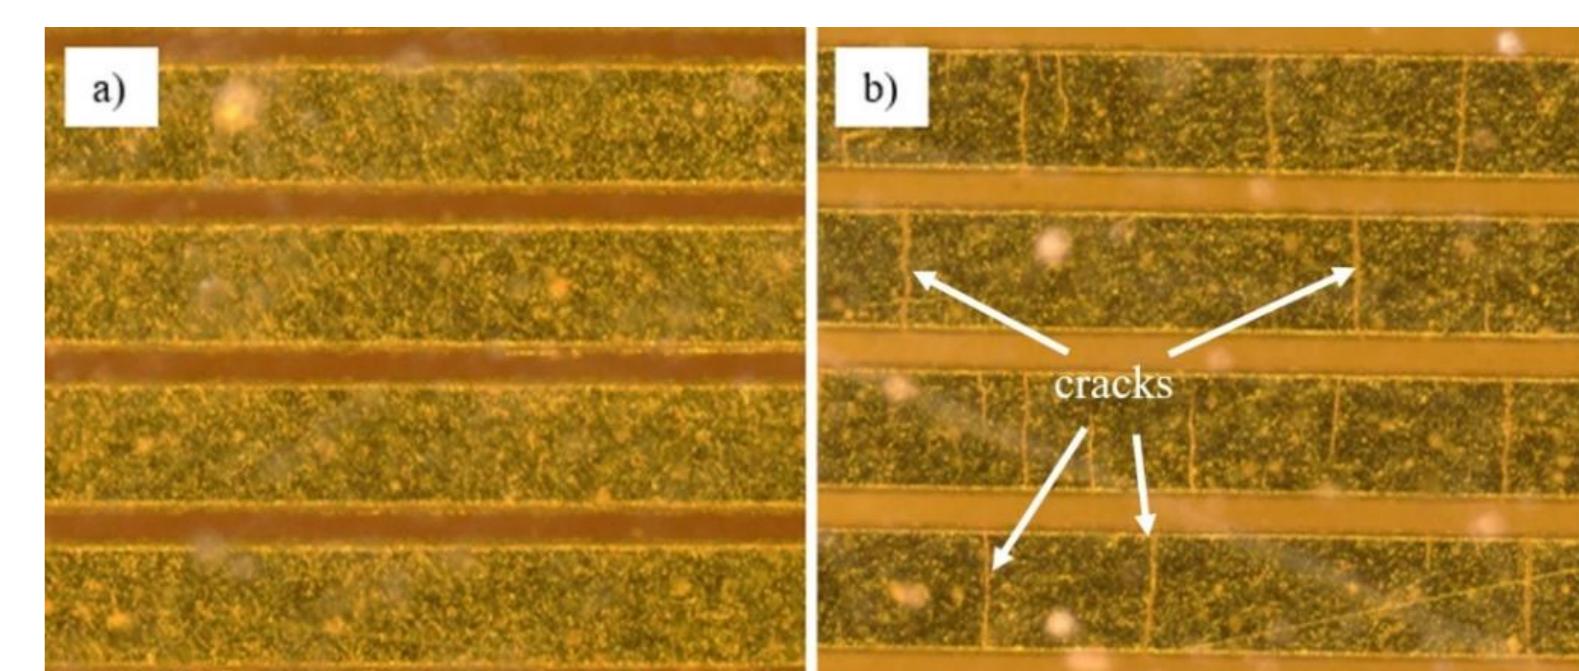
Figure 5. Optical microscopy images (300x magnification) of polyurethane-coated strain gauge Constantan foil resistive grid (a) before and (b) after submerged fatigue testing. The white arrows in (b) point to some of the cracked Constantan locations.

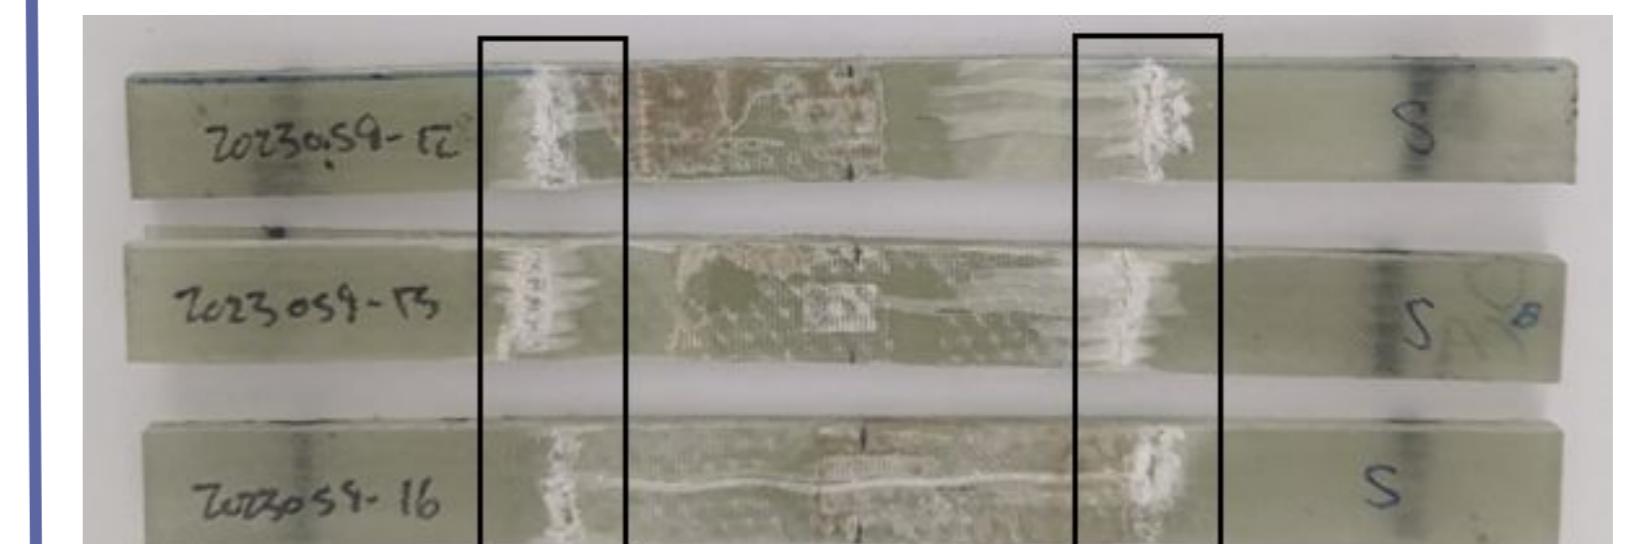
Figure 6. Epoxy specimens with rectangles indicating top sheet crush locations from loading noses.

- Outputs:
 - Cycles to composite failure (Table 1)
 - Cycles to strain gauge failure (SGF) (Table 2)
 - Failure modes (Figure 6).
- Methods developed and measurements taken at the coupon scale will be used to inform methods and designs for subsequent:
 - Submerged subcomponent testing
 - Full-scale testing
 - Standards development.
- The benefits of designing marine energy structures designs are decreased lifetime costs and increased production.

- Thirty composite coupons with 60 strain gauges were tested in submerged fatigue conditions.
- Coatings did not have an apparent effect on the number of cycles to failure of the composite materials, likely because water intrusion occurred at loading points (Figure 6).
- Strain gauges did not last the duration of testing and likely failed when the metal in the strain gauges cracked (Figure 5).
- Strain gauge durability was more dependent on strain values than the coating types used.
- Results will be used for future submerged fatigue subcomponent and full-scale instrumentation methods.
- Submerged fatigue tests with adequate instrumentation methods will lead to effective validations of marine energy structural components.
