EXTERNALLY BONDED FBG STRAIN SENSORS FOR STRUCTURAL HEALTH MONITORING OF MARINE HYDROKINETIC STRUCTURES

ABSTRACT

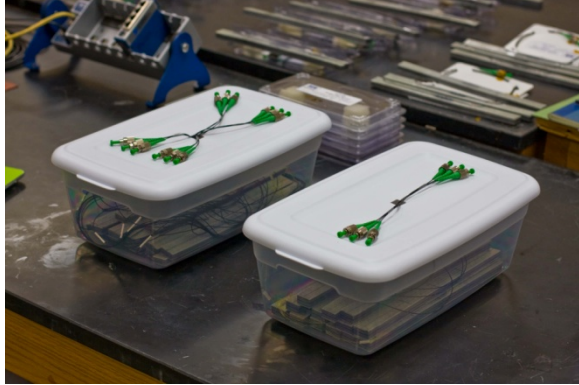
FIGURE 2: COUPONS IN SOAK TUBS

The set of coupons to be soaked in salt water were placed tubs with the FBG connects passed through a hole in the lid and out of the water, as shown in Figure 2. ASTM standard D570 was used to simulate a marine environment and the tubs were placed in a furnace for five months at 50° to assist salt-water diffusion. This is within the operating range of both sensors [22, 23]. Mass and wavelength measurements were taken for every coupon before and after the soaking process. These measurements were also tracked for a set of representative coupons during the first month to determine the amount of water absorbed by the composite matrix and its effect on material strain.

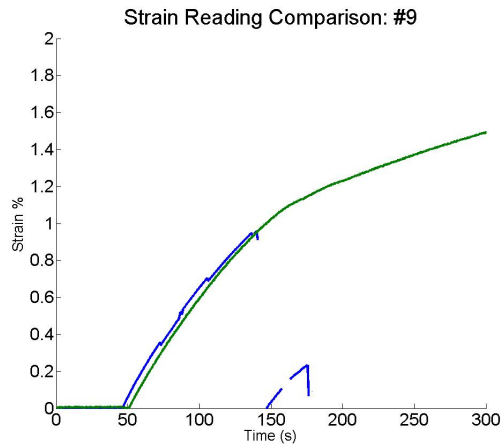
FIGURE 7: COMPARISON OF EXTENSOMETER AND FBG STRAIN USING EXTENSOMETER (GREEN) AND UNCOATED OS100 (BLUE)

Also of interest was the accuracy of the FBG strain measurements throughout the mechanical testing. Figure 7 shows the strain readings from the extensometer and an uncoated os1100 FBG, sample 9, plotted against time. As seen, the strain readings correlate very well up until sensor

failure; however, the FBG jumps slightly in its reading over the course of time. This occurs as the sensor response begins to degrade and the software detects multiple, small wavelength peaks that each fit the peak definition criteria. Each could be selected as the true peak and the software determines the peak that best fits the given criteria, however incorrect it may be. It needs to be noted that the software does allow parameter calibration that could reduce the error in peak selection and that the peaks selected are very near the true strain. Also seen in Figure 7 is that the software does return a value after sensor failure though it is very much in error.

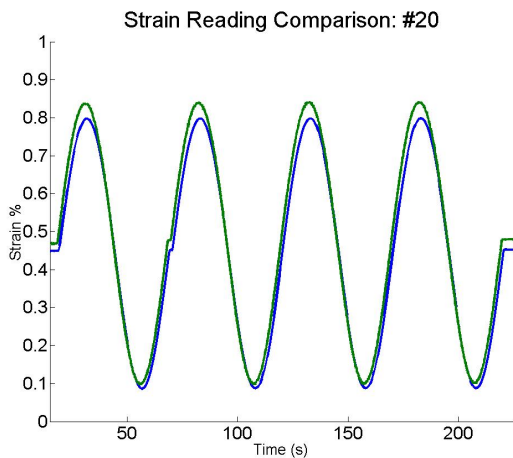
FIGURE 9: STRAIN RESPONSE FOR FATIGUE TEST OF SAMPLE 20 USING EXTENSOMETER (GREEN) AND RECOATED OS100 (BLUE)

R-value of 0.1 to produce a maximum load near 0.75% strain, and based upon the dry, static test results. This resulted in maximum and minimum tensile loads of 28 kips and 2.8 kips, respectively, at a frequency of 1 Hz. Dry, fatigue tests demonstrated good agreement between the FBG sensors and the extensometer. Temperature compensated strain measurements for sample 20 are shown in Figure 9. The dry coupons failed at an average of 3,000 cycles and occurred earlier than would be expected for this layout. Similar carbon fiber laminates have been shown to strain statically to 1.5% and fail in the realm of one million cycles at 0.5% strain [24]. Fatigue failure consistently occurred within the grips. This is likely a result of the high grip pressures in conjunction with the curvature of the coupons and was not attributed to the shear between the outer glass and carbon layers, as seen in the wet, static tests. While this indicates error in failure loads, the performance of the FBG sensors may still be evaluated. For all of the dry samples, the coupons failed before the sensors and sensor bonds and provided clean output signals.
